SHIPPING ENCAPSULATED CS-137 SOURCES AS SPECIAL AND NORMAL FORM

E.D. Robbins
Westinghouse Hanford Company

D. Carlson
Chem-Nuclear Environmental Services, Inc.

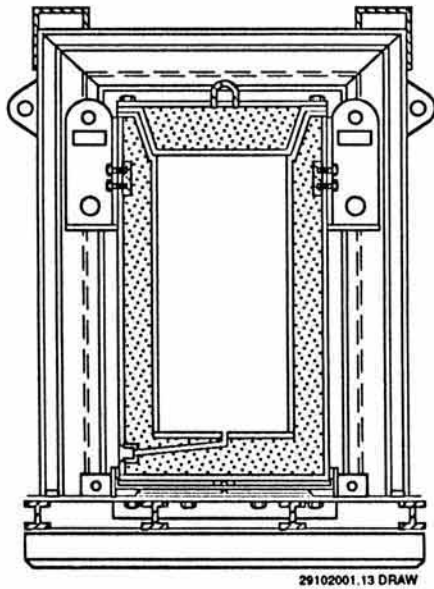
Fig. 2a. Model GE-600 shielded container (cask).

The first shipment (one capsule) was made on August 17, 1988. Upon arrival, it was discovered that the overpack contained several milliliters of water. Two measures were taken to eliminate this from occurring in future shipments. First, the overpack was redesigned with an improved valve system. Second, the loading procedure was revised to require pulling a vacuum on the overpack to further ensure dryness. This vacuum drying required that the overpack be evacuated to 4 mm Hg less than the vapor pressure of water at pool water temperature and held for 15 min. The overpack was then isolated from the vacuum pump and considered to be dry if pressure rose less than 4 mm Hg in 5 min. This new design and procedure proved to be more successful in eliminating the water.

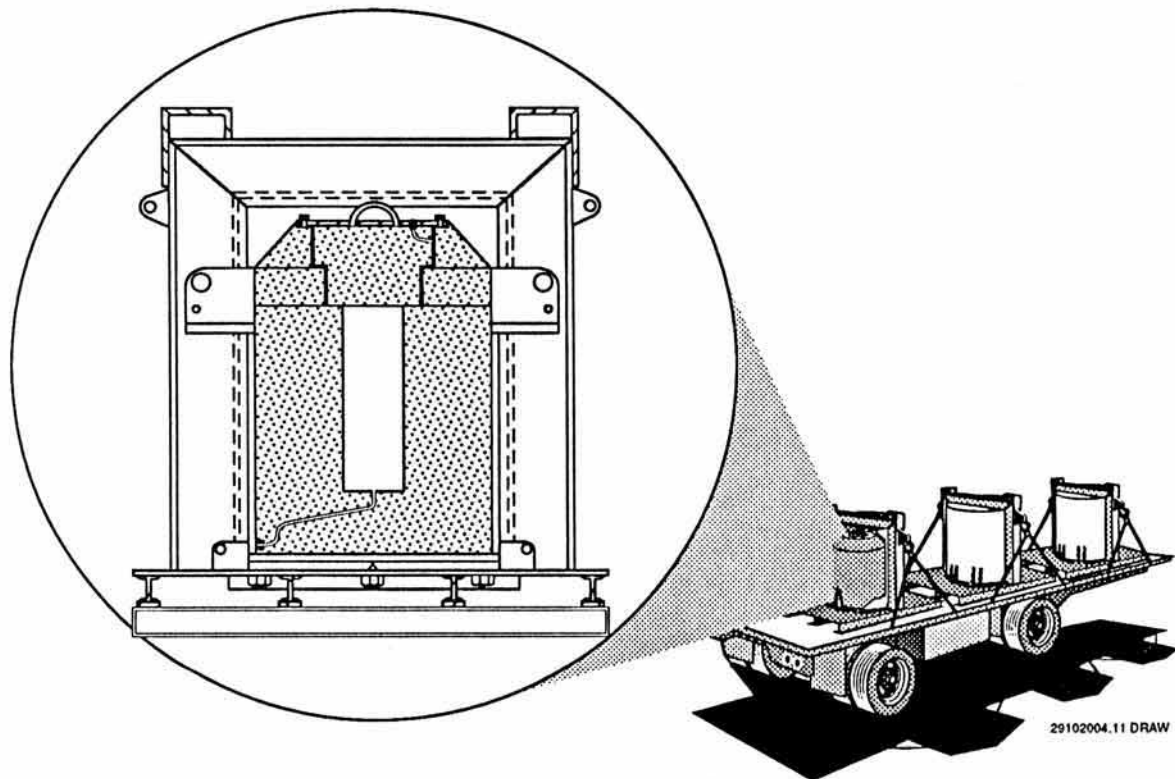
Fig. 2b. Model-1500 shielded container (cask).

In August 1989, during special form shipping, water was discovered in one of the Model-1500 casks when it arrived at the Hanford Site. Since the loading procedure included blowing down the cask to ensure its internal dryness, the mechanism for this influx of water was not immediately apparent. The most probable cause was a leak from the internal void areas of the cask into the center cavity. Several cask integrity tests, described below were conducted to definitively establish the source of the water.

These tests demonstrated that several casks had internal leakage. The problem was eventually isolated to a leak between the drain line and the internal portions of the cask (Fig. 2b). The situation was corrected by welding a new drain line internal to the original drain line. No further incidents were encountered and the last special form source was shipped in April 1990. In addition, these tests were incorporated into the CoC for the cask to be performed before every third shipment.

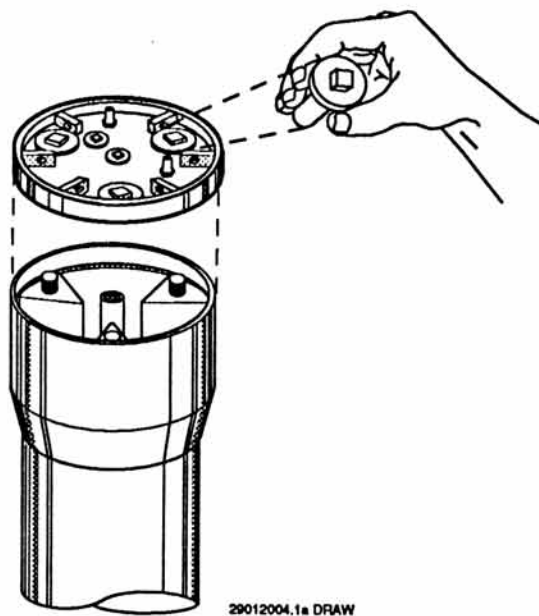
Fig. 3a. New special form canister.

On August 15 1990, during unloading at the WESF, operators noted that when the closure nuts were untorqued on one canister, a small amount of steam escaped.

Evaluating of the canister design drawings indicated that the most likely steam source was water trapped between the closure nuts and their holes in the canister lid. Actual testing of the canisters with nonradioactive capsules confirmed this evaluation. Further evaluation determined that this water could not enter the payload area of the canister or the cask cavity, and was therefore of limited concern.
