# REMEDIAL ACTION CONTRACTOR RESPONSIVENESS: DEWATERING AND THE IPS DURING CONSTRUCTION AT THE DURANGO DISPOSAL CELL

Marjorie L. Wesely, Anne C. Connell  
Morrison Knudsen Corp.

J. Patrick Powers  
Muesser Rutledge

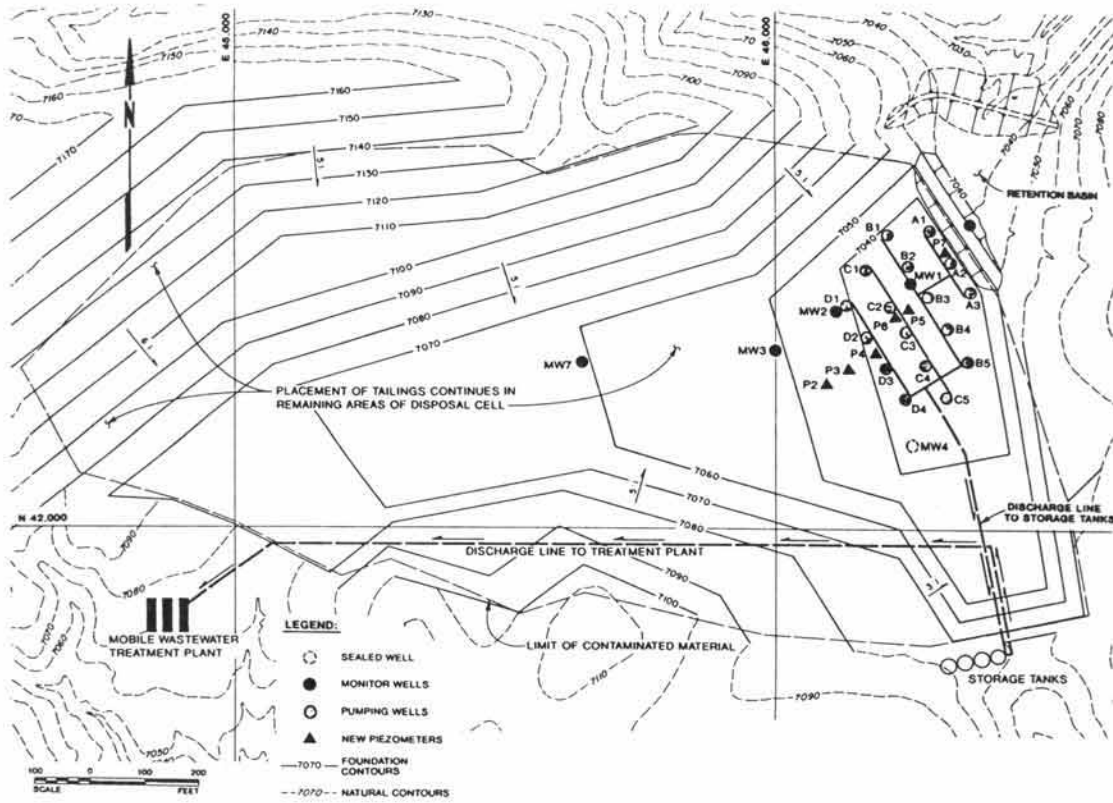
A pilot dewatering system was installed consisting of a grid of 17 pumping wells on the completed east slope, west of the seep (Fig. 1). This pumping operation would have limited impact on the construction schedule, would begin the process of removing and treating the water, and with careful instrumentation, would provide data for reliable determination of the final fix. These 17 wells were supplemented by 6 piezometers (P2-P7) located within and adjacent to the well array to provide drawdown data at key points.

Fig. 1. Plan view of the 17 wells dewatering system.

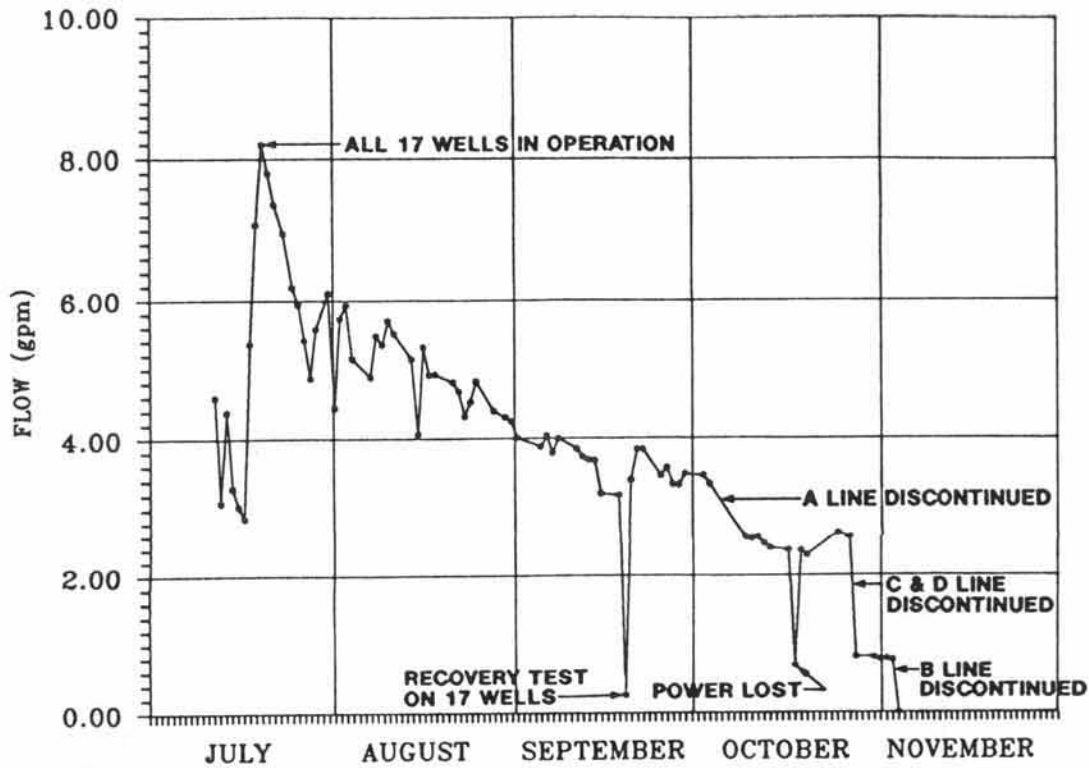
Figure 2 is a summary of the flow rate (gpm) for the seventeen pumping wells through November of 1989. When all wells (except D2) were initially pumping on July 20, total combined flow was approximately 8 gpm (11,500 gallons per day [gpd]). The pumping rate declined to 6 gpm (8600 gpd) by July 25, to 4 gpm (5760 gpd) by September 8 and prior to shutdown had dropped to less than 3.5 gpm (< 5000 gpd). The pumping rates for the well field showed decreased flows in wells trending from the north to the south. As an example, on August 25, 1989 the A-line of wells showed flows for the northern A-1 well reading 0.57, the middle well A-2 reading 0.23 and the southern A-3 well reading 0.18. This trend held quite consistently for the other well lines. Plotting individual maximum flow rates for each well, Fig. 3 illustrates the trend of higher flow from wells in the north to lower flow in the southern wells.

Fig. 2. Summary of the flow rate for the seventeen well pumping system.

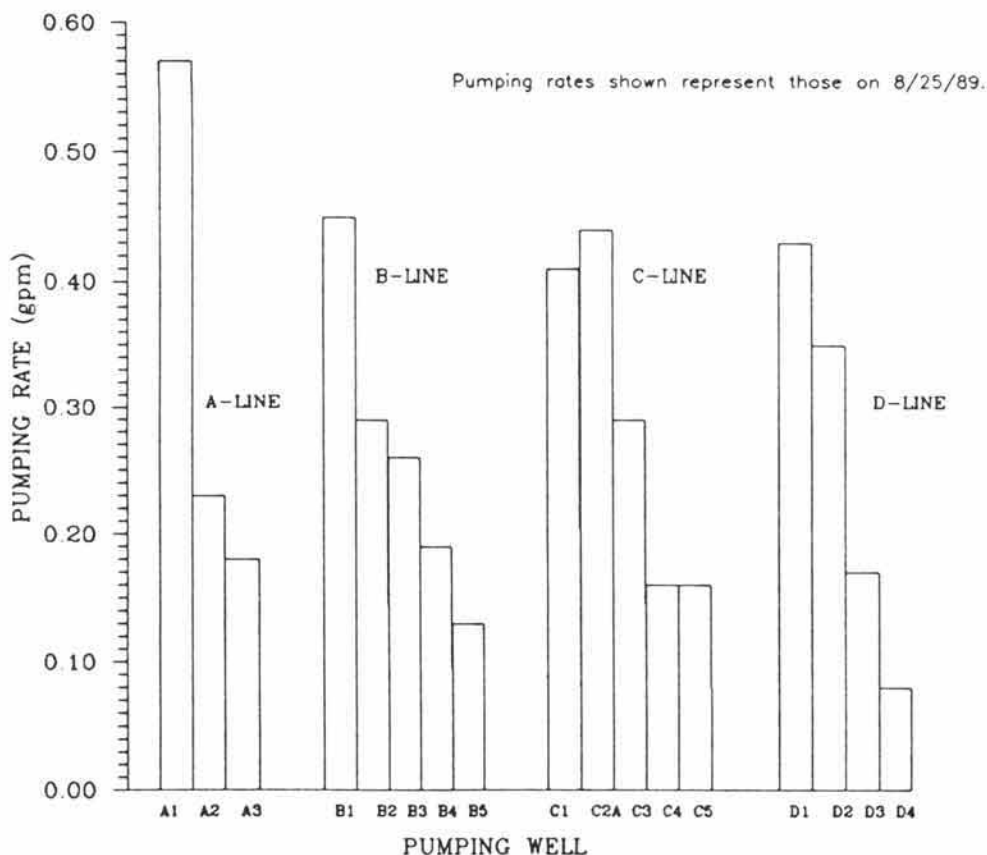
Fig. 3. Pumping rates for seventeen well pumping system.

The anomalies perceived in the data were at last explained. The southern wells pumped less than the northern ones because the 1987 winter cover rose to the south, and the saturated thickness intercepted by the southern wells was less.

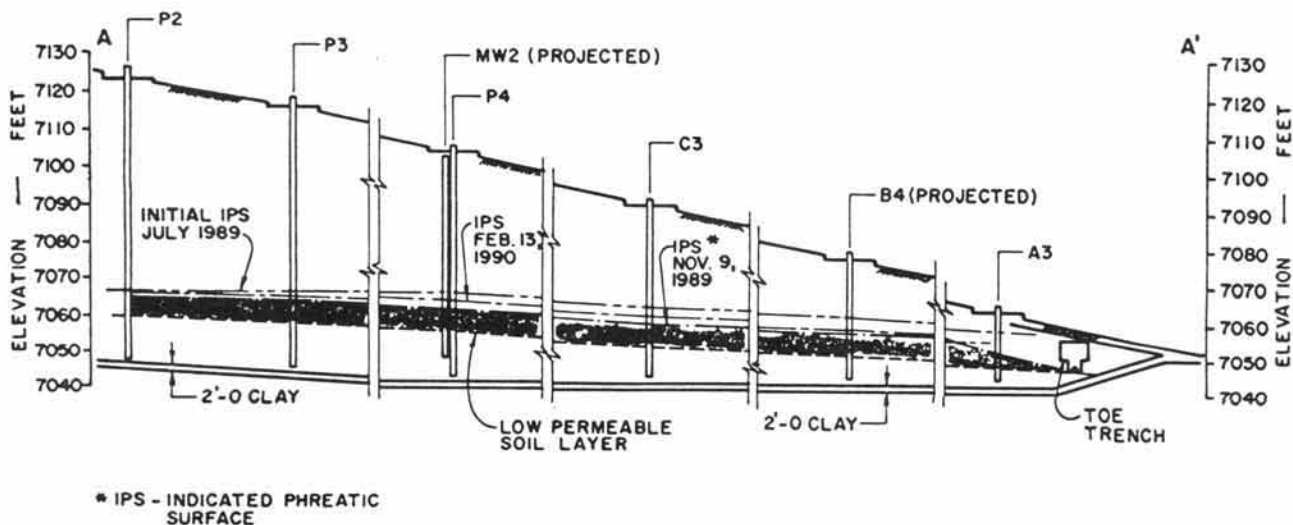
a six inch layer of dark soil was encountered and was identified as low level contaminated vicinity property (vp) material placed as winter cover in 1987. The sandy tailings above the layer began to slough and seep water while the tailings material beneath the layer remained dry (without seeping water). The well point system just west of the test pit indicated an IPS at elevation 7051' although the soil in the test pit below elevation 7048' was apparently not saturated. For months, the data and analyses indicated that the tailings were not fully saturated below the IPS. But the indications had been inconclusive. The test pits finally confirmed that the true condition was a perched water body above the 1987 winter cover. Beneath the layer, the tailings were unsaturated. Figure 4 depicts the perched water in an east/west cross section through the eastern slope of the disposal embankment.

From aerial photographs taken in the winter of 1987 and quality assurance (QA) data collected during contaminated material placement in October and November of 1987, the vp winter cover surface elevation contours were estimated. The embankment surface dipped to the northeastern corner not covered with the vp material. This corner acted as a sump where water accumulated from snowmelt and rainfall. During the following construction season, the ponded water was removed and the saturated contaminated material excavated, spread in a thin lift on top

Fig. 4. Cross section through observation and pumping wells showing the perched water on top of the low permeable soil layer.
