## **REMEDIATION OF AN UMTRA VICINITY PROPERTY CONTAINING MIXED WASTES**

John Elmer, P.E.  
IT Corporation  
U.S. Department of Energy Grand Junction Office  
Grand Junction, Colorado

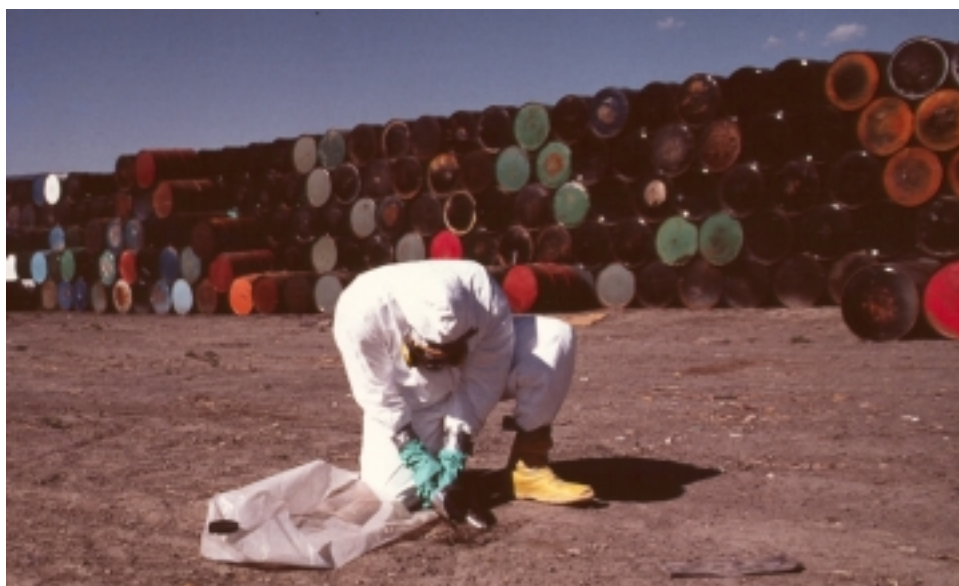
Both airborne and soil samples were taken in 1989 to determine if there was potential for DOE and contractor personnel to be exposed to hazardous materials (see Fig. 1). Photoionization detector measurements obtained near the incinerator showed volatile organic compounds in excess of 200 parts per million (ppm). Analyses of soil samples indicated the presence of heavy metals, such as lead, and chemical compounds, such as endosulfan, pyrene, and DDT.

*Fig. 1. Sampling Soil for Hazardous Waste While Facility Was Operational*

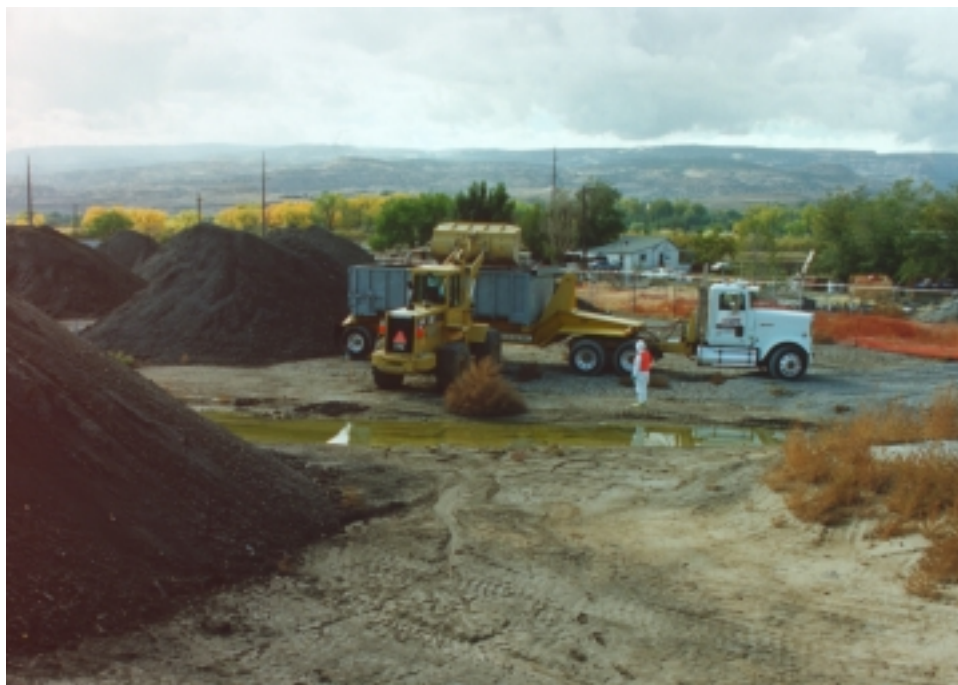
In 1993, EPA returned to the site to excavate and stockpile 6,120 cubic meters (8,000 cubic yards) of lead-contaminated soil (see Fig. 2). The stockpiles were covered with plastic until a contractor could be procured to treat the waste. In 1994, EPA treated

*Fig. 2. Stockpiles of Treated Material*

the contaminated soil with a solidification/stabilization process by mixing cement, fly ash, water, and soil in a pugmill. The mix formula, determined through bench-scale tests, was computer controlled to ensure consistency. The resulting grayish soil was stockpiled in 380-cubic-meter (500-cubic-yard) piles. Lead concentrations in representative samples from these piles, analyzed with the TCLP method, ranged from 0.15 to 0.46 milligram per liter (mg/L). In addition to the TCLP tests, EPA collected samples from various stockpiles and ran Multiple Extraction Procedure (MEP) tests for lead. This method is time-phased to determine if the leachate amounts increase during a 9-day period. Leachate contaminant levels measured in the MEP tests ranged from 0.30 to 0.5 mg/L, which were below regulatory levels.

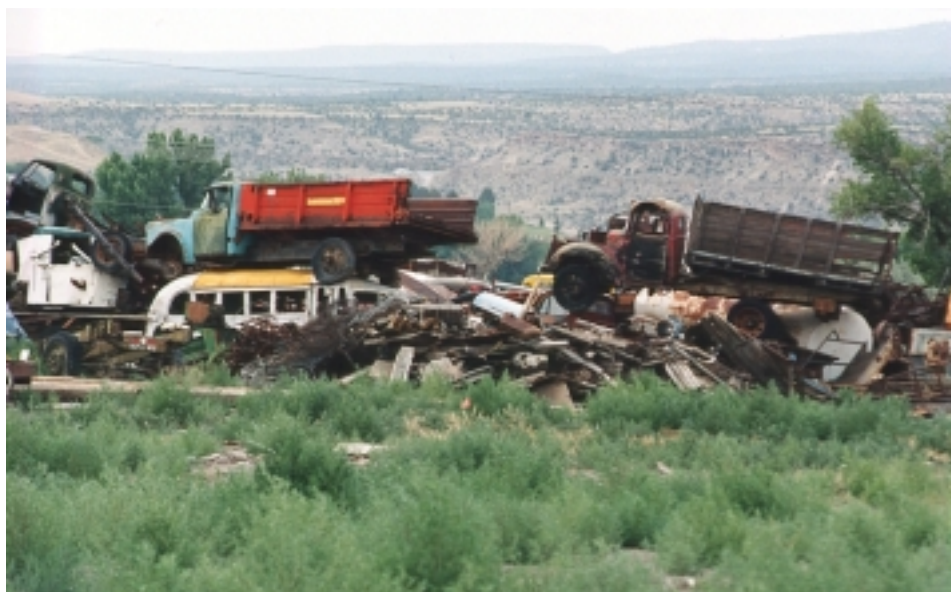
The auto salvage yard (see Fig. 3) was operated by a tenant who had an oral lease arrangement with the property owner. When DOE approached the tenant and owner on how to work around the auto salvage operation, they offered to start moving the cars off the site. After waiting on the salvage yard operator for more than 12 months, the site was finally cleared of enough vehicles so that DOE could perform further assessments. DOE determined that yellowcake contamination was tied primarily to where drums had been previously stored. Historical aerial photos of the site indicated that the auto salvage business crept north over the years onto the former drum storage area. DOE used this information to work with CDPHE to establish a sampling plan for yellowcake contamination on a smaller area than previously assumed. This plan helped reduce laboratory costs because field-screening techniques were not commercially available to identify the presence of yellowcake in soil.

*Fig. 3. Auto Salvage Yard Before Remediation*

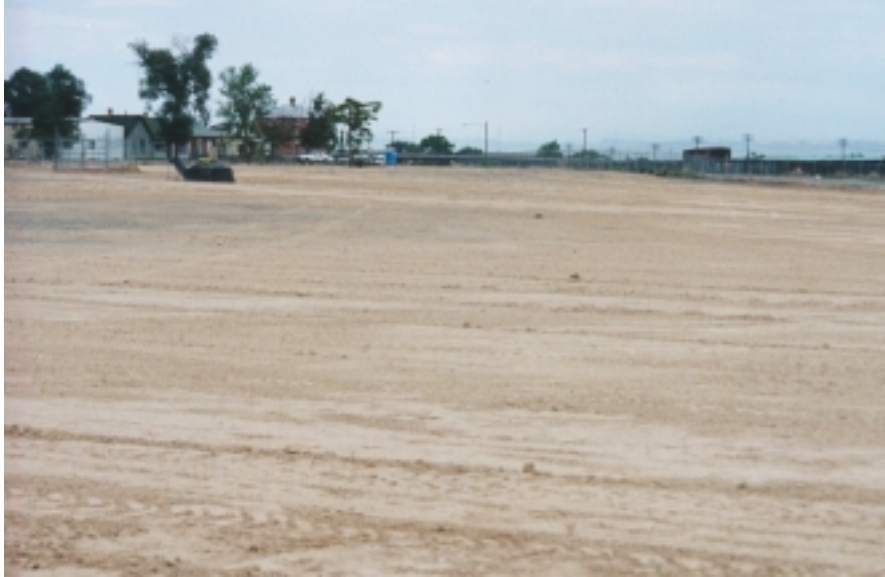
EPA returned to the site several times to complete the backfill and reconstruction. The site is currently vacant land (see Fig. 4). Because the tenant and the property owners have discontinued their operations, future land use is unknown. The city has prepared a Major Street Plan indicating the long-term need to construct a minor arterial street through the property to alleviate traffic congestion in downtown Grand Junction.

*Fig. 4. Site Reconstruction Completed*
