## CHARACTERIZATION OF TANK 241-Z-361

A. M. Hopkins, L. J. Olguin, D. M. Bogen, Fluor Hanford, Inc.;  
S. E. Clarke, U.S. DOE; S. C. Adams, IT Group

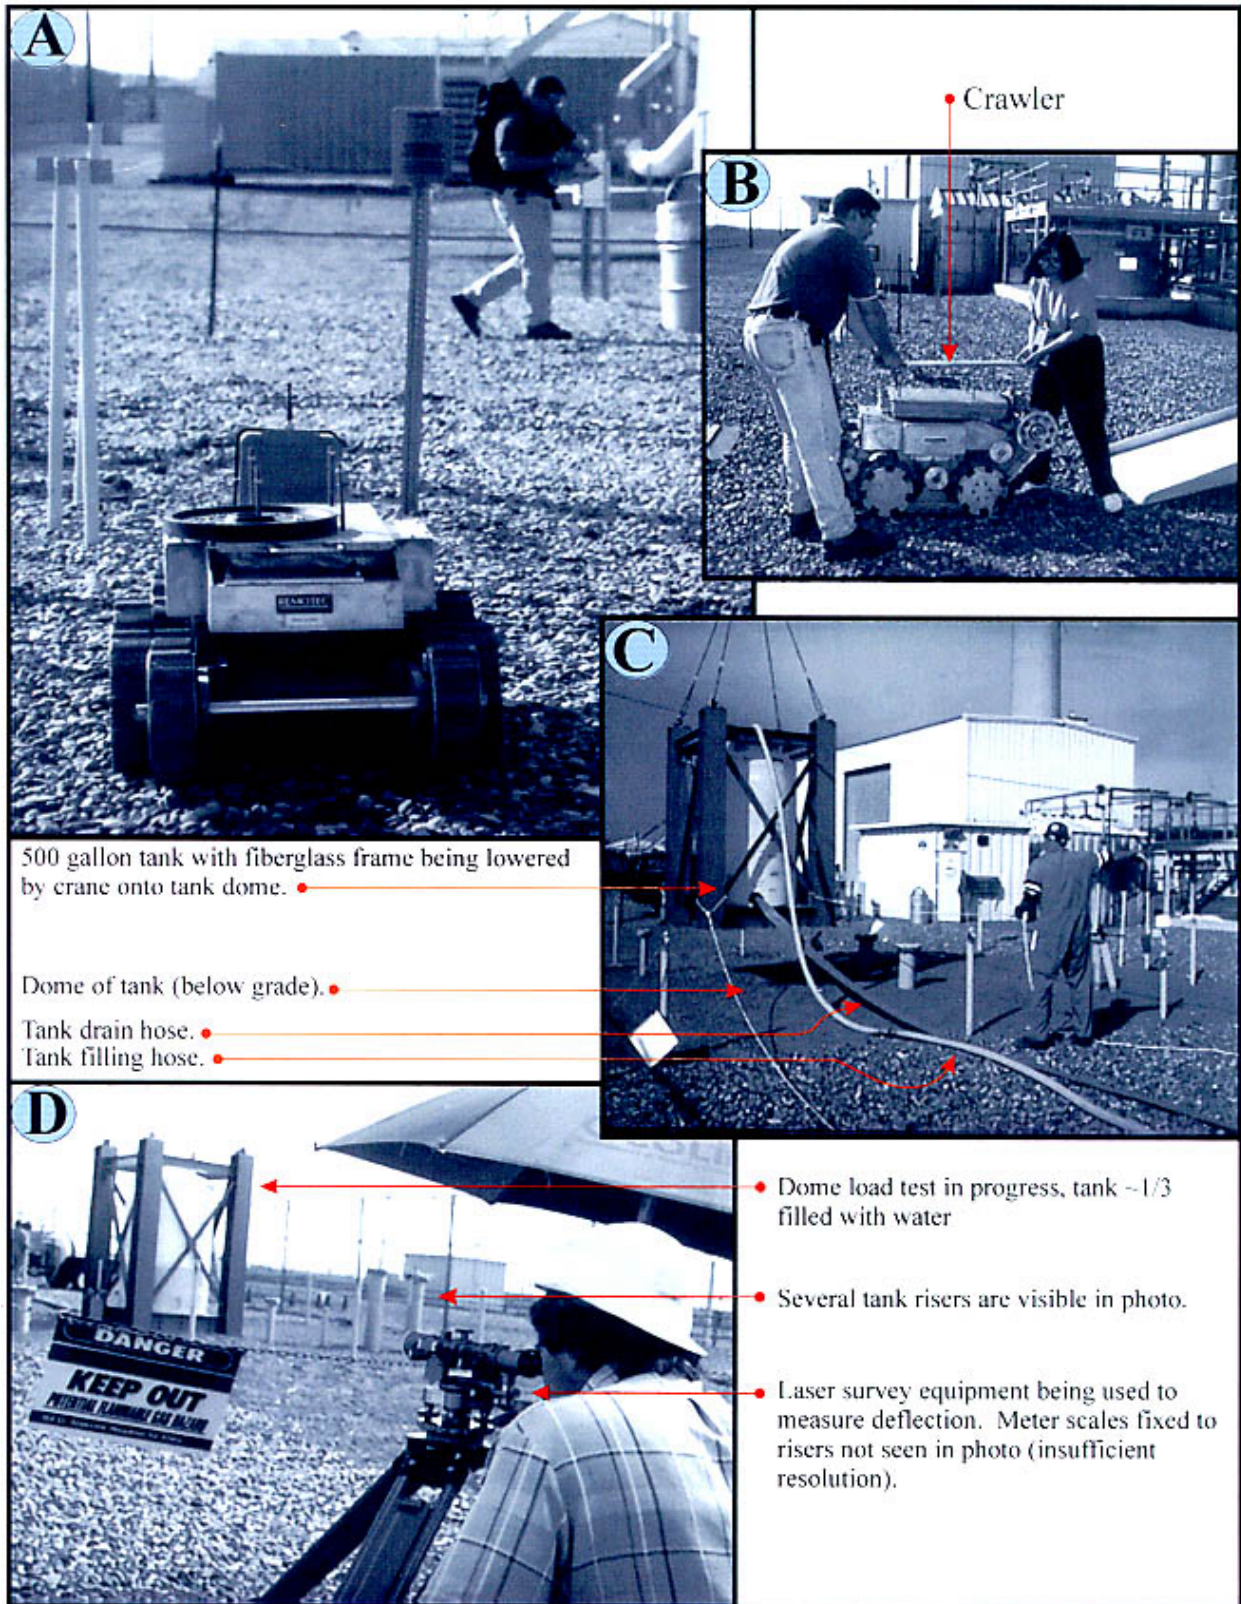
The first load test used a remotely controlled "crawler" with a total footprint load of 272 kg (600 pounds) to access the area around the tank and up to the tank walls (Figure 2 [A&B]). This test provided assurances, with a safety factor of 2X, that an individual plus equipment weighing up to 136 kg (300 pounds) could safely access the tank. With this established, we were able to access the tank and examine the risers and soils for the presence of radioactive contamination and/or flammable gases. Neither was detected.

The second load test was intended to establish a safe working load over the tank dome itself for personnel to perform Phase I Tasks 2 and 3. This test involved the use of a 1,890 L (500-gallon) translucent tank, installed in a non-sparking framework of fiberglass (Figure 2 [B&C]). The fiberglass framework was selected to provide a non-sparking structural support for the tank and a means of attaching the lifting equipment to the tank. Non-sparking tools and equipment were required to avoid the risk of a deflagration until the presence or absence of flammable gases inside the tank was established. Water was slowly added to the tank in 227 kg (500 pound) increments (~60 gallons) and the load held 5 to 45 minutes while the risers were surveyed for deflection. This process was repeated until a total of 1,800 kg (4000 pounds) had been placed on the tank top with the measured deflection within previously established limits. If deflection beyond calculated maximums were observed, the load would immediately be removed and the test terminated. Deflection at the risers were measured at three points (three different risers, one each in the tank center, the SW, and NW corners of the tank) using laser survey equipment accurate to within .25 micrometers (0.001") (Figure 2D). Successful completion of this test established that personnel and equipment up to a total of 907 kg (2000) pounds, with a safety factor of 2X, could work above the tank.

**Figure 2: Tank perimeter and dome load tests:** A, remote operation of crawler during perimeter load test, B, relative size of remotely controlled crawler, C, lowering of water tank onto the tank dome, D, measurement of dome deflection using a laser survey equipment.

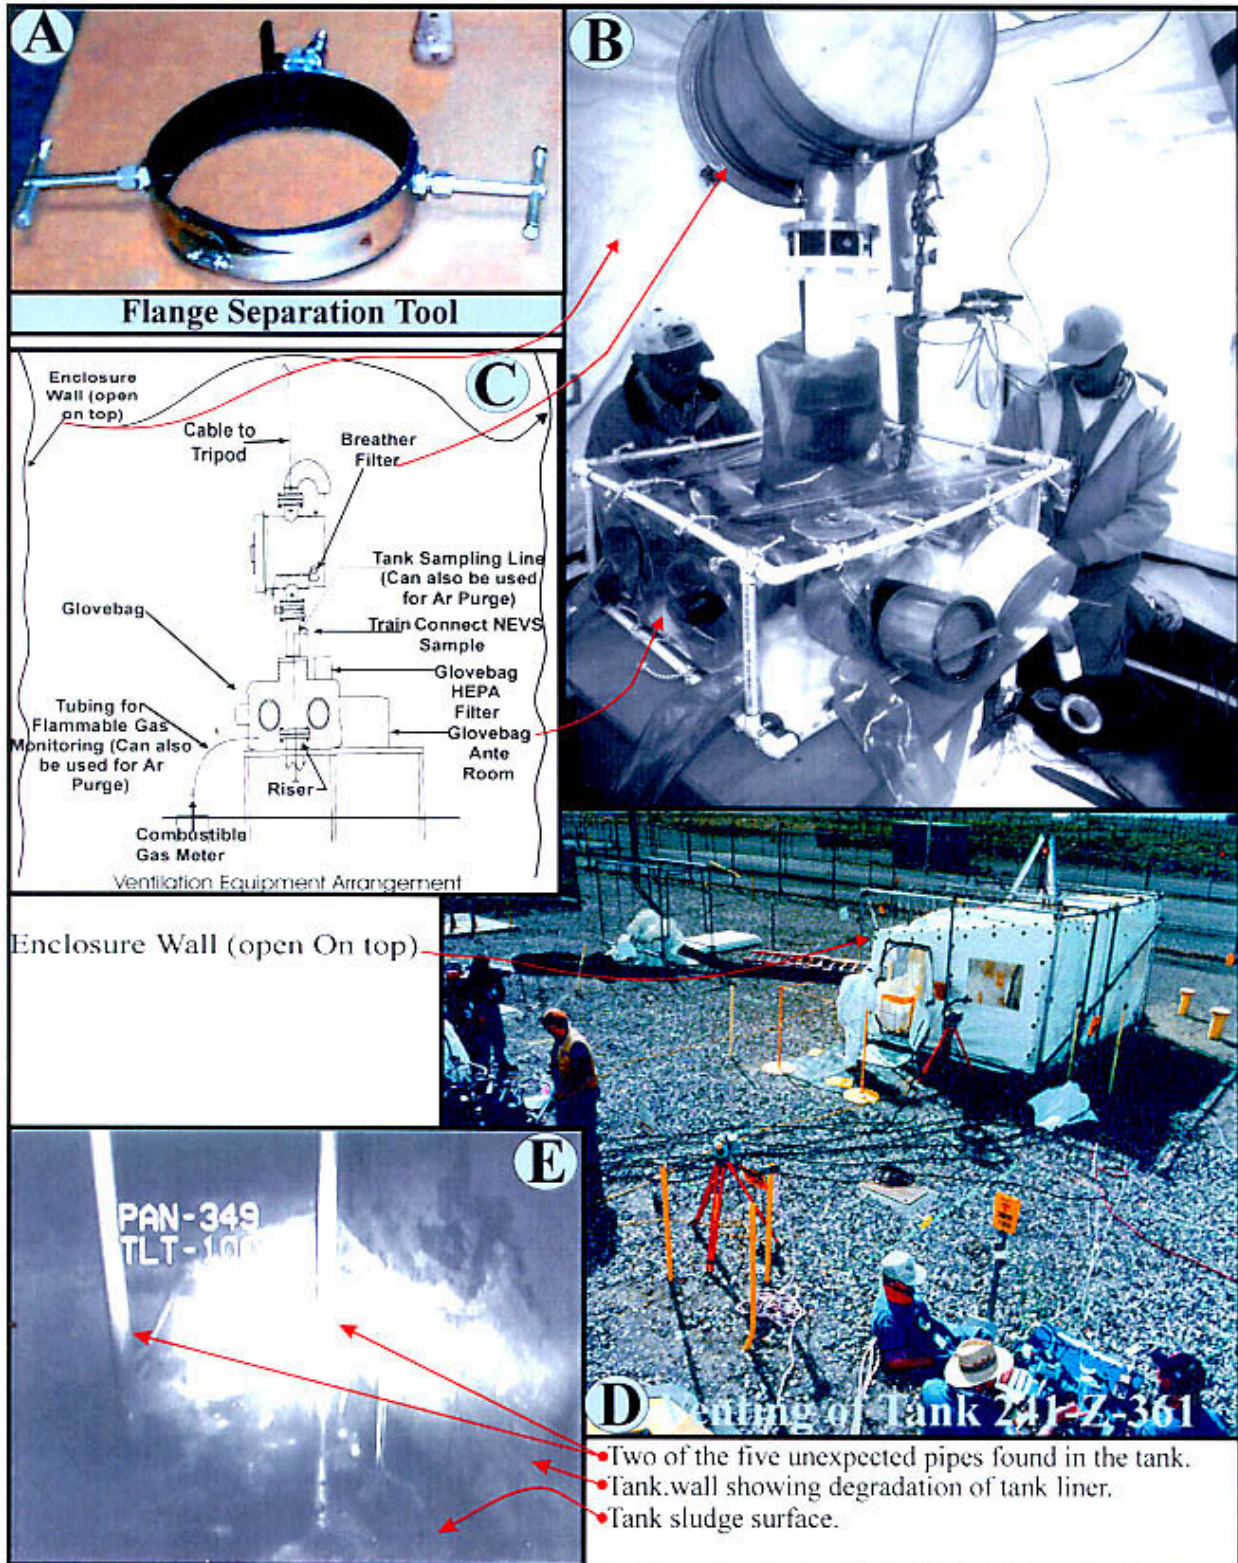
After the tank had been successfully ventilated (Figure 3D) and the breather filter had been installed, the tank headspace was sampled for organic vapors and the interior of the tank was video taped (Figure 3E).

**Figure 3: Tank venting, breather filter installation, vapor sampling, and video taping of tank interior:** A. pipe band, a tool to control rate of gas release, B. photo showing setup of glovebag with enclosure, C. schematic of tank venting equipment, D. photo of enclosure, E. still photo made from video tape of the tank interior.

The low levels of hydrogen are believed to be due to leakage around a tank riser. The riser upon which the breather filter was installed was found to be loose in the tank dome. Had we been able to discover this earlier in the process, the hydrogen concerns could have been alleviated. However, until the hydrogen levels were known, very little work was permitted on the tank. Given the ease with which hydrogen-oxygen mixtures may be ignited, the ability to "shake" risers to assess their attachment to the tank was not even considered.

The video of the tank confirmed our suspicions that the tank had not appreciably degraded from the 1975 time period. However, we were shocked to discover five pipes extending from the 20 cm (8") risers and the two 91 cm (3') manholes down into the sludge (Figures 3E& 4A). The records indicated that everything, with the exception of the risers, had been removed from the tank in 1985. In addition, significant cracks were found in the tank dome. Some of the cracks have what appears to be "black stuff" in them. We believe that this is some of the 0.64 cm (1/4") of tar sealer applied to the tank dome prior to the second 10 cm (4") of concrete poured over the tar. If this assumption is valid, then several of the cracks penetrate completely through the original tank dome and support the caution applied to loads permitted on the tank. The other two items of note in the video is the presence of free liquid above the sludge, and what appears to be a remnant of the original steel liner.

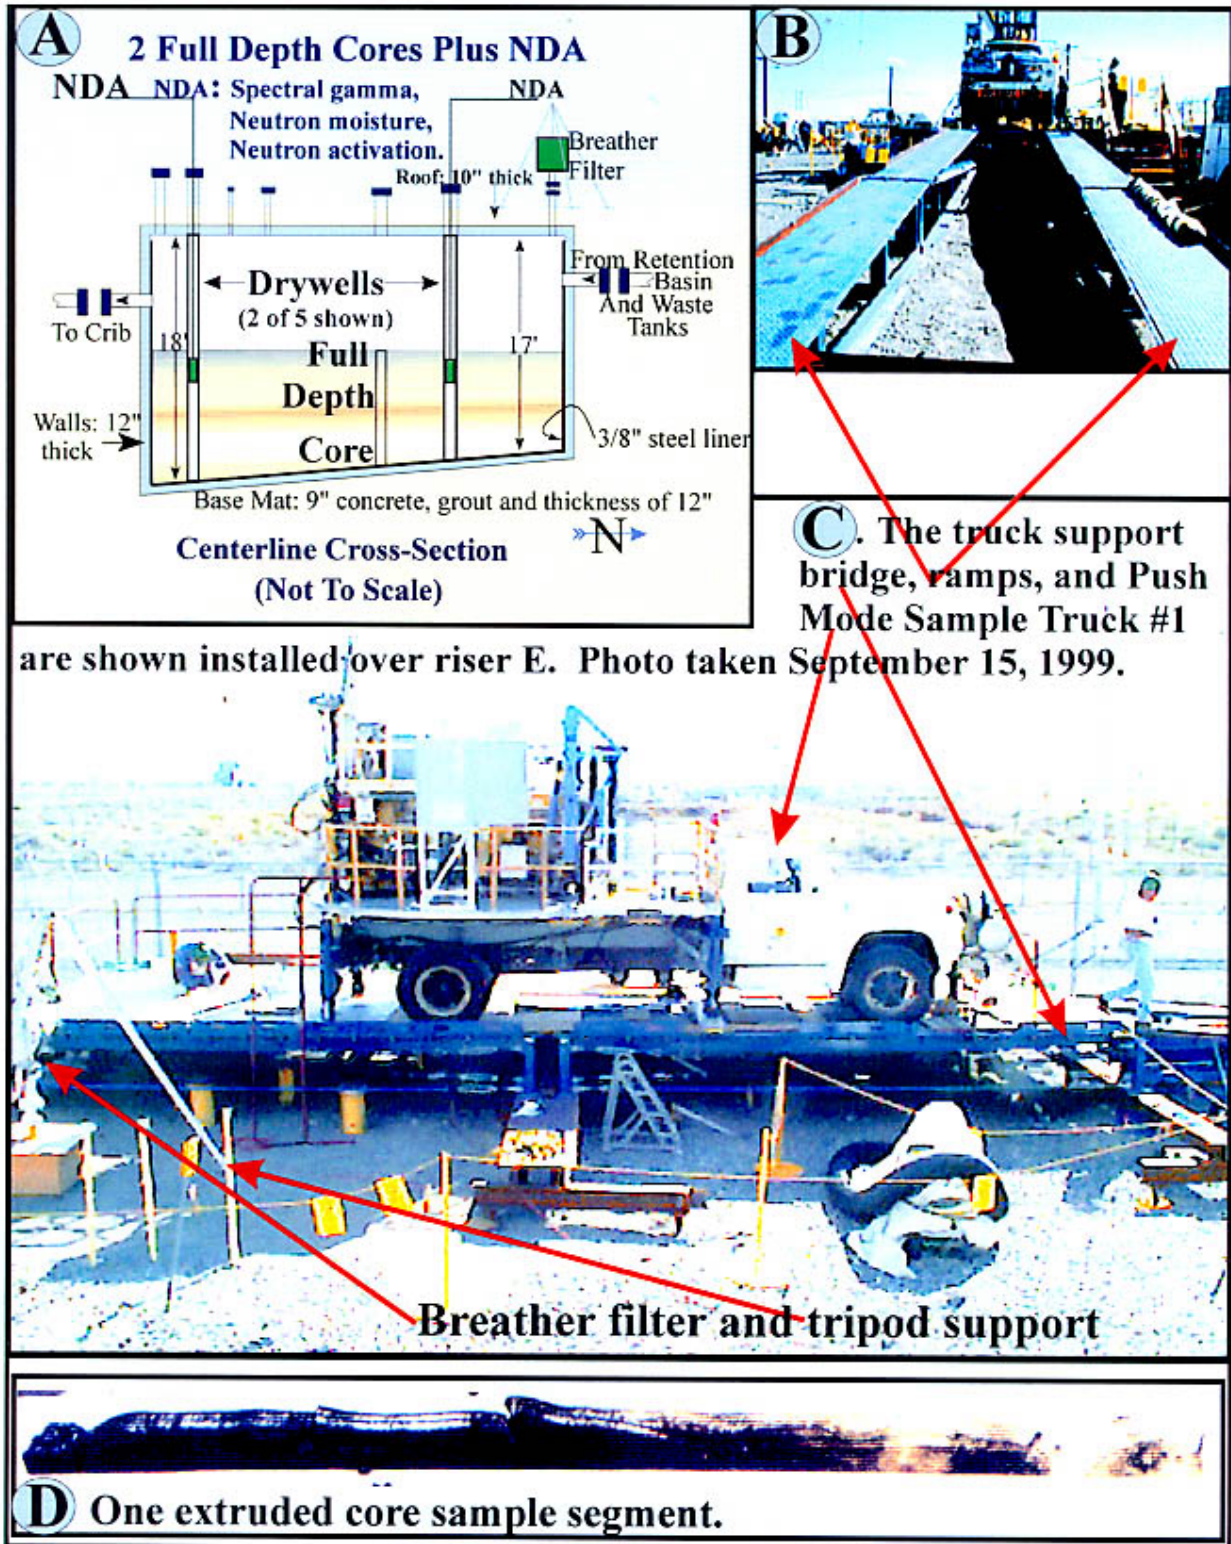
During our research into the history of the tank, reference was found to drywells, but no records were ever found that supported that they had either been installed or removed. This change in tank configuration caused the team to revise our sampling plans and the TSAP. Previous planning included three full depth core samples from risers B, E, and F. However, the video also showed wires, bottles and discarded "tubing" below riser B (Figure 3E). Because of the debris, we elected to NOT use that riser for fear the logging equipment might become entangled and compound the existing problems of core sampling this tank. Our planning was reduced to two cores (risers E and F) supplemented by down hole logging (NDA) in risers B, F, and G if the installed pipes turned out to be drywells. The down hole logging would use passive detectors and a Cf source for a neutron generator for activation analysis. Subsequent investigation (tank entries) showed the pipes to be drywells with 38 cm (15") to 46 cm (18") of condensation water in them. The water was removed and pipes dried in preparation for the NDA work (Figure 4A).

**Figure 4:** A, Schematic showing new strategy of core sampling and NDA of selected drywells. Not all core samples or NDA of drywells shown, B, Photograph of ramp and west end of bridge, C, Photograph of sampling truck positioned over riser E, D, Photograph of one of ten extruded core segments (five segments/core) shortly after extrusion. Strata and included salts are visible.

The ultimate structural pier solution was the use of "screw piers". These piers have one end formed very similar to an auger, and are simply screwed into the ground. Various lengths are available, and can be joined to reach any depth required. A hydraulic driver was suspended from a tracked backhoe to give us enough reach to avoid loading the tank walls and still reach all of the needed pier locations. Steel I-beams are supported on the piers, and welded perpendicular to the short I-beams are larger I-beams for support of the truck bridges (Figure 4 [B&C]).
