## **RESPONSE AND CLEANUP OF UNINTENTIONAL DISPERSAL OF AN IRIIDIUM-192 RADIOGRAPHY SOURCE**

R. Shult  
Duratek, Inc.

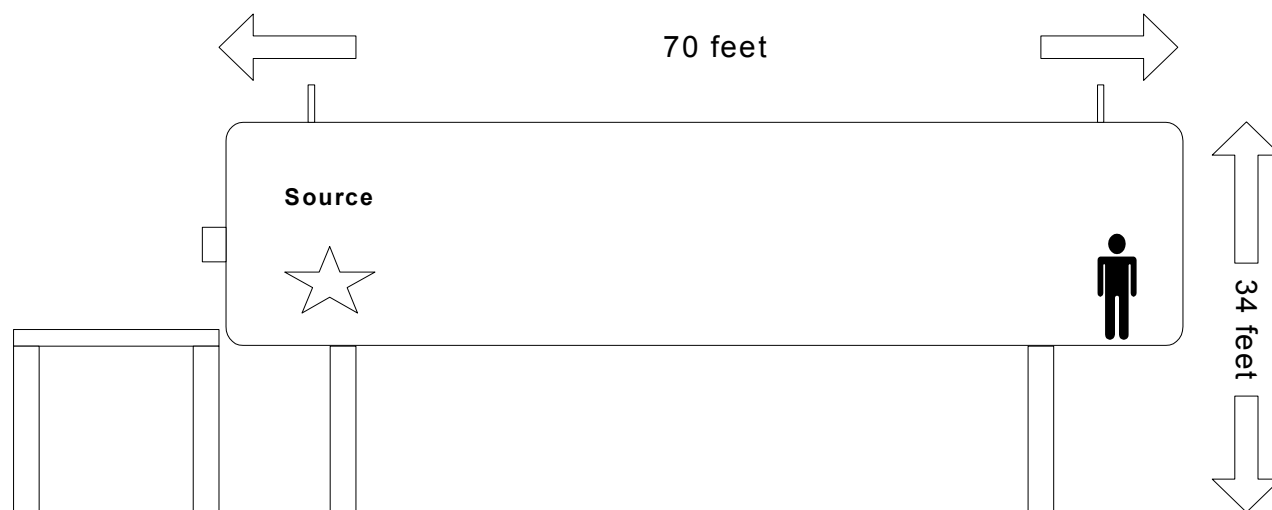
After the metal source jackets were breached, the majority of the source became disconnected from the drive tube and could not be retracted into the radiography camera. The radiographer who was inside the tank during the source breach was at a distance of approximately 50 ft (15 m) from the source. After several attempts at retracting the source he noticed the radiation levels remained higher than expected. His initial belief was that the source had simply become disconnected. That an actual breach of the source jackets had occurred was not discovered for several hours.

Fig. 1 Relation of radiographer, source and tank F5.

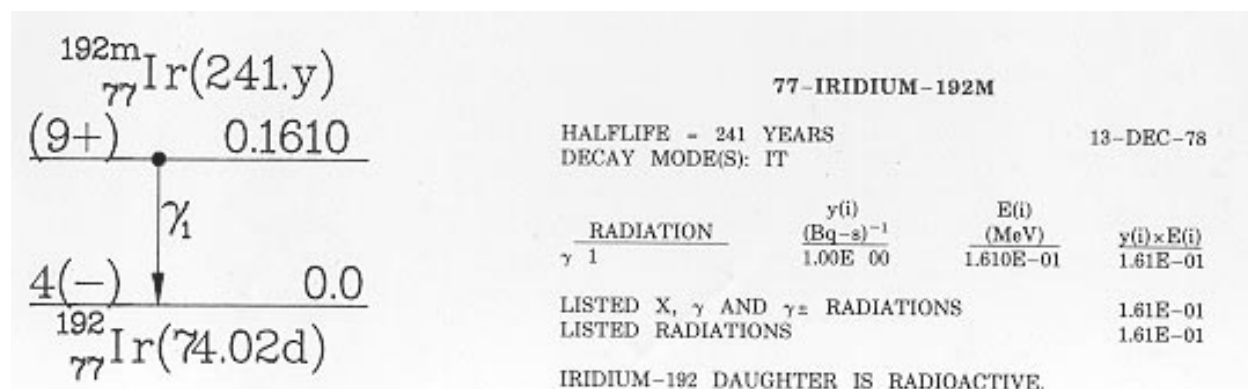
$^{192}\text{Ir}$  decays with a 74-day half life and has abundant beta and gamma emissions. Figure 2 (from ICRP 30) shows the decay scheme for  $^{192\text{m}}\text{Ir}$  metastable (m2). There is another metastable state (m1) of much shorter half life (less than 2 minutes). Of significance is the longer half life of the metastable state (241 years), which reduces the benefit of time and decay of the shorter lived  $^{192}\text{Ir}$ . The ratio of metastable  $^{192\text{m}}\text{Ir}$  to  $^{192}\text{Ir}$  was not determined. Based upon discussions with the source manufacturer, it is estimated  $^{192\text{m}}\text{Ir}$  to be a single digit percent at time of production.

Fig. 2 Decay scheme of  $^{192\text{m}}\text{Ir}$  from ICRP 30.

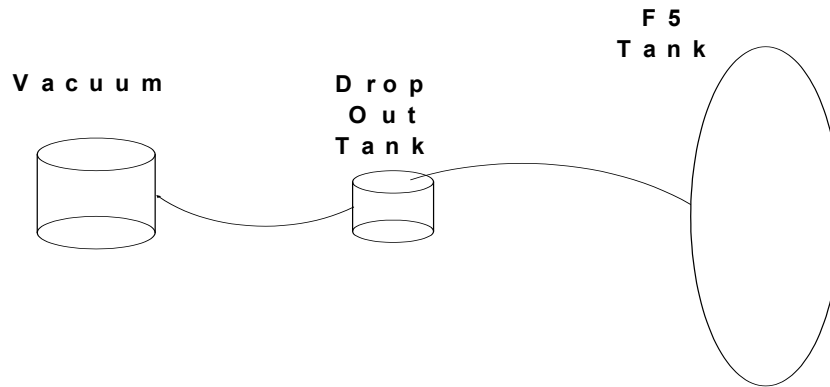
Fig. 3 Configuration of HEPA vacuum, drop out tank and affected tank F5

After retrieval of the camera, gross decontamination of the work platform was conducted. High Efficiency Particulate Absorber (HEPA) vacuums were used for collecting loose material. Shadow shields were used on the platform around the tank opening to reduce worker exposures. A remote camera system was installed to evaluate the interior of the tank and provide videotapes to offsite support engineers. A modified vacuum system with a small in-line drop out tank for debris collection was fabricated to provide for gross cleaning inside the tank (fig. 3). The in-line tank had an outer annulus that was filled with cement for additional shielding (fig. 4). Fittings between vacuum system and drop out tank were designed with quick disconnect fittings in order to reduce personnel exposures. Initial efforts with the camera failed to visibly detect the source particles, so the vacuum head was connected to a radiation detector with a remote readout. As

the radiation levels increased with placement of the vacuum head, the vacuum system would be turned on to retrieve loose debris. Retrieval of the source material was confirmed by monitoring the increasing radiation levels in the vacuum debris collection tanks.

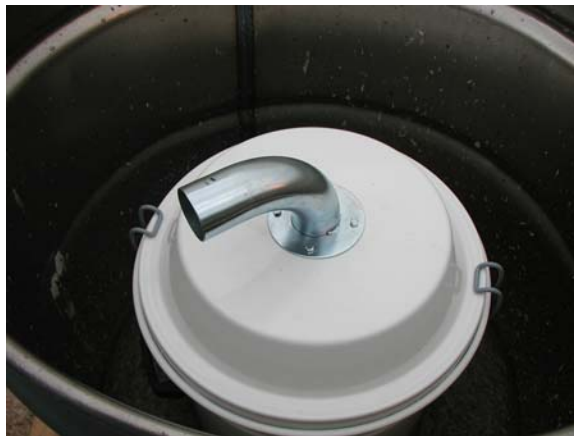
Fig. 4 Drop out debris Ttank with annulus for Ccement shielding
