RECOOLING & OPENING OF SNF CASKS

G. Boehme, J. Griep, R. Jaeger, B. Knobbe
Energiewerke Nord GmbH (EWN)

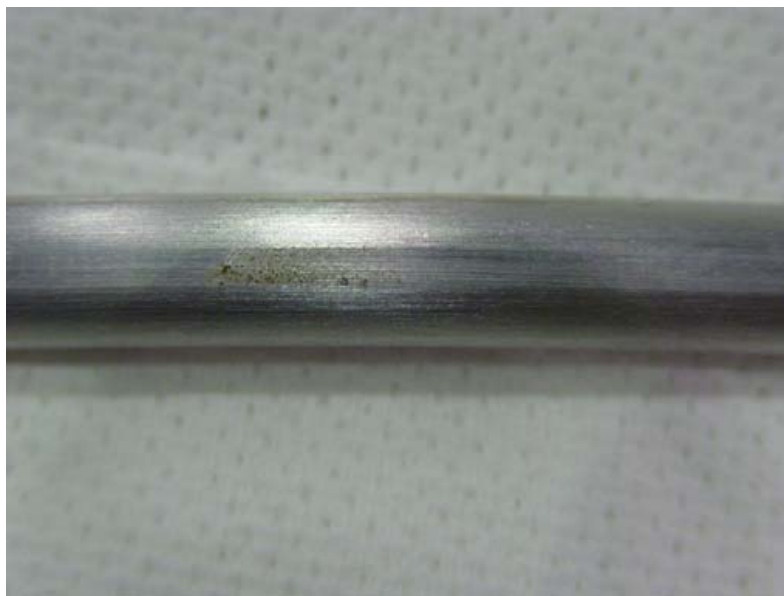
The next inspection of the sealing elements was carried out outside the water and thus under better conditions. The first suspicious circumstances (Fig. 1) were later confirmed in the

laboratory. However, the visual inspection already showed that the seals were properly installed, at least defects and foreign bodies were not found at the first two investigated SNF casks. The deposition areas of the dried spots with their borders already detected with the underwater camera were now in the dry state more clearly seen on the sealing area of the cask. The print of the seal on the sealing area of the cask was here and there covered by dried spots. Such spots could also be seen on the aluminium coated seal at the same places. On the pressed area of the seal, defects were seen. Under microscope, defects became in some cases visible as stitch-like pitting scars. In some cases, brown depositions in the scars could be seen.

Fig. 1 Pitting scars on the aluminum coated seal of the Primary Lid

Partly, the borders of the deposition areas can clearly be identified as result of drying process. On the spots of the aluminum coated seal damaged by pitting scars, the appearance of Cl and Fe is significant (Fig. 3). In the micrograph of the aluminum coat of the seal, pitting could be detected at the damaged spots. This was already seen before with a magnifying glass (Fig. 1).

The measurement of pitting corrosion showed depths up to 0.025 mm. The deposition on the seal, mainly near the tapped blind holes, reached a thickness of nearly 0.020 mm.

The presence of Cl and Fe especially in the deposition borders leads to the termination of passivation of the aluminum and makes pitting possible.

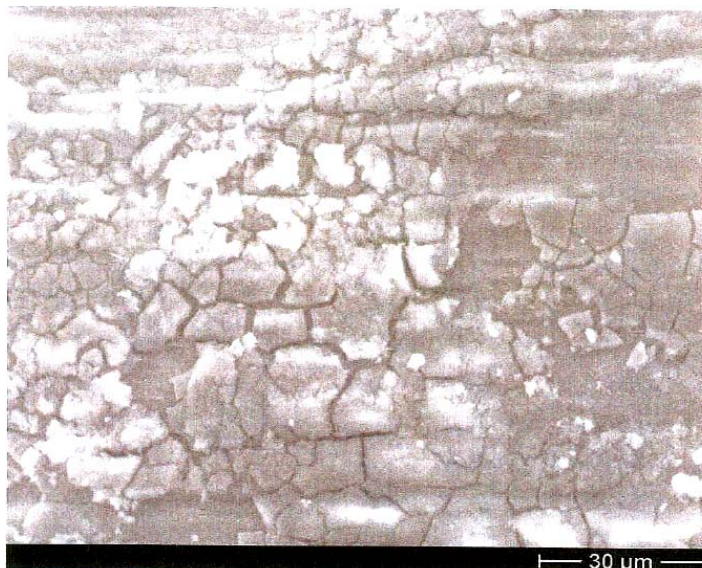
The composition of the detected depositions (Table IV) and their thickness, and the composition of the depositions in the corrosion scars had to be investigated. Furthermore, foreign material from preservatives and other auxiliaries used for the clearance of the casks had to be found. Dimension and depth of the existing corrosion scars in the Al-coat of the seal had to be determined as well. By transverse microsections (Fig. 2) in the sample material and assessment by SEM, it was intended to investigate the Al-coat damages.

Fig. 2 SEM picture at the place of pitting corrosion of the aluminum seal

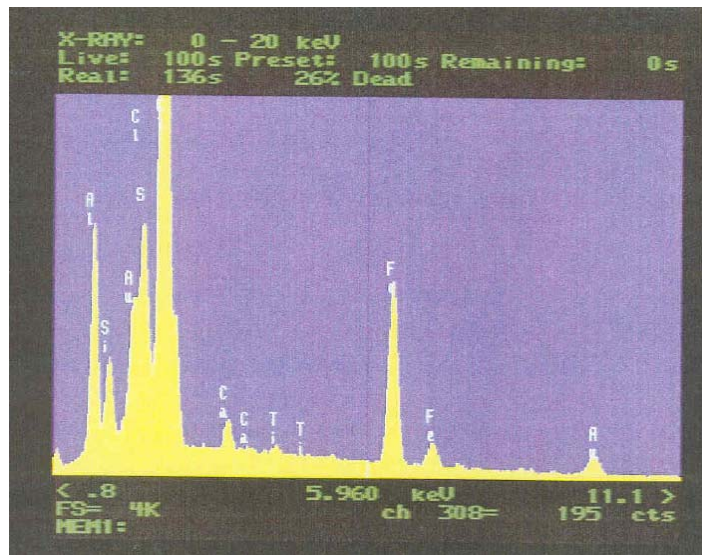
Fig. 3 EDX investigation of the aluminum seal at a Spot with Findings.

The formation of depositions can be explained by transport processes of the ceramic paste and by corrosion products from the tapped blind holes during evacuating and drying of the inner cask room under vacuum conditions/saturated steam state. The found Cl content could also come from the elastomeric seal and Fe with high probability from not Ni-coated tapped blind holes.

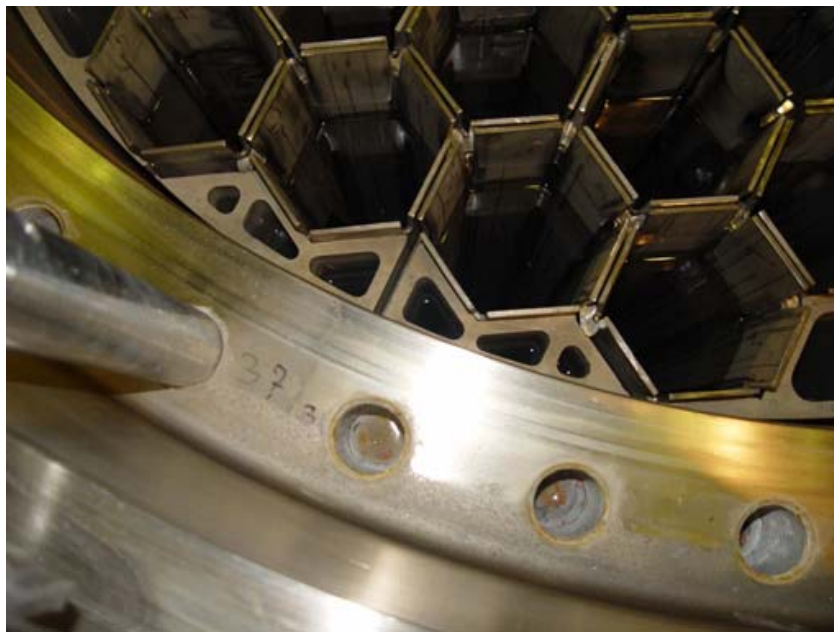
Fig. 4 View into the SNF cask – again unloaded after 3.7 years

The state of the basket for the spent fuel elements did not show indications of wear, corrosion or other changes (Fig. 4). The nickel-plated inside surface of the casks and the sealing area of the primary and secondary lid were bright blast except of the described depositions on the sealing area of the primary lid, and it looked like just prepared for first use. There were only indications of corrosion (rust) in the tapped blind holes which were not protected by a nickel coat and near them on the cask flange.
