REMEDICATION OF RADIUM CONTAMINATED LAND AT A FORMER ADMIRALTY RESEARCH CENTRE

A. Graham, R. Murley, L. R. Fellingham
RWE NUKEM Ltd, B424, Harwell, Didcot, Oxfordshire,
OX11 0QJ, UNITED KINGDOM

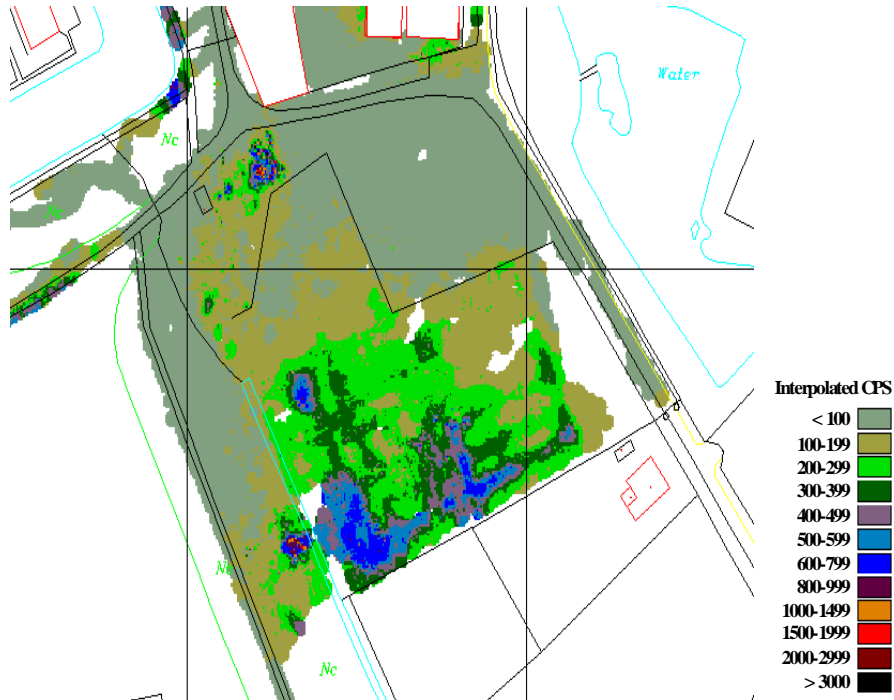
detectors were mounted in a line at 1 m spacings across the back of a four-wheel drive, all terrain vehicle. The outputs of these surveys were computer processed and displayed as a series of colour contour maps showing the areal distribution of gamma count rate, which was then related to the contamination distribution. An example is shown in Fig. 2.

Fig. 2 Ground contamination survey of allotments area using the Groundhog system

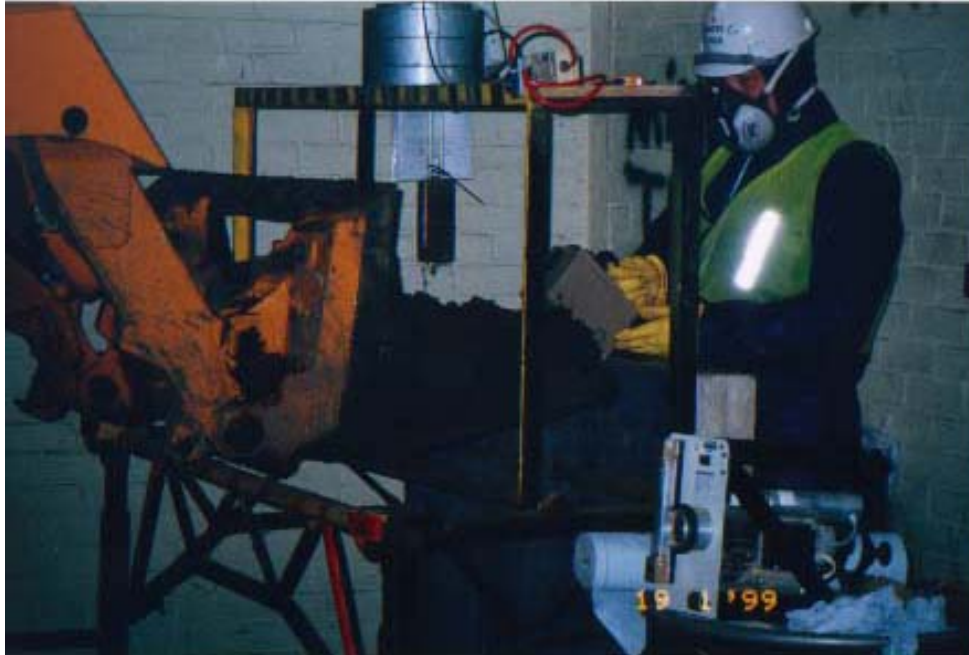
Fig. 3 Radioactive assaying of waste

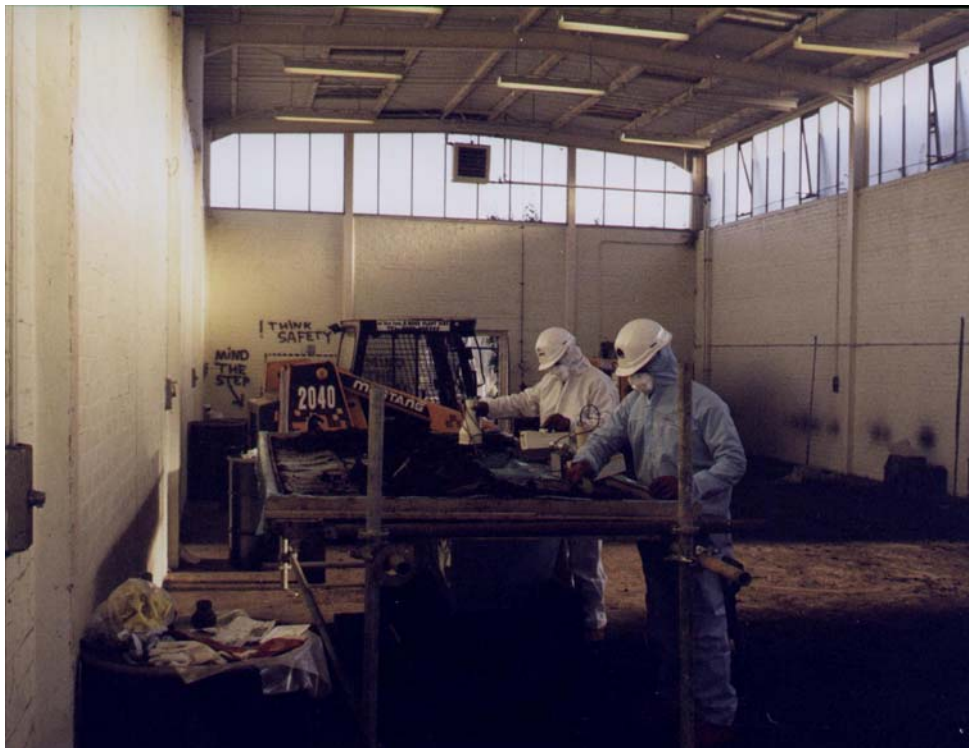
Fig. 4 Monitoring and segregation of waste exported offsite for disposal, particularly to Drigg as low level waste.
