## **Cleanup Progress on High Hazard Legacy Facilities at Sellafield: Pile Fuel Cladding Silo**

D. Skilbeck  
British Nuclear Group Sellafield Ltd  
Sellafield, Seascale, Cumbria, England, CA20 1PG  
United Kingdom

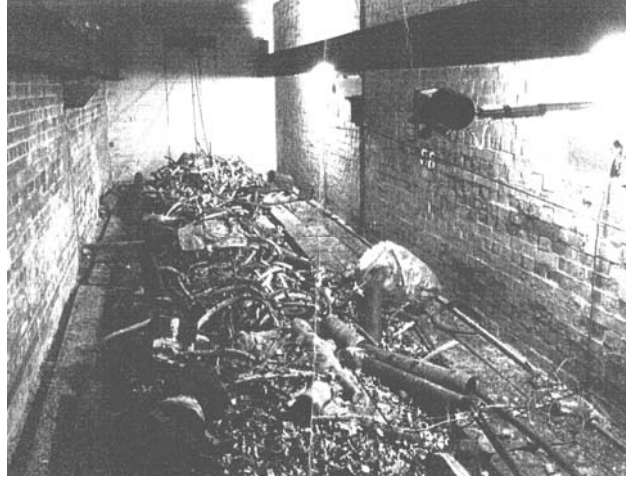
The tipping of waste into the Pile Fuel Cladding Silo ceased in 1965 and the contents have been left undisturbed since that time. When waste tipping was coming to an end, some difficulty had been encountered with waste becoming trapped on the deflector plates above each waste storage compartment. This prevented full discharge of the waste into the storage compartments and resulted in the build up of waste in the Transfer Tunnel at the top of the silo.

Fig. 2. Waste protruding above the compartment charge holes within the transfer tunnel.

Then the waste that had remained in the tunnel since the 1960s had to be cleared (Fig. 2.). A waste clearance method was conceived initially to poke the waste back into the storage compartments. It was subsequently developed and equipped with hydraulic cutters to chop up scaffolding and steel covers that also resided within the tunnel. This simple but effective method cleared all of the bulk waste, scaffolding, and residual material into the compartments (Fig. 3.).

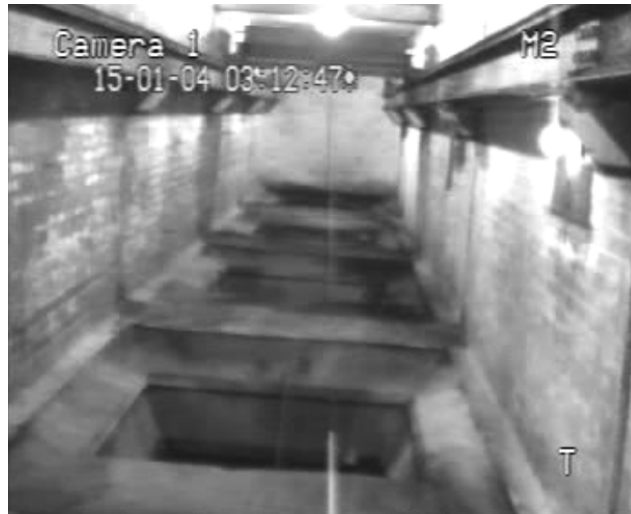
Fig. 3. View inside the transfer tunnel upon completion of waste clearance work.

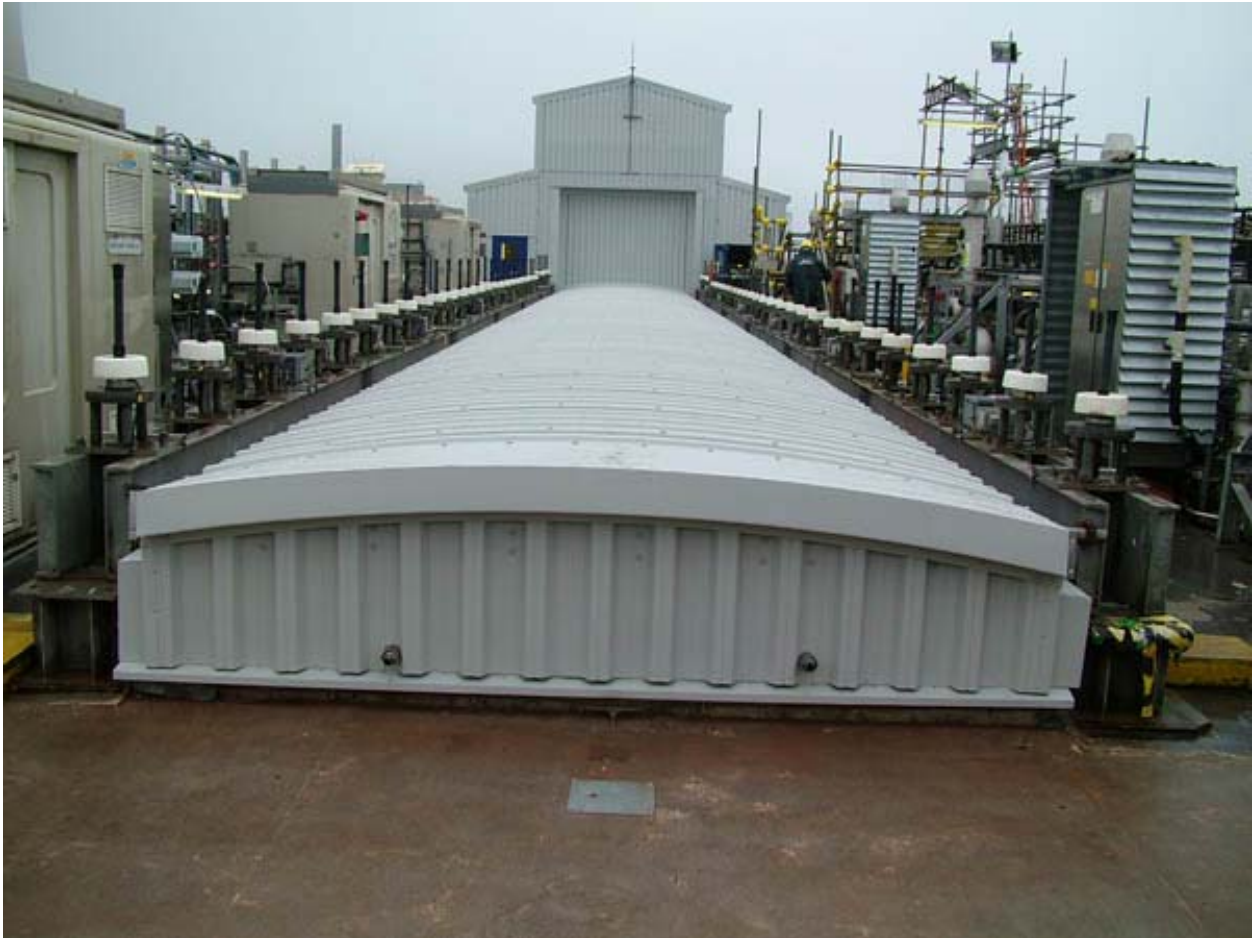
Fig. 4. View following total demolition and capping of the Transfer Tunnel

Following complete removal of the tunnel roof, the tunnel walls were then demolished to the specified level. The remaining low-level walls were then made good and a weatherproof cap was installed and supported upon them (Fig. 4).
