**Managing the Retrieval Risk of Buried Transuranic (TRU) Waste
with Unique Characteristics**

R.D. Wojtasek
Navarro Research and Engineering, Inc.
669 Emory Valley Road, Oak Ridge, TN 37830
USA

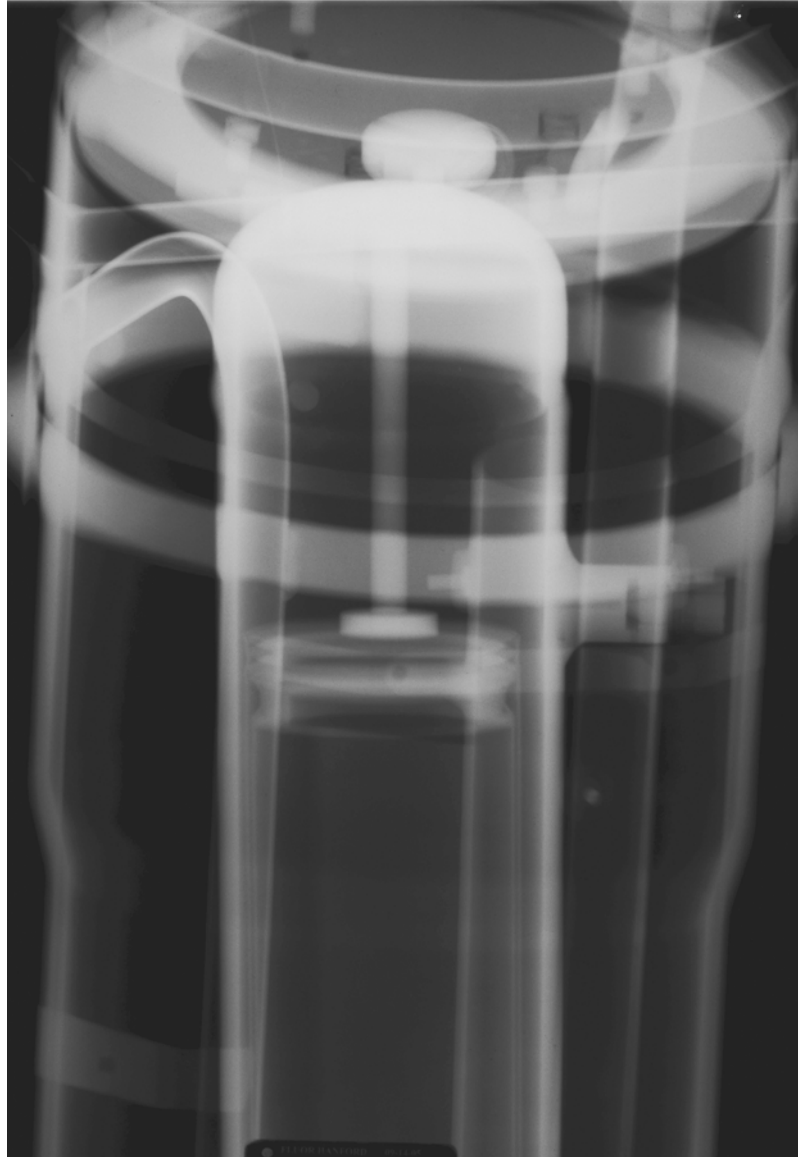
Of interest were the configuration of the internal packaging, the presence of the vent plug, and the structural integrity of the bird cage. An initial radiograph was taken to determine the orientation of the vent plug on the source capsule of each Pu-238 drum. The radiographic equipment was then repositioned to obtain a profile of the vent plug. Radiographic film was placed directly behind the drum and duplicate radiographs were shot to provide both Hanford and SRS with a record of the inspection of each drum. Radiographs of the first three drums indicated that the drum containment was as expected. The structural integrity of the birdcage was important since the documented safety analysis took credit for the spacing provided by the birdcage. The birdcage radiographs indicated no change in geometry compared to the drawings. Fig. 3 and Fig. 4 are radiograph photographs illustrating characteristics of the source capsule and internal aluminum cans. Detailed examination of the radiographs clearly showed the individual aluminum can walls, the aluminum can Magneform® sealed tops, the conical vent plug, and the shape of the plutonium oxide in the bottom of the can. In some cans, objects were observed that may have been used to load the oxide into the cans.

Fig. 3. Radiograph photograph of the top of a source capsule, vent plug, and nested aluminum cans.

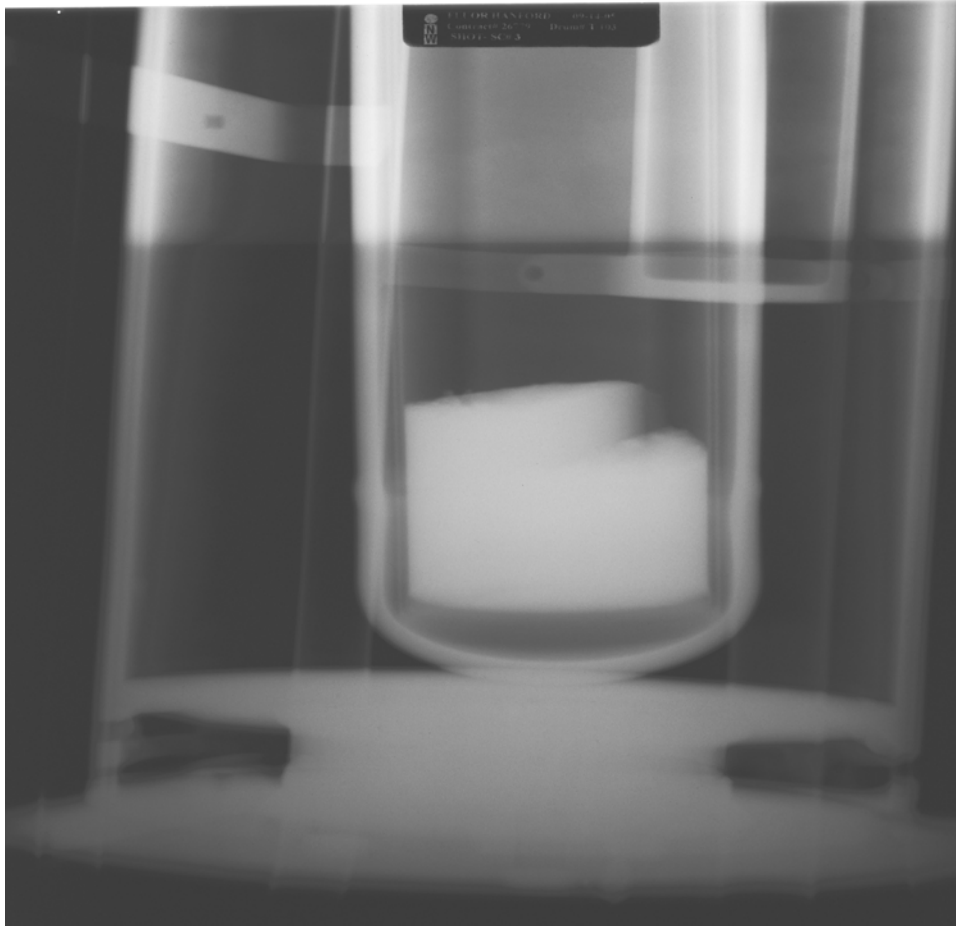
Fig. 4. Radiograph photograph of the bottom of a source capsule, the plutonium oxide, and a shipping container.
