Characterisation Progress at the Windscale Pile Reactors *Challenges and Results*

P. F. Ervin
CH2M HILL International Nuclear Services
P.O. BOX 24548, Denver, CO 80224

Pile 1 Fuel Channel Inspection

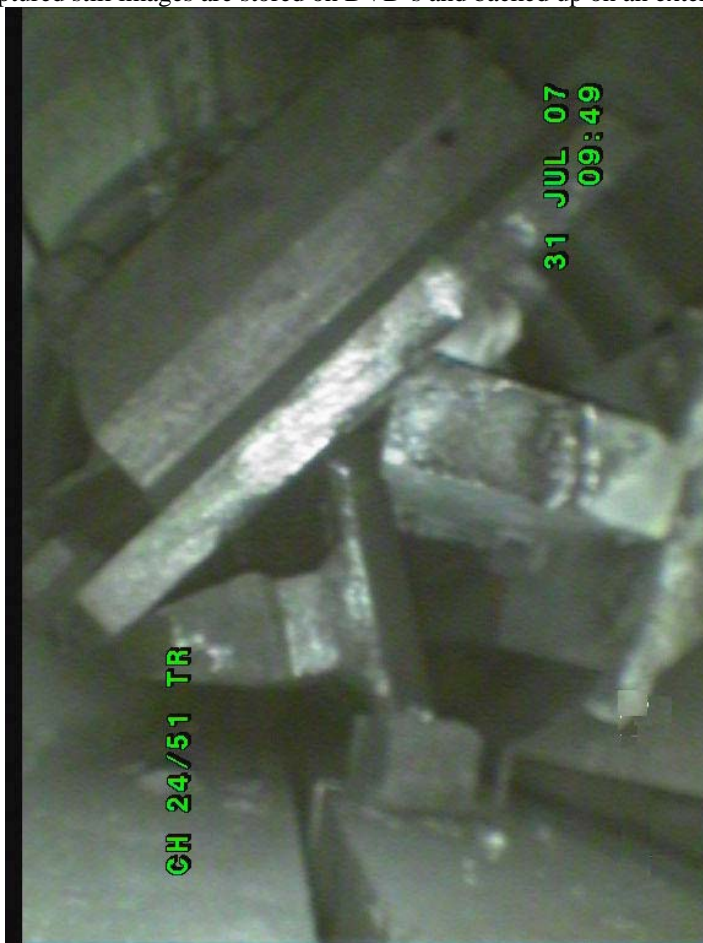
Systematic inspection with a 10mm diameter endoscope allowed the inspection past fuel and debris blockages (Figure I) for the first time since the 1957 fire. The 12.2 meter long insertion tube on the probe allowed the

Figure I—Fuel Channel Blocked By Three Graphite Boats.

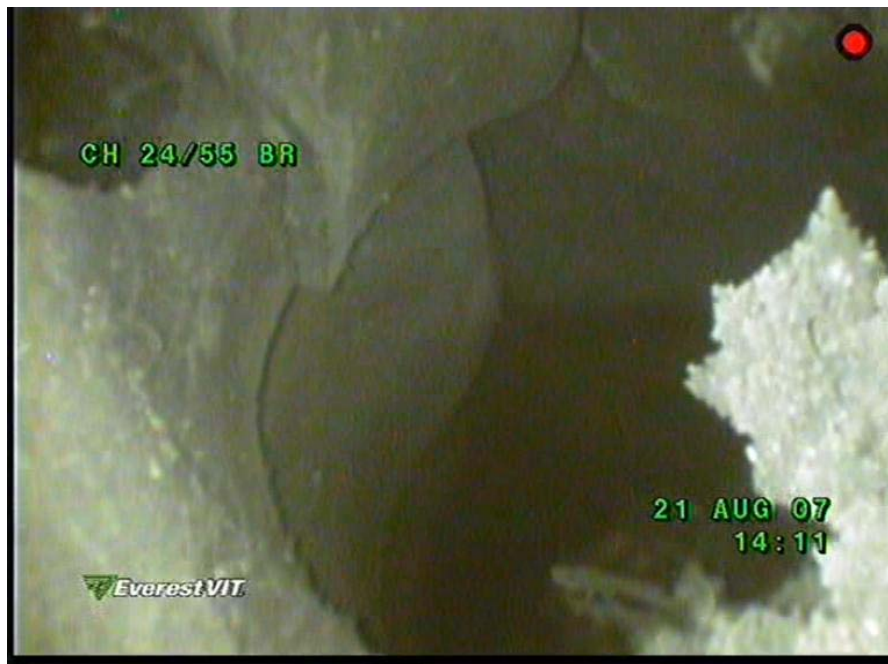
The graphite conditions range from pristine sharp-edged blocks to blocks that show progressively increasing amounts of worn and weathered conditions. Graphite loss (Figure II) has occurred to the extent that adjacent fuel channels are connected by openings that from informal scaling appear to be multiple inches in height. Two types of “damage” are observed, physical removal of graphite and a weathering of graphite surfaces generally in the presence of re-solidified molten lead. All forms of damage vary considerably between adjacent blocks, potentially reflecting some block specific phenomena e.g. Wigner energy content or release rate.

Figure II—Graphite Damage/Displacement In A Fuel Channel.

In general block gap edges show what appears to be an erosion/ablation removal of material in that the underlying graphite appears solid and capable of load bearing. This is currently believed to be from the fire fighting water flashing to large volumes of steam with resultant high velocity flow through and between the fuel and isotope channels. Some of the erosion/ablation is possibly from the cavitation associated with the fire water flashing to steam. The third removal method is assumed from the oxidation of the surface of the graphite blocks and subsequent removal similar to that observed in the consumption of charcoal in a fire box or barbeque. The loss of material is distributed throughout the FAZ in such a manner that varying combinations of all three mechanisms are postulated to have occurred.

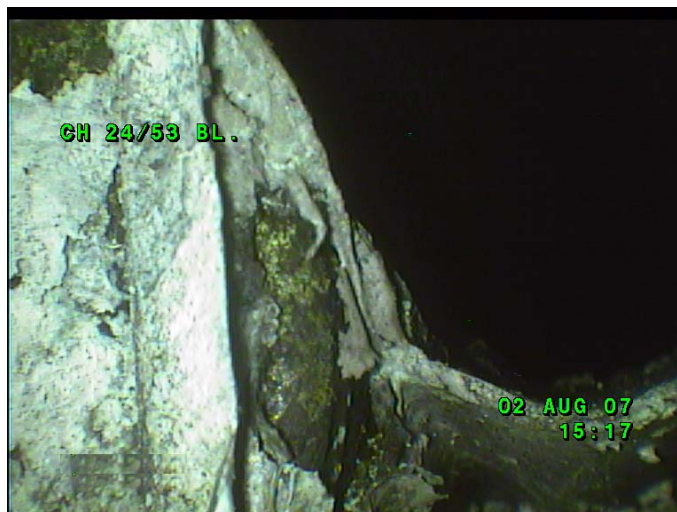
For the first time in 50 years, images have been obtained from deep within fuel channels damaged in the 1957 fire Pile 1 Reactor fire. Displaced graphite, intact and relatively intact fuel (Figure III) and fuel debris conditions were obtained by visual inspection and the material behaviour in response to the passage and incidental contact of the inspection probe.

Figure 3—Partially melted fuel cartridge with fuel pin exposed.

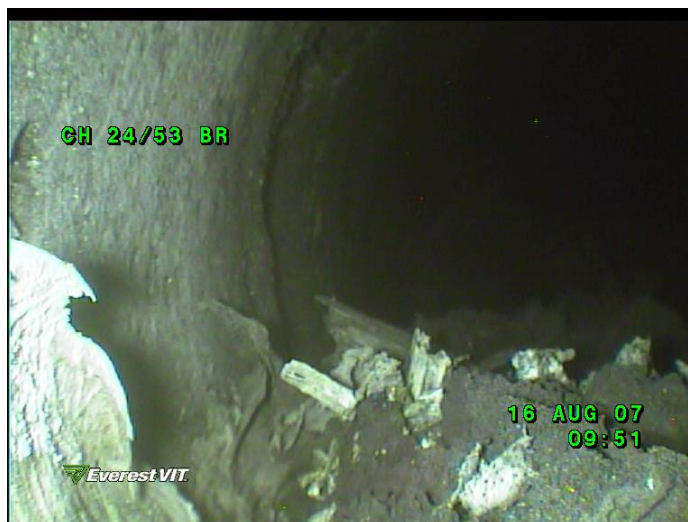
The reactor contains fuel ranging from pristine appearing intact fuel cartridges to clinker-like (Figure IV) and pseudo-cryptocrystalline appearing clumps of material.

Figure IV— Fuel debris containing fragments of partially melted fuel cartridge fins.

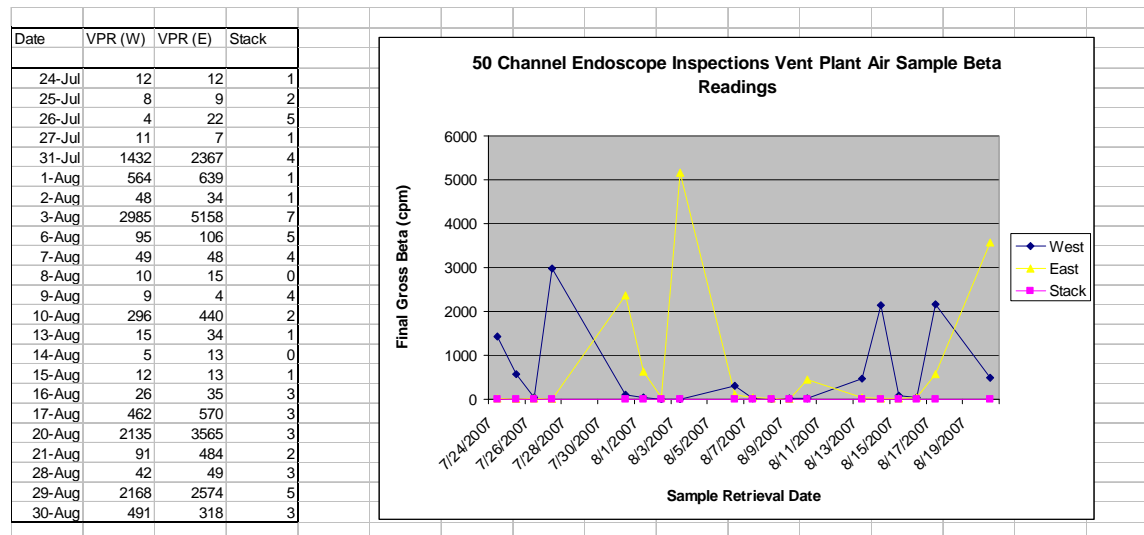
Fig. 7.—Beta Readings At The Vent Plant Air Samplers And The Stack Monitor.

As can be seen from the data, despite significant changes in the daily reading, essentially no release occurred. This indicates that the particle size is large enough to be captured by HEPA filters. This information can be used to support the assessment of waste encapsulation methods. The quantities of dust seem to be a small fraction of the total material to be removed from the channels.

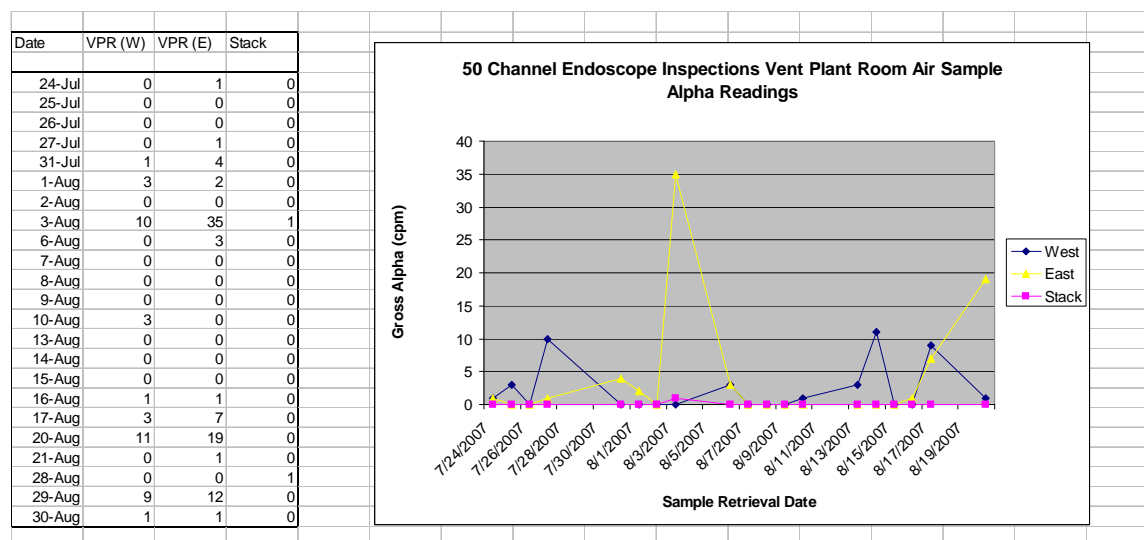
Fig. 8.—Alpha Readings At The Vent Plant Air Samplers And The Stack Monitor.
