## **The MacArthur Maze Fire: How Hot Was It? - 9223**

Christopher S. Bajwa, Earl. P. Easton, and Darrell S. Dunn  
U.S. Nuclear Regulatory Commission  
Washington, DC 20555

### **ABSTRACT**

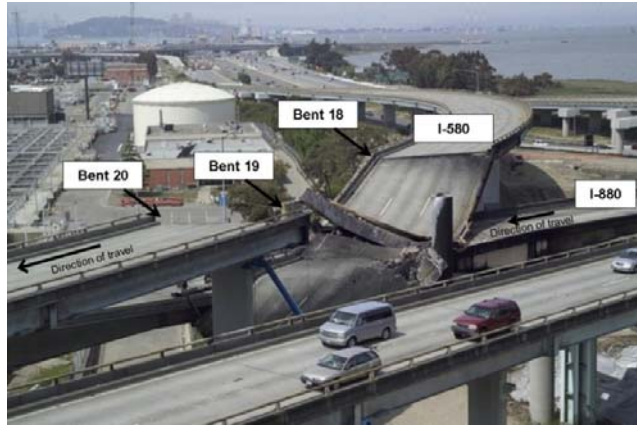
The fire, fueled by the gasoline from the tanker, heated the steel girders to temperatures where the steel strength was reduced and was insufficient to support the weight of the elevated roadway. The I-580 overpass collapsed about 17 minutes after the fire started, based on surveillance video taken from a water treatment plant adjacent to the highway interchange. The main portion of the fire spread along a section of the I-880 roadway. Some of the gasoline went through the scupper drain on I-880 and burned on the ground around the support pillar. An aerial photograph of the area with the accident site identified is shown in Figure 1 [1]. A photograph of the scene after the fire was extinguished is shown in Figure 2<sup>1</sup> [2].

**Fig. 2. Postfire aerial view of the collapsed section of I-580 looking west. Picture from Caltrans**

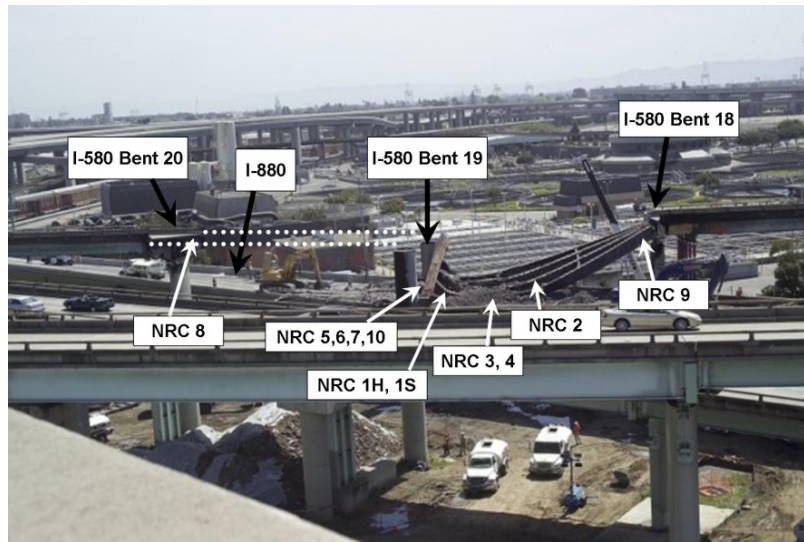
Samples from the plate girders were obtained from the structures near Bents 18 through 20. Samples obtained near the connection to Bent 20 showed some signs of fire damage to the latex paint. The underlayer of red-colored lead-containing paint was mostly intact but had evidence of blistering from the thermal exposure. For plate girders near Bent 18, damage to the latex paint was variable. On the outermost I-580 girder located the greatest distance from the I-880 road bed, the latex paint was mostly intact retaining its original gray color.

Between Bent 18 and Bent 19, the plate girders from I-580 were in contact with the I-880 roadway. Significant beam distortion is apparent as a consequence of heating, the resultant weakening of the steel structure, and the load of the concrete structure. No paint was noted on these beam sections. Based on this observation, it was determined that the plate girder section designated as Plate Girder 5 in Figure 4, and shown in detail in Figure 5, was originally located between Bent 18 and Bent 19 where the I-580 overpass was in contact with the I-880 road bed. Originally, the plate girder was approximately 122 cm [48 in] high. As shown in Figure 5, the end of Plate Girder 5, that was believed to be closest to Bent 19, buckled as the result of a loss of strength at elevated temperature and the subsequent impact with the I-880 road bed.

**Fig. 3. View of damage during demolition looking southwest. Bent 18, 19, and 20 and approximate locations of collected specimens are indicated. Dotted lines represent pre-accident overpass structure that was demolished and removed prior to this photograph. Original picture from Caltrans website <http://www.dot.ca.gov/dist4/photography/images/070430/index2.html>**

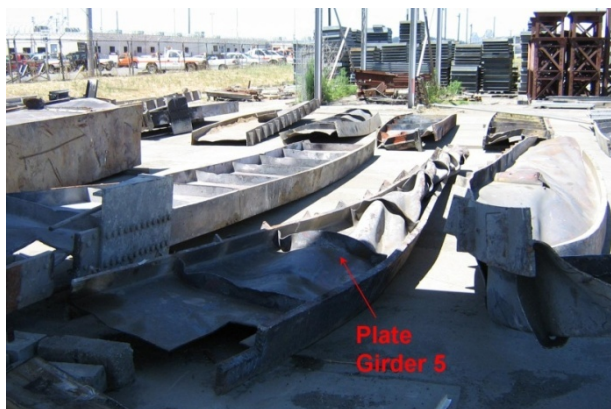
**Fig. 4. Girders at the Caltrans storage yard.**

The damage to the paint on the steel girders may also indicate the temperature [7]. Photographs taken during demolition and the condition of the girders observed in the Caltrans storage yard clearly indicate that the paint was destroyed on girders closest to the fire. For the thermally exposed samples described in this paper, discoloration and significant damage of the paint was observed after the exposure at 550°C [1,022°F]. After exposure, the paint appeared to be a yellow-green color. At 700°C [1,292°F], the paint was completely destroyed. At higher temperatures, the specimen was covered with a dark gray oxide layer.

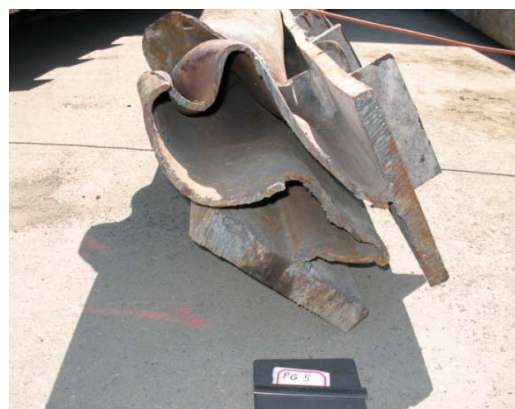
**Fig. 5. Photograph of Plate Girder 5 believed to be between Bent 18 and Bent 19.**

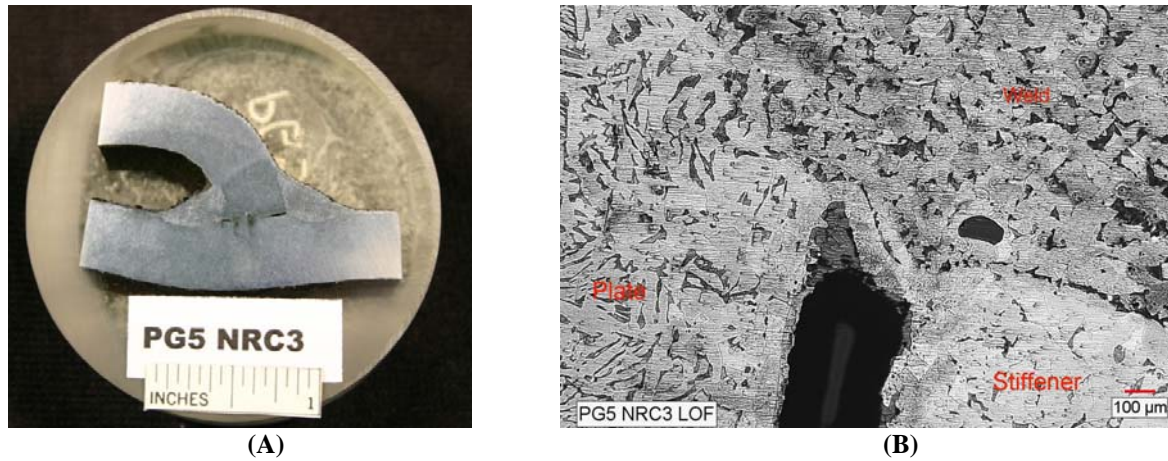
Figure 6 (A) shows a specimen from Sample NRC 3 after mounting, polishing, and etching. The distortion of the plate and the stiffener are obvious, given that the plate and stiffener were originally perpendicular to each other. Figure 6 (B) shows the microstructures of the plate girder, the stiffener, and the weld. As expected, the plate and the stiffener consist of ferrite and pearlite. The welds are also ferrite and pearlite and contain no indication of a dendritic structure that would have been present immediately after welding.

**Fig. 6. Metallurgical specimen from Sample NRC 3 after mounting, polishing, and etching (A). Microstructure of stiffener fillet weld, plate girder, and stiffener (B).**

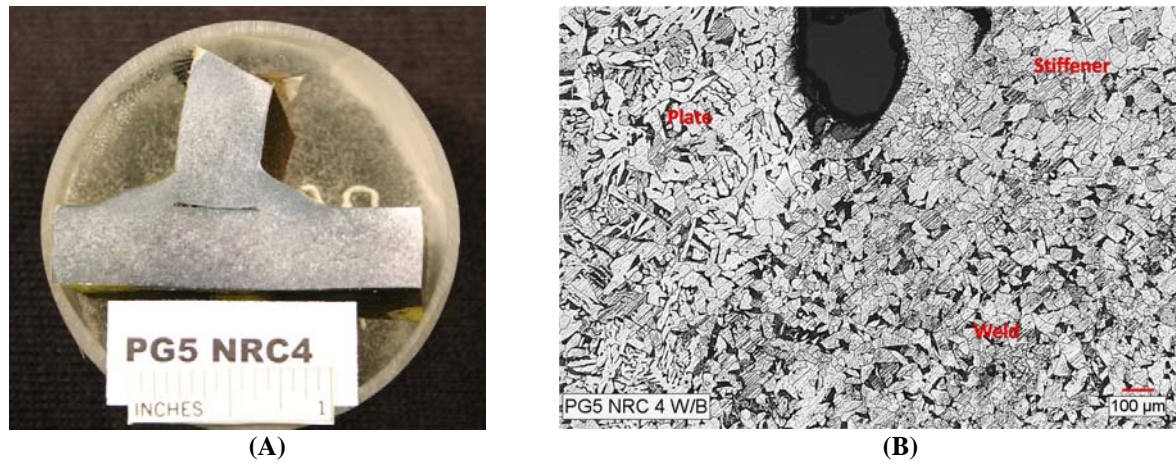
A specimen from Sample NRC 4 is shown in Figure 7. The microstructure of the weld, plate, and stiffener consists of ferrite and pearlite. Similar to Sample NRC 3, the weld on Sample NRC 4 shows no signs of any dendritic structure that was likely to be present after welding. The stiffener welds in both Samples NRC 3 and NRC 4 are fully transformed and practically indistinguishable from the plate.

**Fig. 7. Metallurgical specimen from Sample NRC 4 after mounting, polishing, and etching (A). Microstructure of stiffener fillet weld, plate girder, and stiffener (B).**

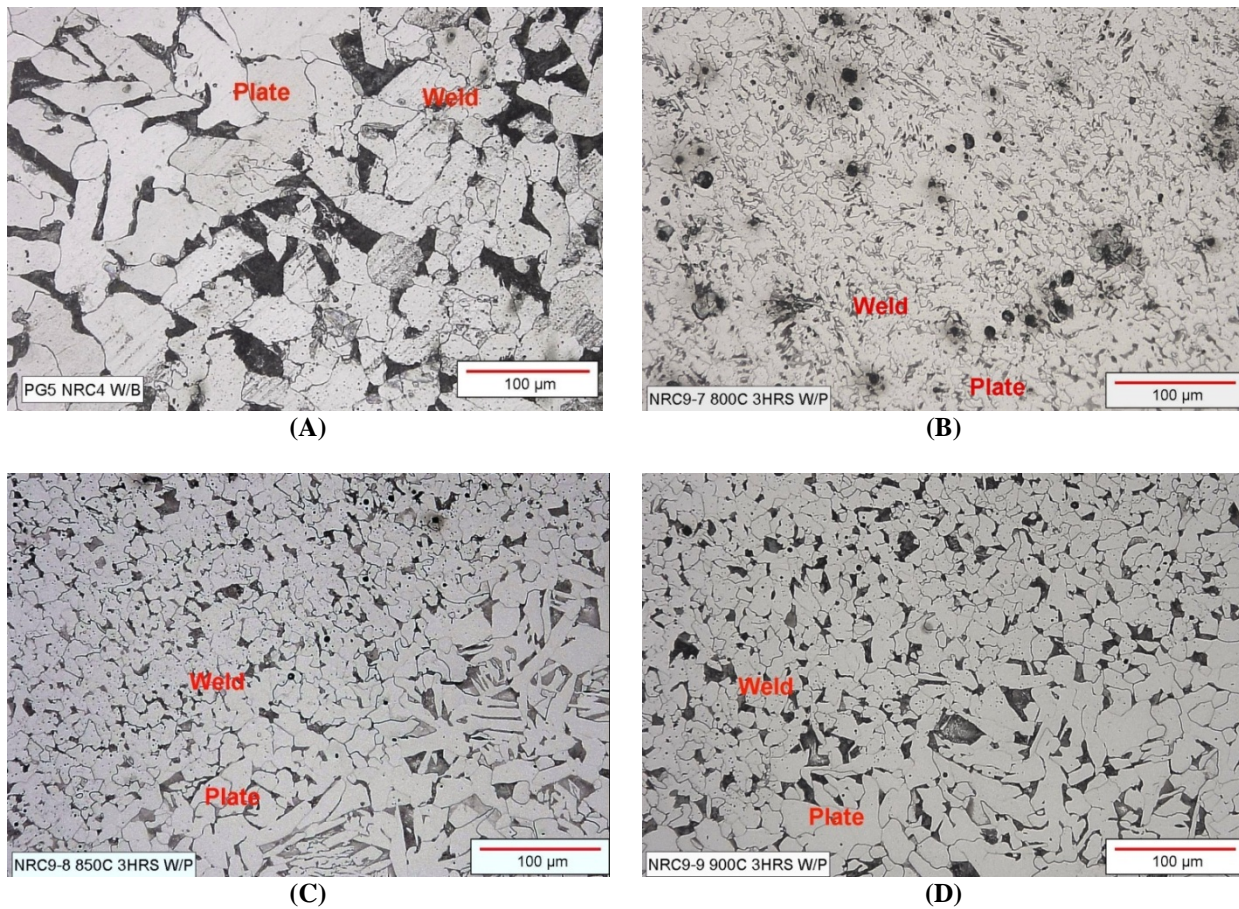
Figure 8 (B, C, and D) shows the microstructure of the plate and the weld after exposure to temperatures of 800 to 900°C [1,472 to 1,652°F] along with the microstructure of a specimen from Sample NRC 4 (A). The microstructural distinction between the weld and the plate is apparent at temperatures of 800°C [1,472°F] or less. At 900°C [1,652°F], the distinction between the weld and the plate is reduced and limited to the differences in grain size between the two regions. The microstructure of the welds in the specimens exposed to 850 or 900°C [1,562 or 1,652°F] appears to be similar to the microstructures observed in welds in specimens taken from Samples NRC 3 and NRC 4.

**Fig. 8. (A) Microstructure of Sample NRC 4; (B) Microstructure of Specimen NRC 9-7, 800°C [1,472°F]; (C) Microstructure of Specimen NRC 9-8, 850°C [1,562°F]; and (D) Microstructure of Specimen NRC 9-9, 900°C [1,652°F].**

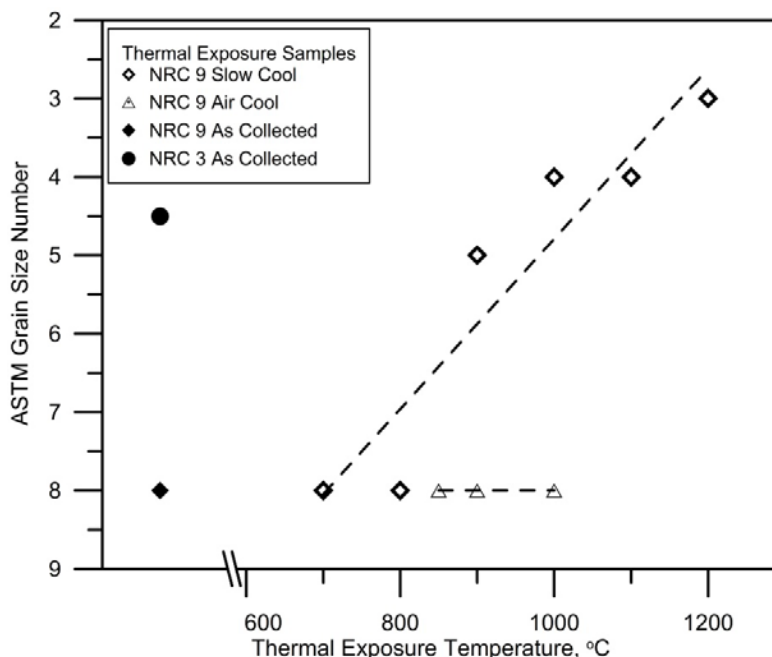
Although the cooling rate for the actual structure is not known, it is expected that the cooling rate was slow owing to the nature of the fire and the overpass collapse. The large size of the girders, limited use of water on the fire, and the insulating effects of the concrete around the girders likely prevented rapid cooling. Based on the grain size of the thermally exposed and slow-cooled specimens from NRC 9, a grain size between 4 and 5 is expected at a temperature of approximately 980 to 1,020 °C [1,796 to 1,868 °F].

Fig. 9. ASTM grain size as a function of thermal exposure conditions.

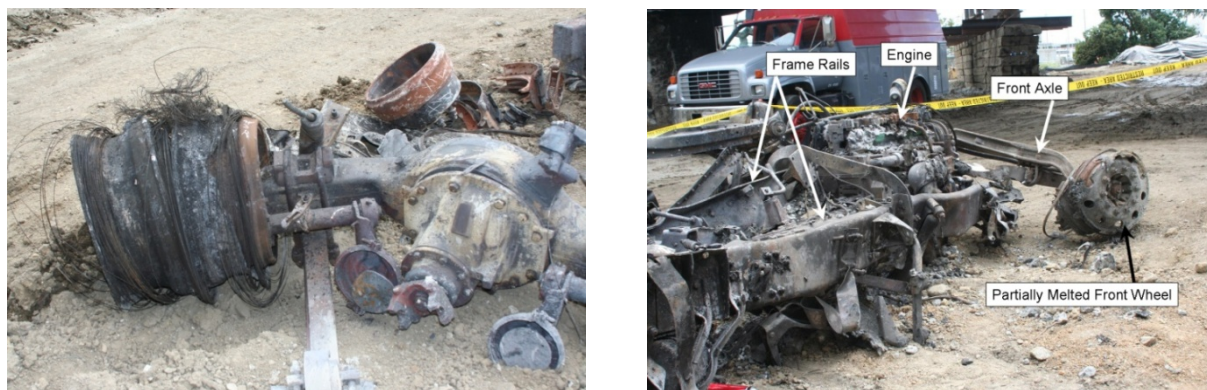
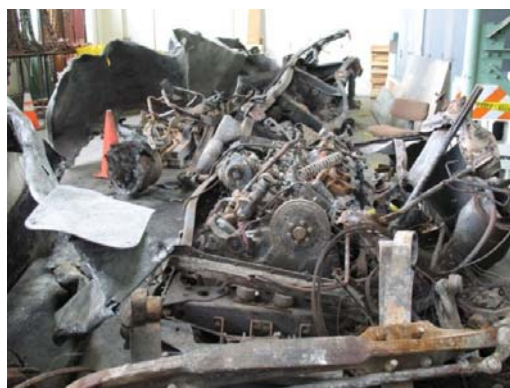
On March 19, 2008, staff from SwRI and NRC inspected the tanker truck involved in the accident and collected selected samples for analysis. A variety of materials were collected including glass, aluminum alloys, steel, copper, brass, and stainless steel. Descriptions of the samples are shown in Table V. Photographs of the truck remains are shown in Figure 10.

**Fig. 10. Photographs of the tanker truck remains at the accident site (A) and at the Caltrans storage facility (B).**

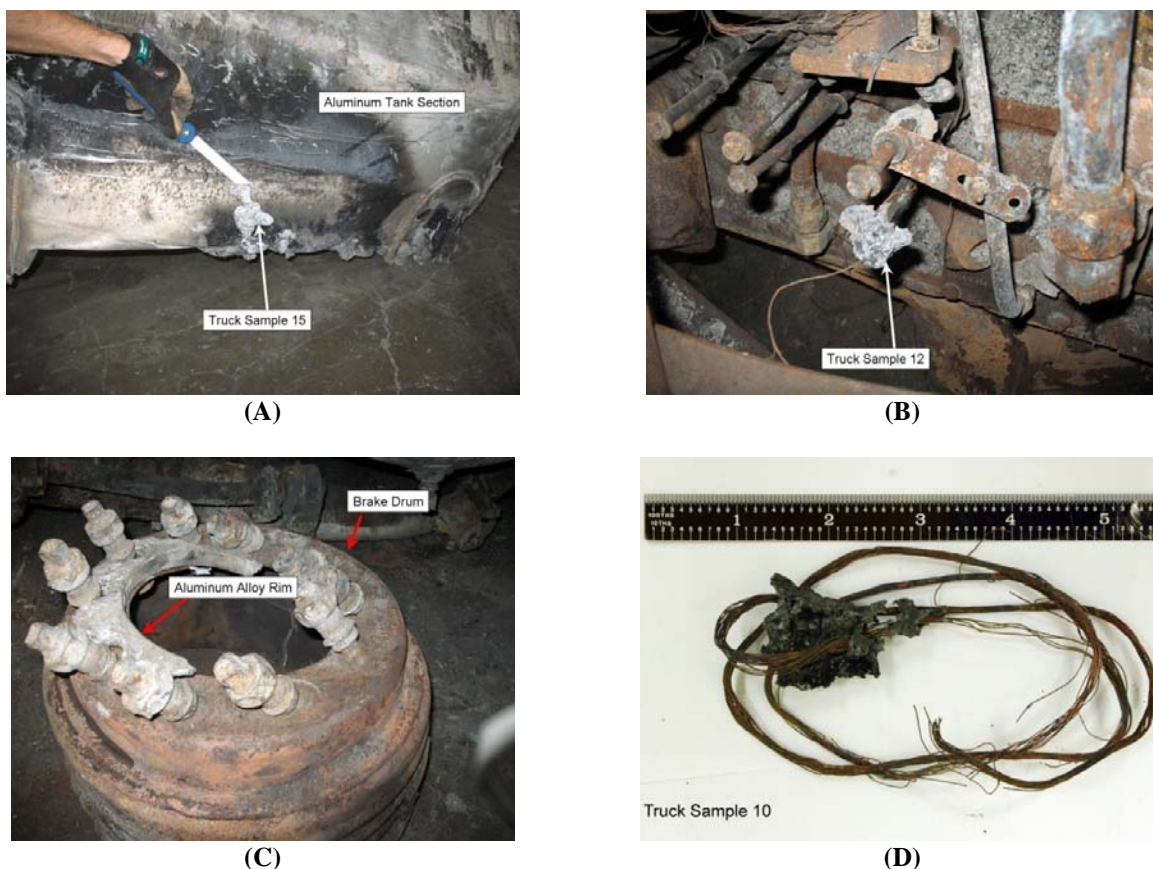
Truck Sample 12 was unique because it had multiple materials including a steel bolt, a strand of steel wire, and an aluminum alloy that may have been from a component or bracket that was attached to the engine. The composition of the aluminum sample is included in Table VI. Figure 11 shows that only the aluminum alloy melted. Similarly, Truck Sample 10, originally located on the truck frame, contained copper wire covered with aluminum that was melted and resolidified. The aluminum composition was determined to contain a significant amount of copper and

thus has a low liquidus temperature of 590°C [1,094°F]. As shown in Figure 11, the small gauge copper wire showed no indication of melting.

Based on the compositional analysis, the liquidus temperature ranged from 590°C [1,094°F] to 720°C [1,330°F]. Melting was clearly apparent in all samples, indicating the temperature in some locations reached values of 720°C [1,330°F]. Because very large portions of the thin-walled tank were not melted, the temperature in these areas was below 570°C [1,058°F].

**Fig. 11. Photographs of the collected aluminum alloy samples. (A) Truck Sample 15: portion of the aluminum tank that had melted; (B) Truck Sample 12: collected from the passenger side of the engine; (C) Truck Sample 14: remains of a partially melted aluminum wheel; (D) Truck Sample 10: section of copper wire partially covered with aluminum.**

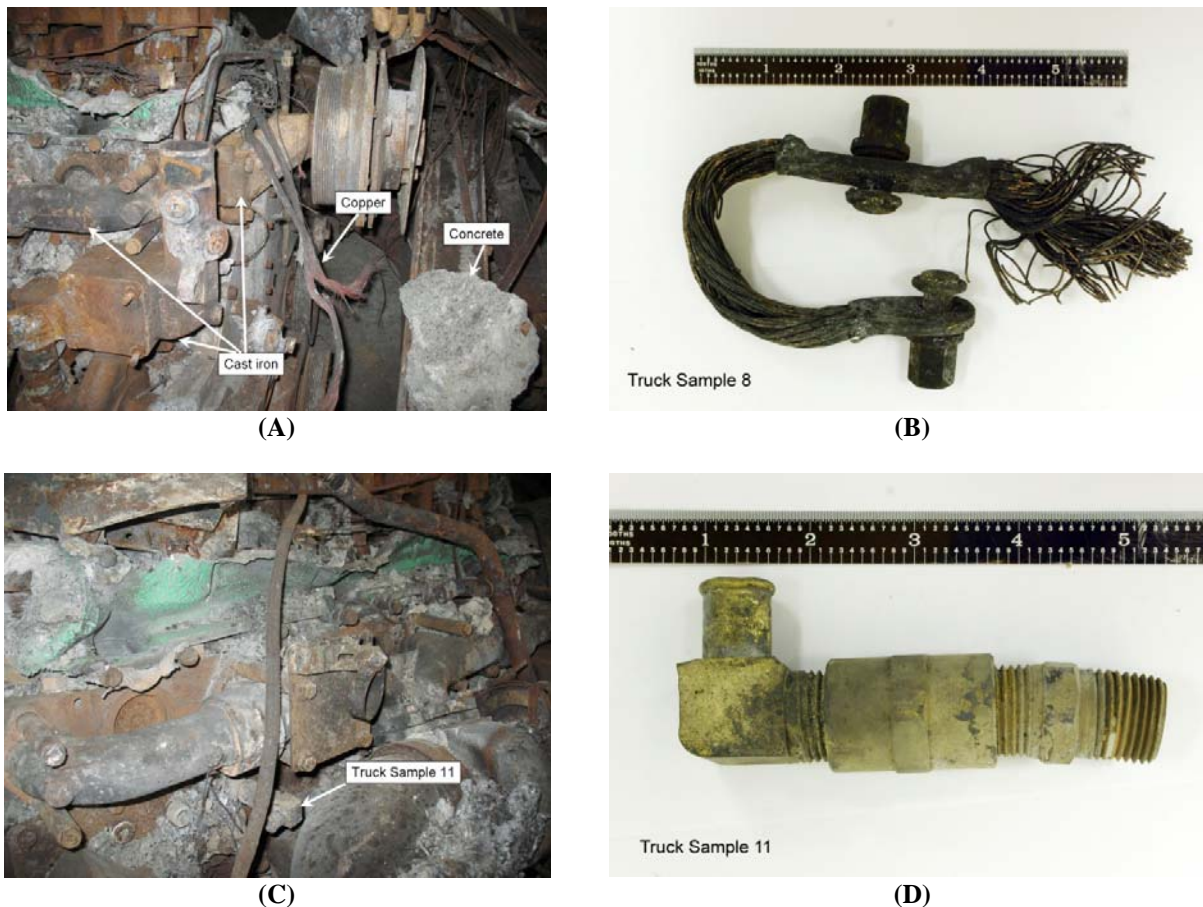
Copper used for electrical system wiring was found throughout the remains of the truck. Large sections of copper wiring, likely the battery cables, were observed in the engine compartment. Copper ground straps were found on the frame of the tanker truck. Smaller gauge wiring that would be expected for signal and marker lights was also found in many locations on the tanker truck frame. None of the copper wires examined displayed signs of melting. A brass fitting was also found attached to the engine block. The location of this sample was located approximately 10 cm [4 in] from Truck Sample 12 that had aluminum which melted during the fire. The brass sample did not display indications of melting. Photographs of the copper-based alloy samples are shown in Figure 12.

pure copper is 1,084 °C [1,983 °F]. As copper wiring was found on many locations along the truck frame, it is apparent that near the truck, the temperature during the fire did not exceed the melting point for copper. The solidus temperature for the brass fitting is 903 °C [1,657 °F], and the liquidus temperature is 930 °C [1,706 °F] based on the copper and zinc concentration. Small amounts of lead are typically added to improve machining but are not expected to significantly alter the solidus or liquidus temperature. As the brass fitting showed no indications of melting the temperature near the engine compartment was estimated to be less than 903 °C [1,657 °F].

**Fig. 12. Photographs of copper alloy materials collected from the tanker truck. (A) battery cable in the engine compartment; (B) ground strap found on tanker truck frame; (C) and (D) brass fitting located on passenger side of the engine.**

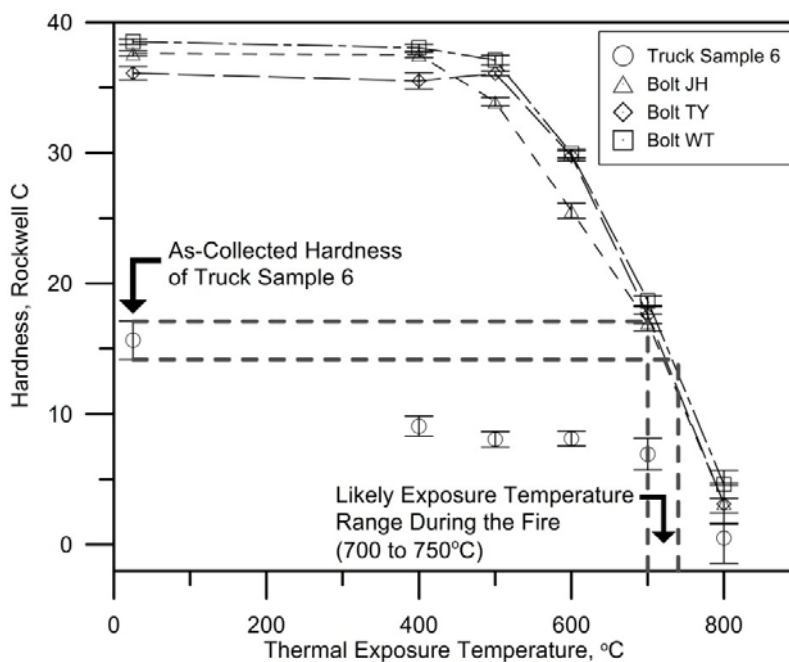
The effect of temperature on hardness is apparent for the new Grade 8 bolts. Although the new bolts had slight compositional differences, the hardness as a function of temperature was similar. At temperatures below 500°C [932°F], the hardness of the Grade 8 bolts is not significantly altered. At higher temperatures, the hardness is a function of exposure temperature. The as-collected hardness of Truck Sample 6 was Rockwell B93.8 ± 1.1 or equivalently Rockwell C16. Data from the bolts JH, TY, and WT suggest an exposure of approximately 720°C [1,328°F] for 2 hours would result in a similar reduction in hardness comparable to the as-collected condition of Truck Sample 6. At 800°C [1,472°F], the hardness of the bolts was less than Rockwell B82 or equivalently Rockwell C5. Figure 13 also shows the effect of thermal exposure on sections of the Truck Sample 6. Most significant is the substantial decrease in hardness observed after the exposure at 800°C [1,472°F]. Based on the data shown in Figure 13, it is estimated that Truck Sample 6 was exposed to a temperature in the range of 700 to 750 °C [1,292 to 1,382 °F] in the MacArthur Maze fire.

Fig. 13. Effect of exposure temperature on the hardness of Truck Sample 6 and commercially available Grade 8 bolts.
