## **Managing Radiological Accidents: A Responder's Perspective - 11362**

Ella B. McNeil, Manager  
Transportation Emergency Preparedness Program  
Office of Transportation, U.S. Department of Energy  
Washington, DC 20585

### **ABSTRACT**

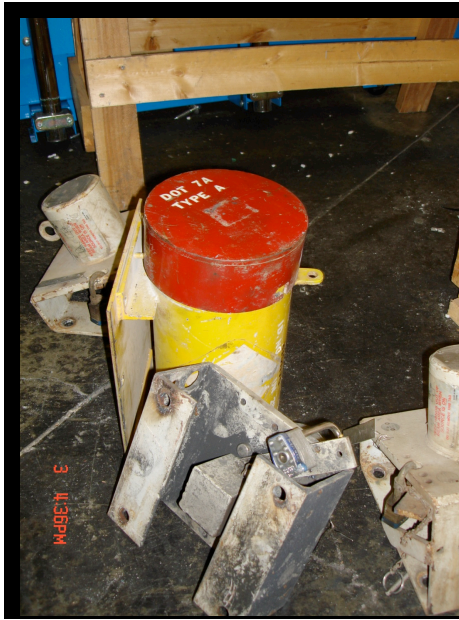
**Figure 1 - Covering sources with shielding caused a Bremsstrahlung effect, resulting in increased radiation rates in the facility.**

- Contamination levels as high as 151,000 disintegrations per minute (dpm) beta/gamma, and 2 millirad/hour at two inches from the surface of the contamination area.
- Radiation levels measured as high as 1 rad/hour at one foot from the lead “pig” in which the ruptured source had been stored.
- Potential for Bremsstrahlung radiation production
- Potential internal exposure hazard (bone)
- Potential external exposure hazard (skin and lens of eye)
- Potential airborne radioactivity of multiple Derived Air Concentration (DAC), assuming complete dispersion and nine cubic meters of work space volume. DAC was calculated to be 2E-09 microcuries per cubic centimeter Sr-90, Class Y, and 3E-07 microcuries per cubic centimeter (Y-90, Class Wand Y)

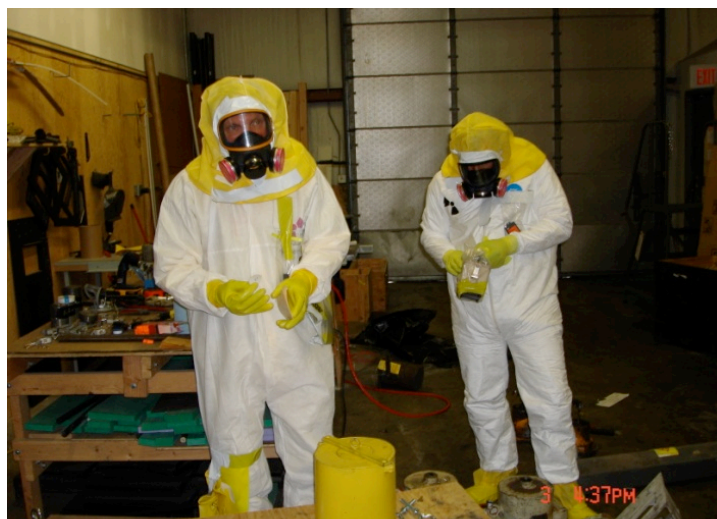
**Figure 2 - Emergency responders conducted surveys at the Sabia facility, detecting both radiation and contamination.**

and Incident Command. Off-site monitoring and evaluation of other businesses, homes and vehicles worked well also due to the established working relationship and trust in each other. Responders discovered the source of contamination to be a 100 millicurie Sr-90 source from a NER 592 gauge, manufactured on August 9, 1984. The source strength at the time of the accident was only approximately 57 millicuries due to normal radioactive decay. Due to increasing levels of surface contamination leading into the facility and the uncertainty of conditions, entry team responders wore double sets of protective clothing and full-face respirators. Responders characterizing the release found Sr-90 and decay product Yttrium-90 (Y-90), to include:

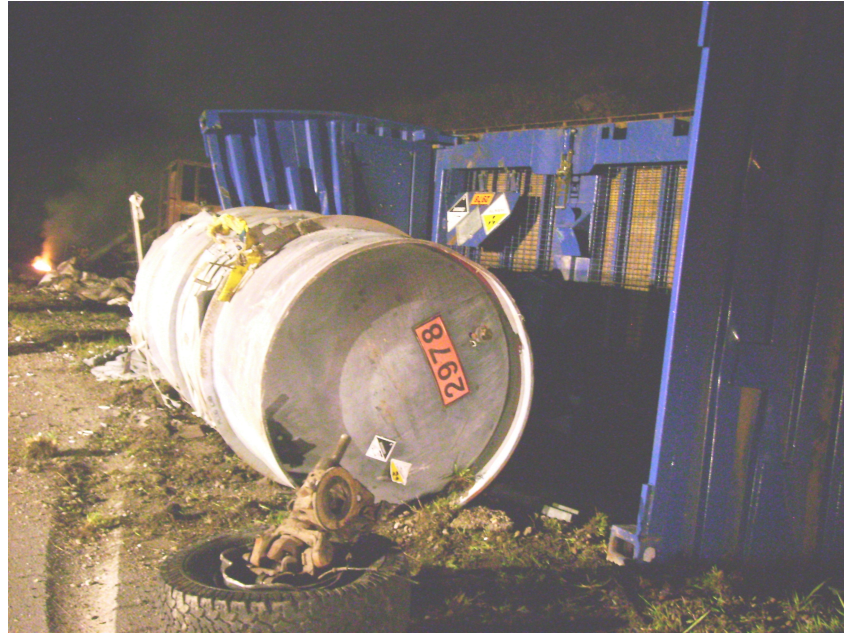
**Figure 4 - The Type B cask carrying the UF6 did not leak, but carved a small trench in the interstate concrete, as shown in the bottom left corner of the picture.**

shipping container revealed no damage to the Model 48Y cylinder, aside from one bent lifting lug. The common carrier contracted with a private hazardous materials firm to assist in the accident recovery. The cylinder was reloaded on another vehicle and was returned to the to the Honeywell facility.
