# ***The Accident at Fukushima : What Happened?***

February 27, 2012

**President and Chief Executive Officer  
Japan Nuclear Technology Institute (JANTI)**

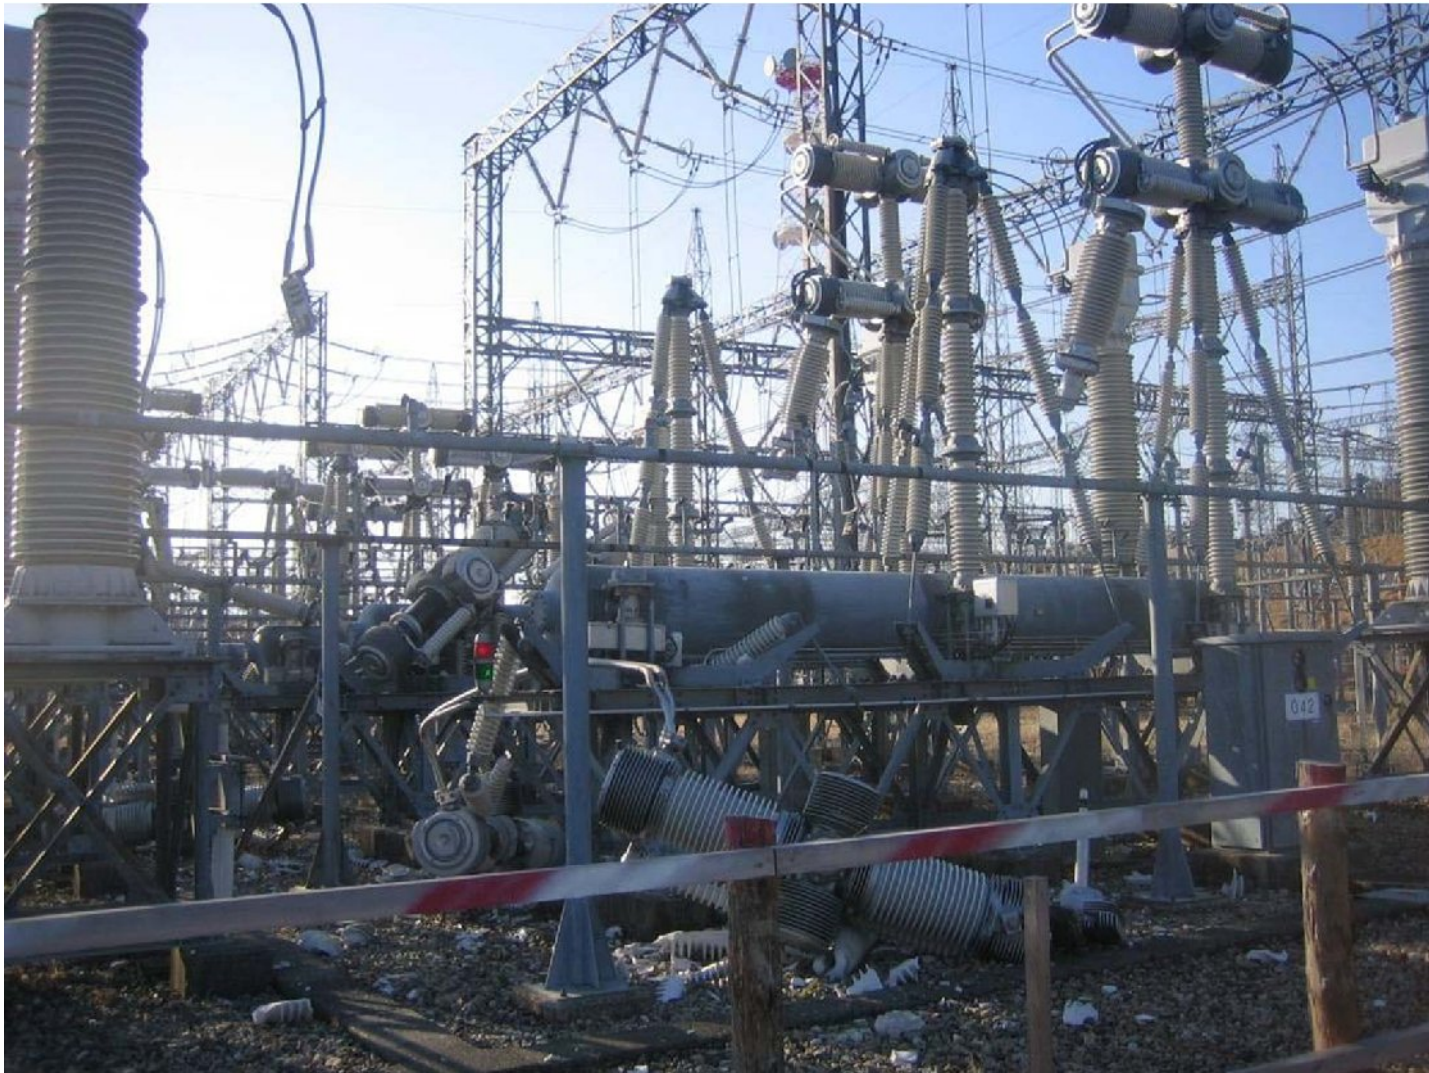
# Damage by Earthquake at Shin-Fukushima Substation

## 275kV Circuit Breaker

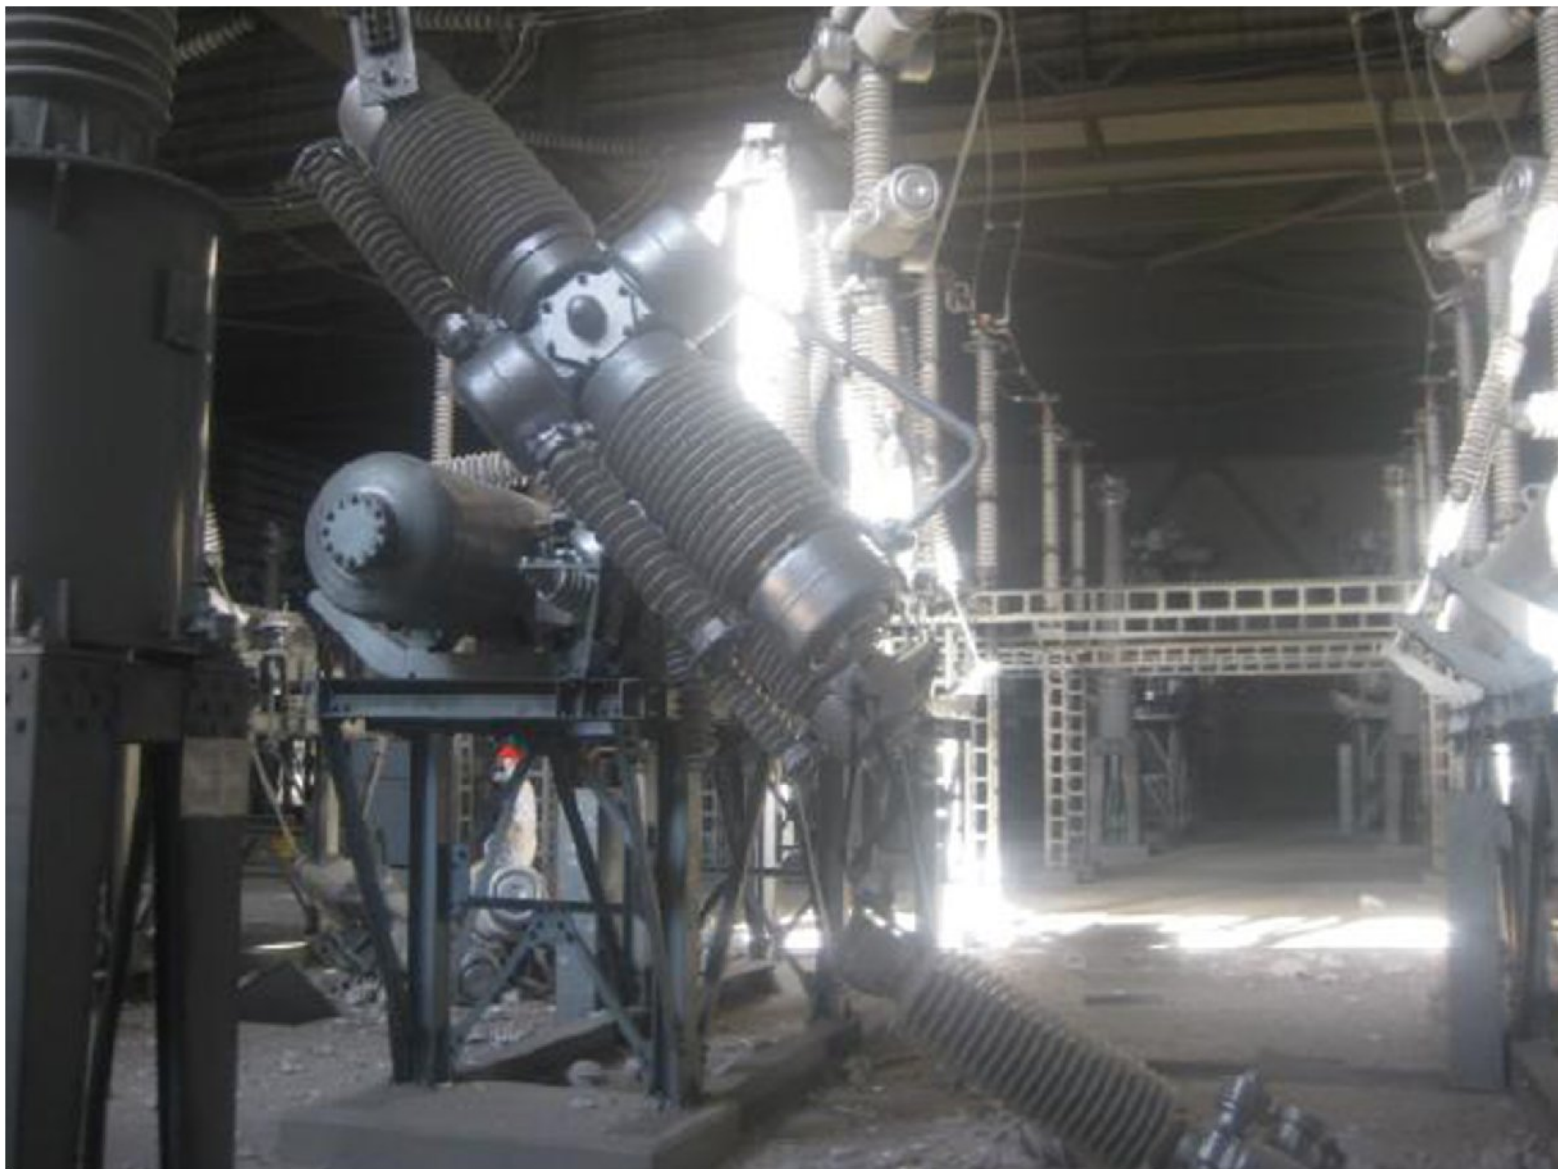
# Damage by Earthquake at Fukushima Daiichi NPS

Circuit Breaker

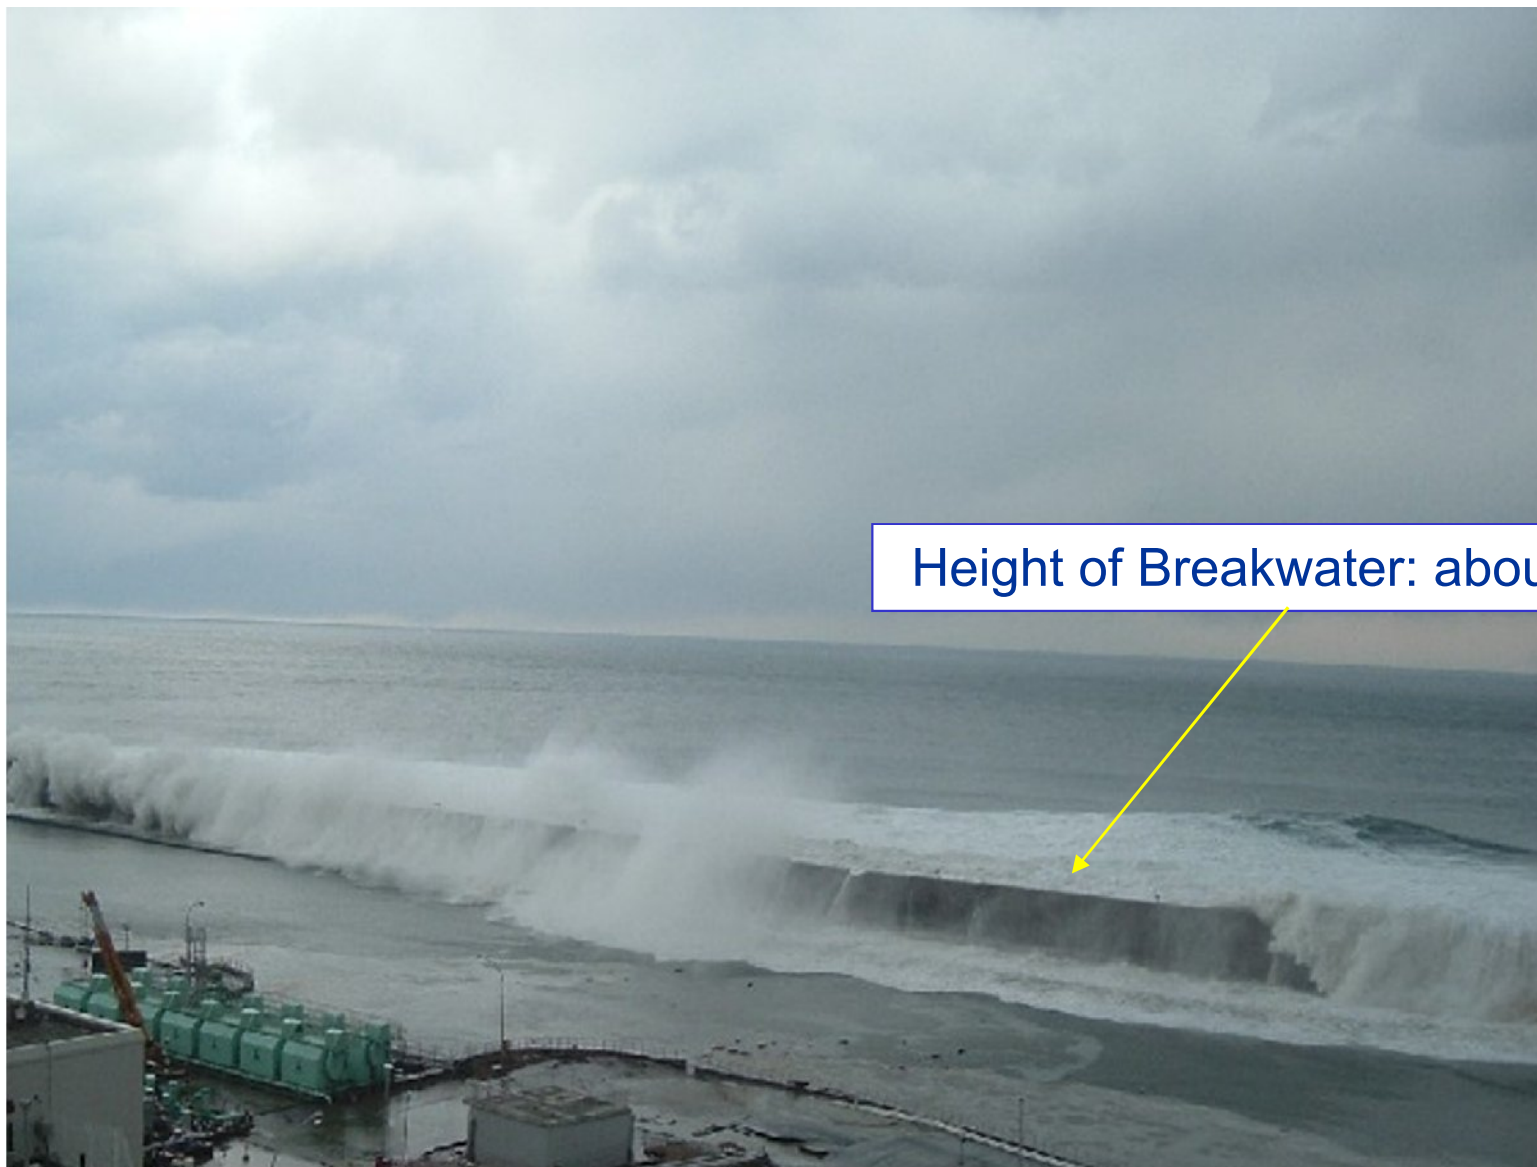
1-2

# Tsunami Striking North Breakwater

Height of Breakwater: about 10m

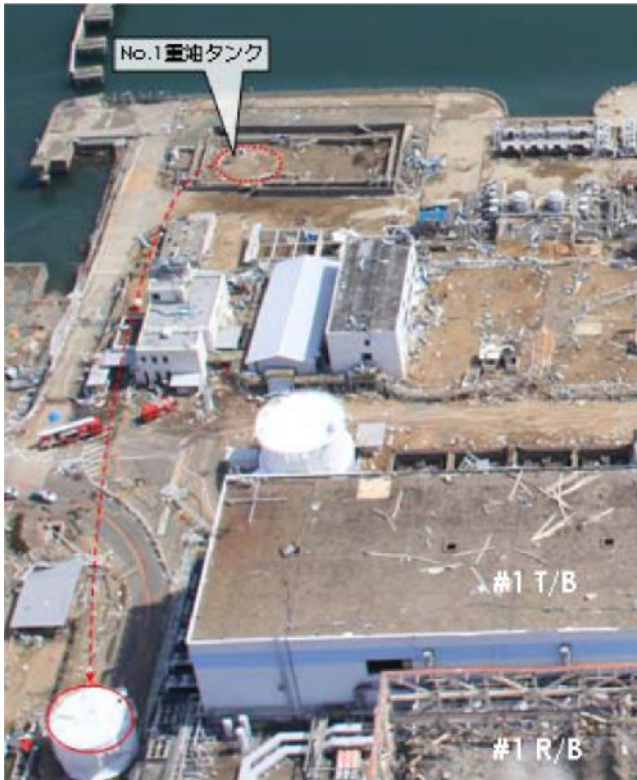
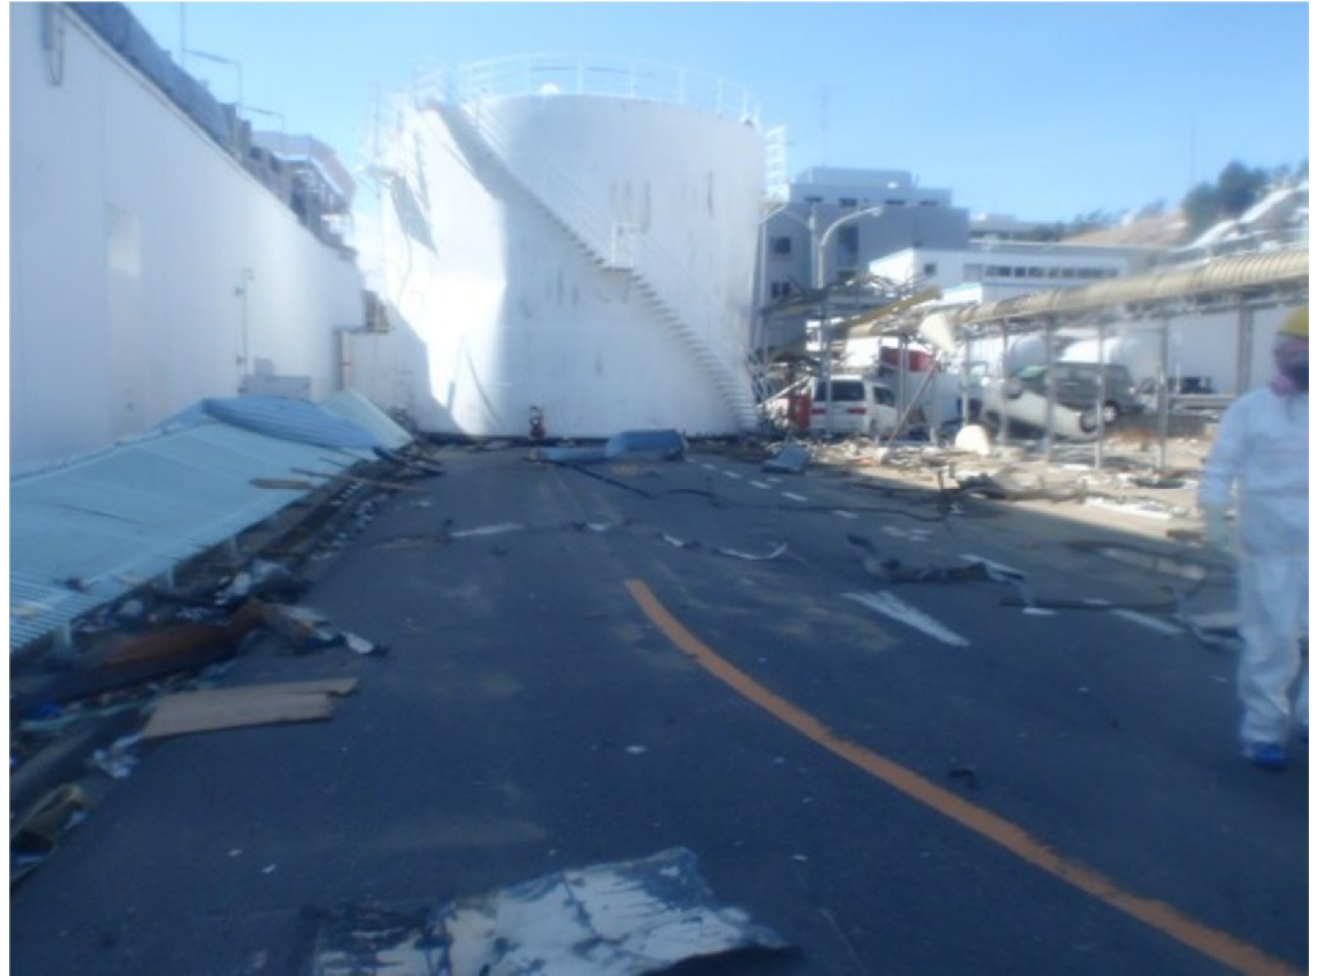
# Example of Damage by Tsunami - Oil Tank

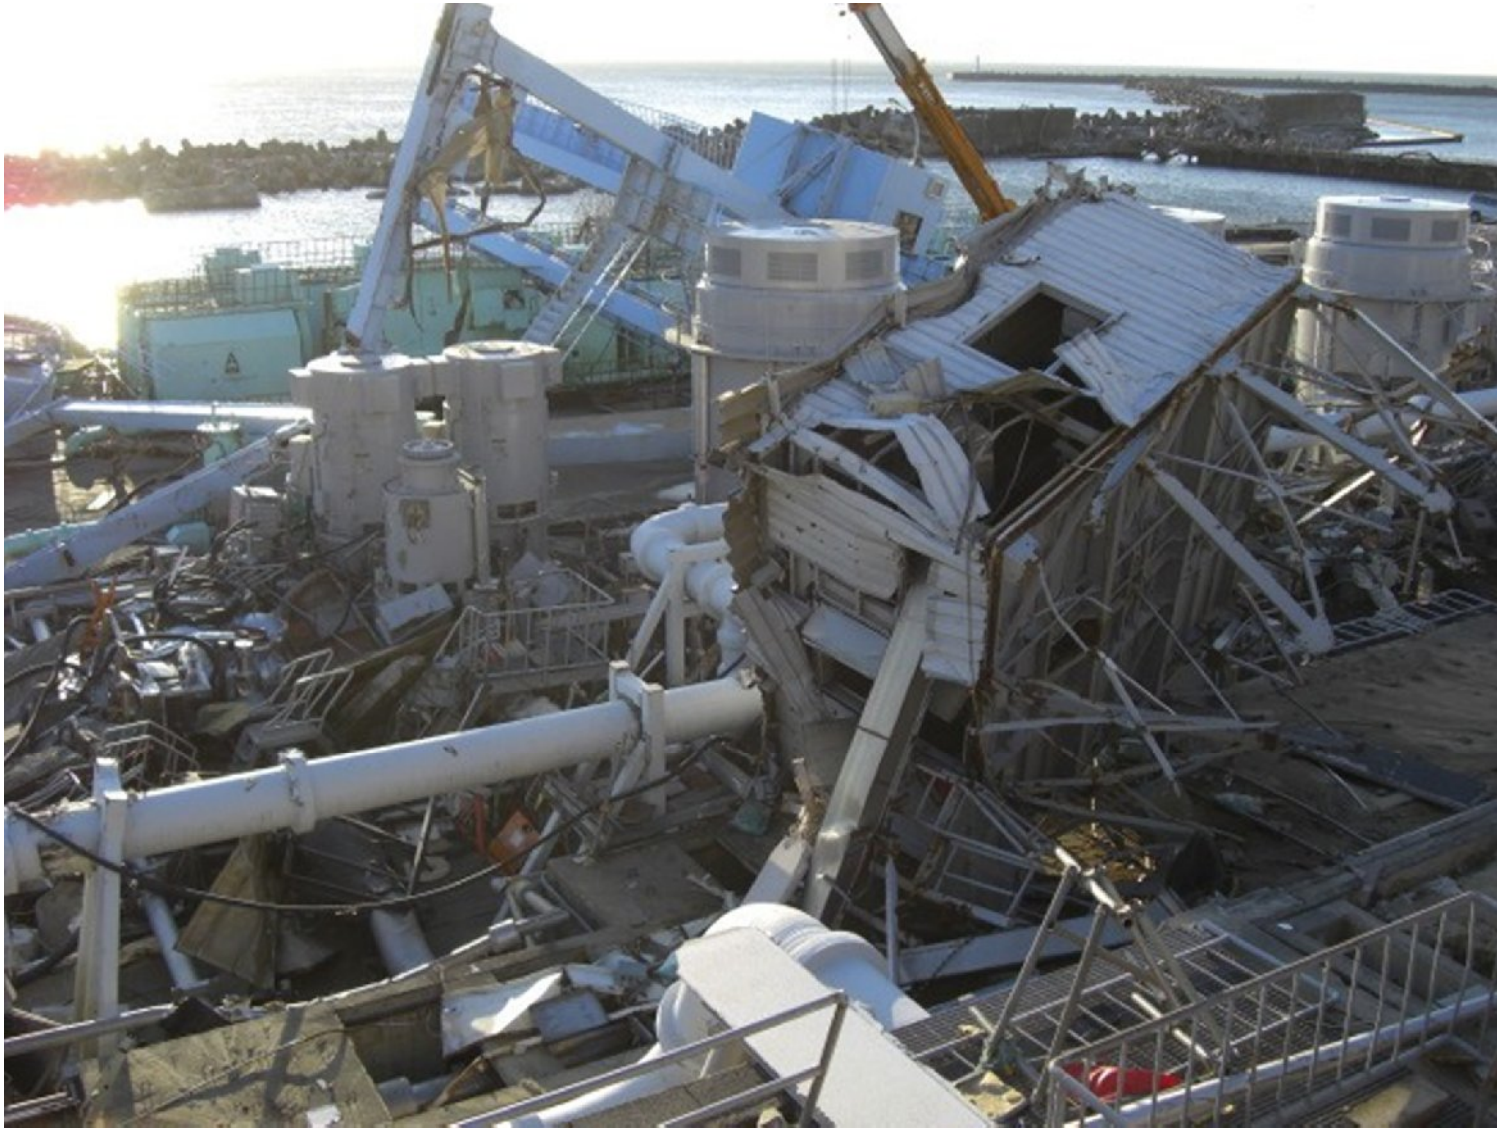
# Example of Damage by Tsunami - Seawater Facility

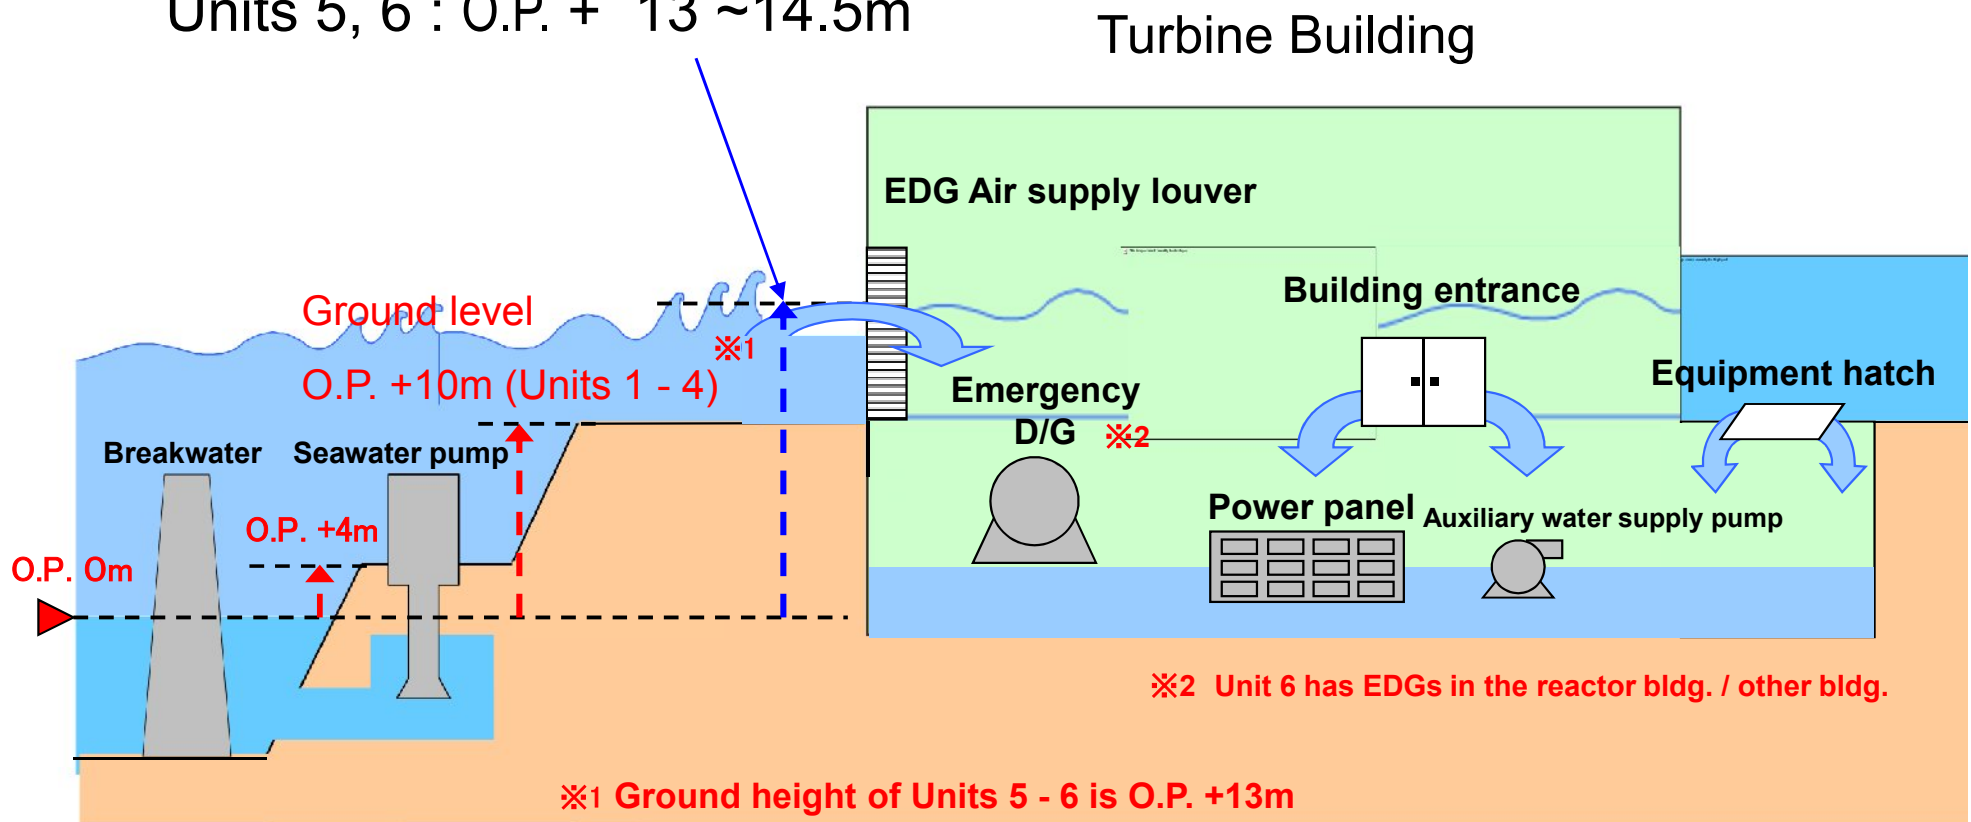
# Flood Pathways into Turbine Building

Units 1- 4 : O.P. +11.5~15.5m

Units 5, 6 : O.P. + 13 ~14.5m

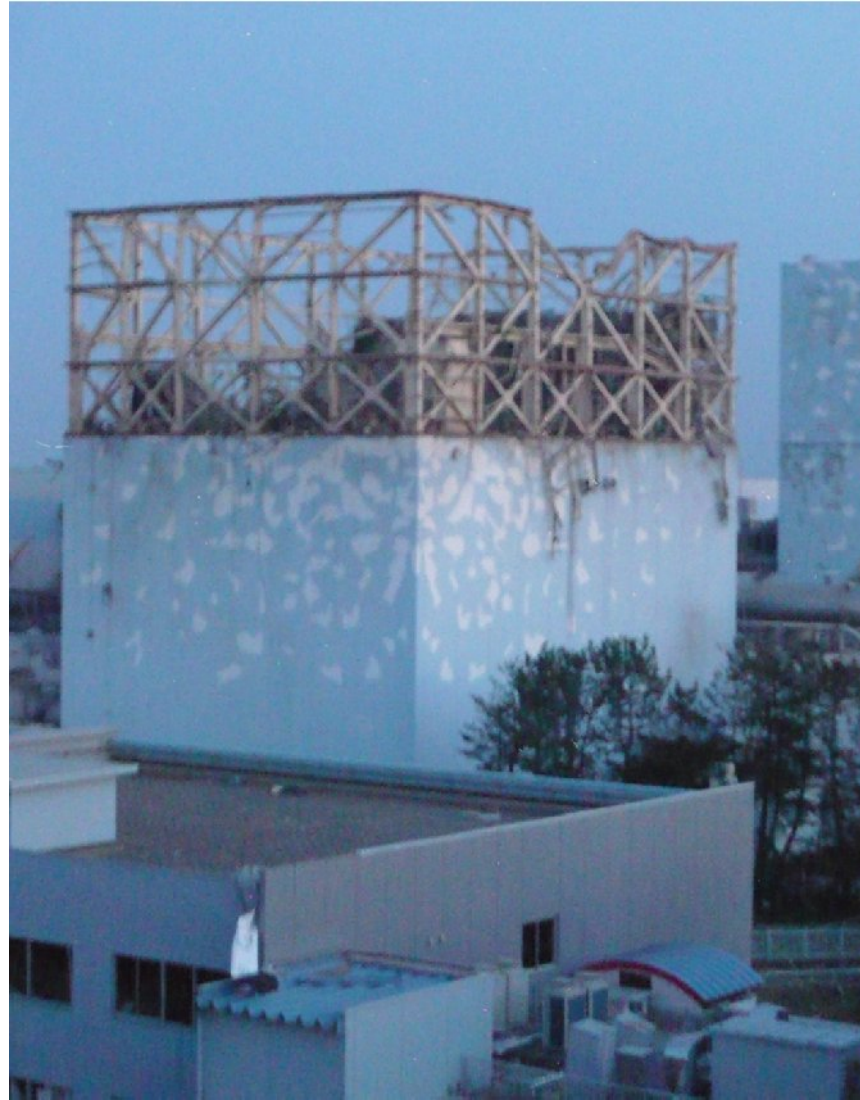
# Hydrogen Explosion at Unit 1

March 12 15:36 Hydrogen Explosion Occurred at R/B.

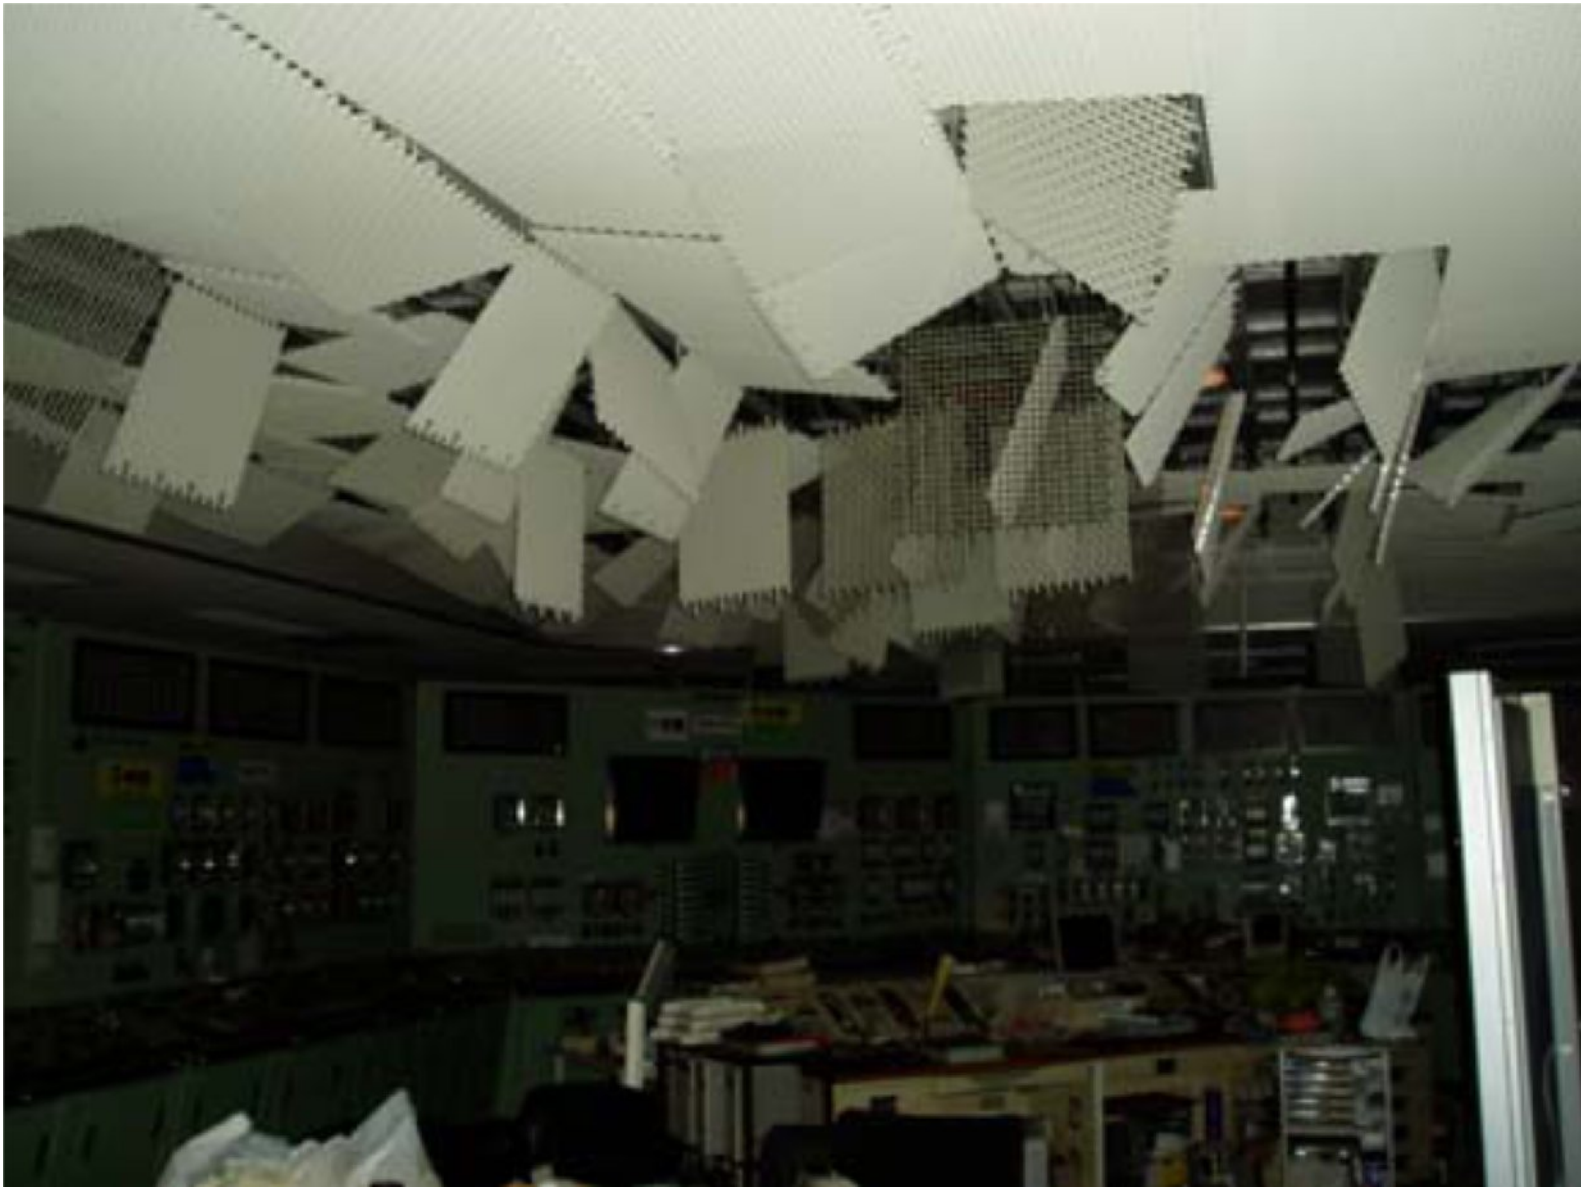
# Damage by Hydrogen Explosion - Main Control Room

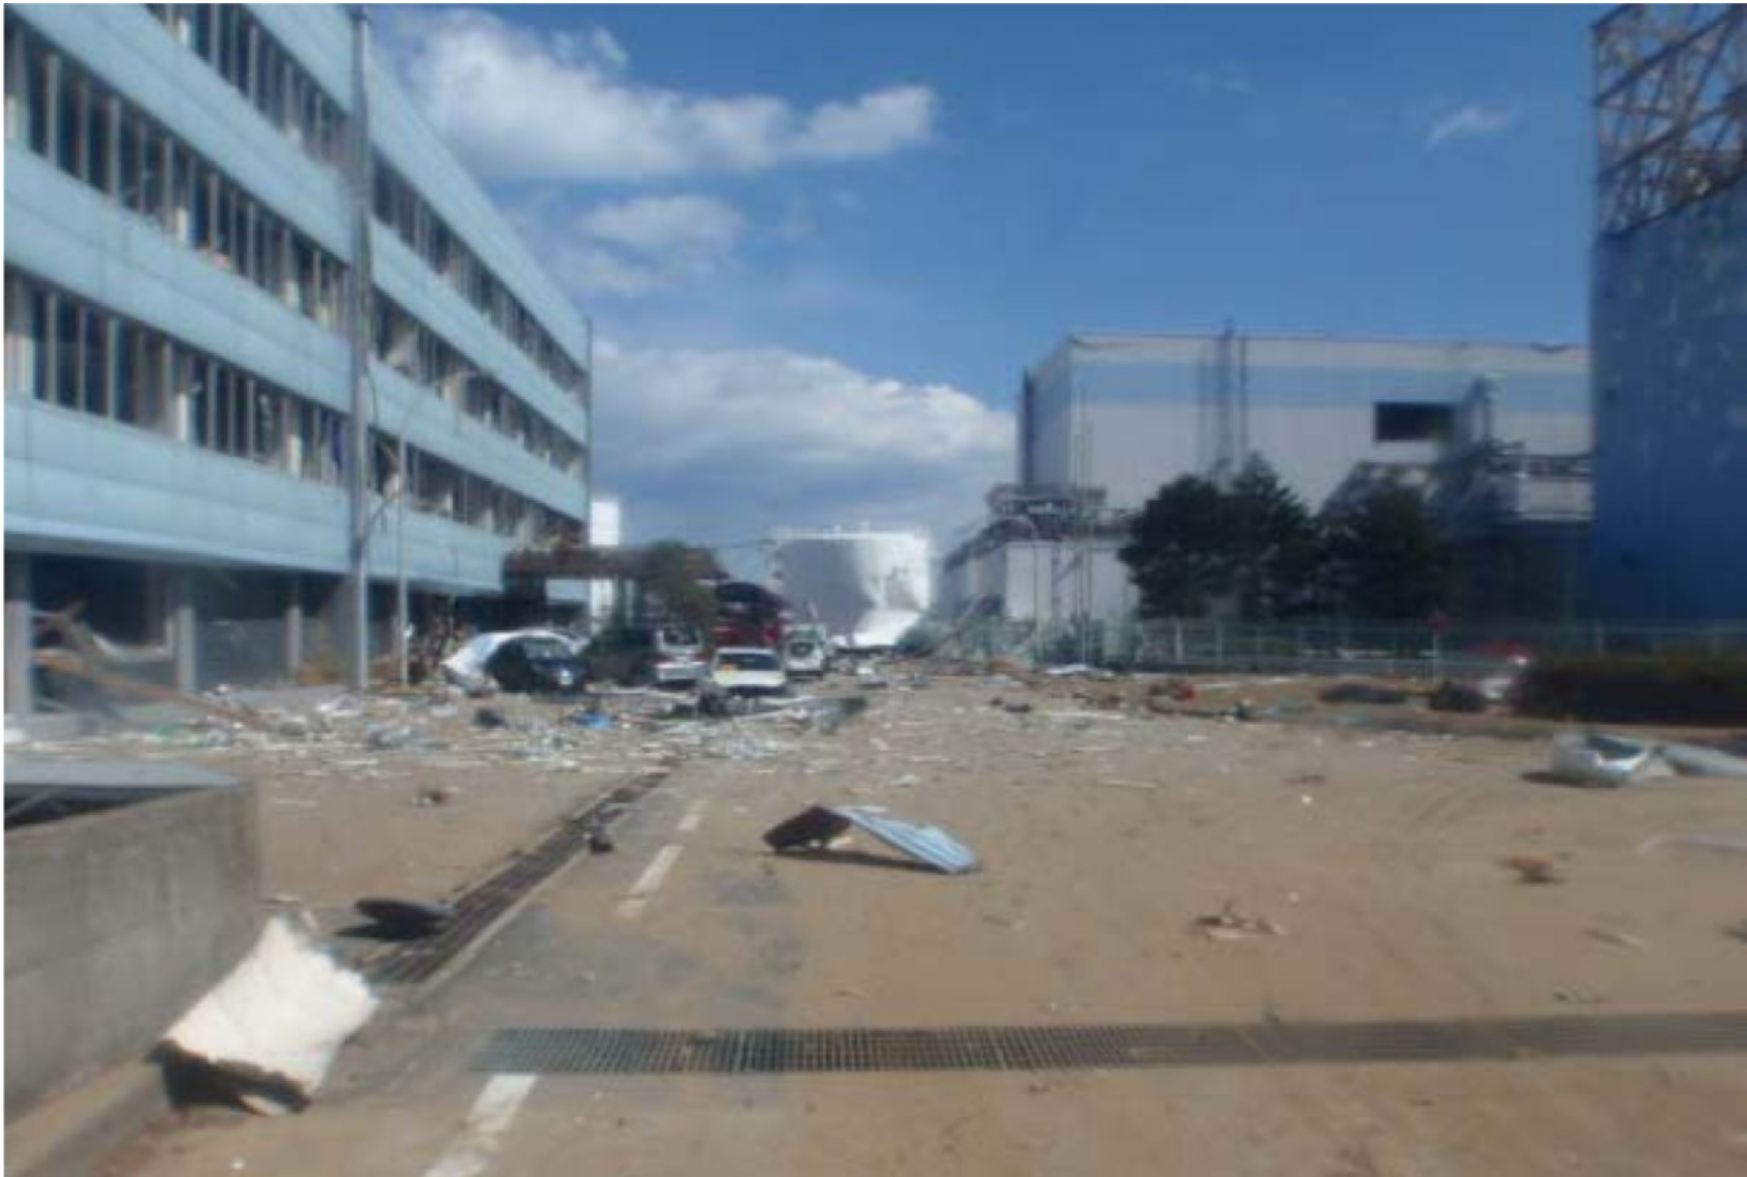
# Damage by Hydrogen Explosion - Adjoining Building

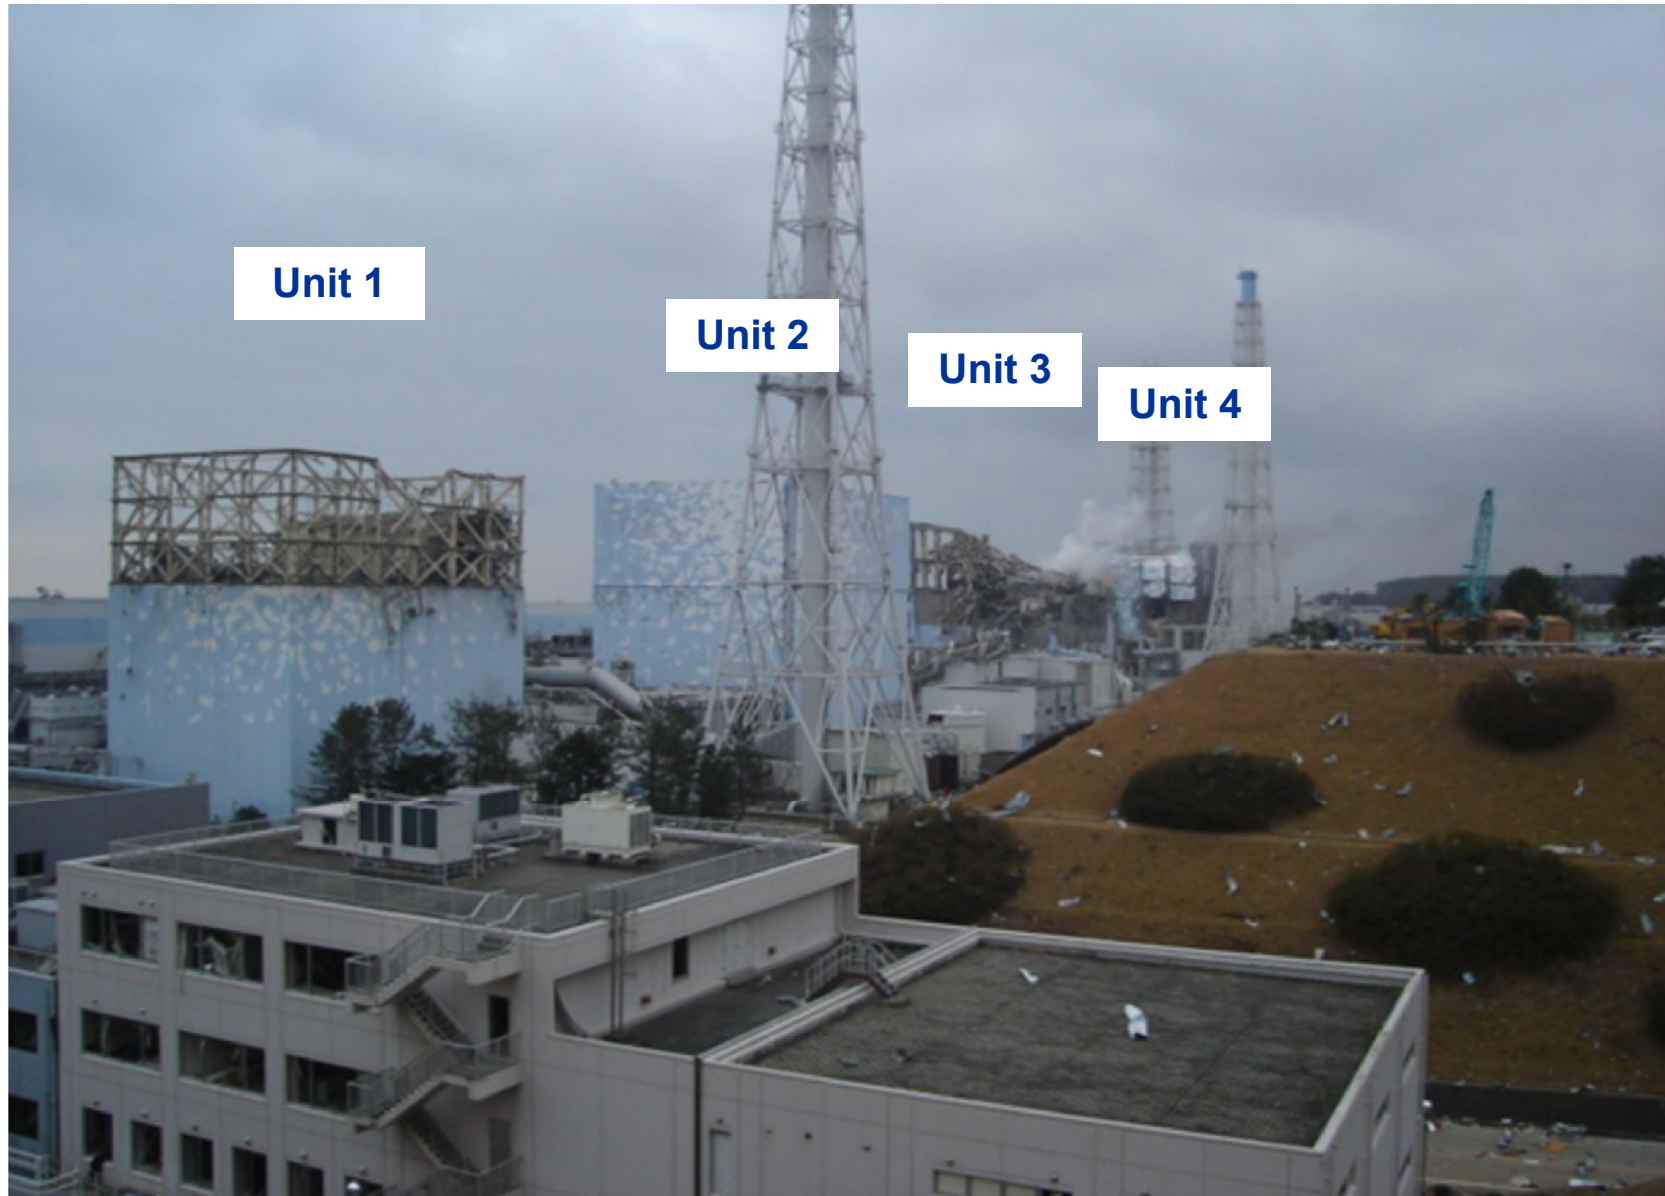
# Units 1 - 4 after Hydrogen Explosions

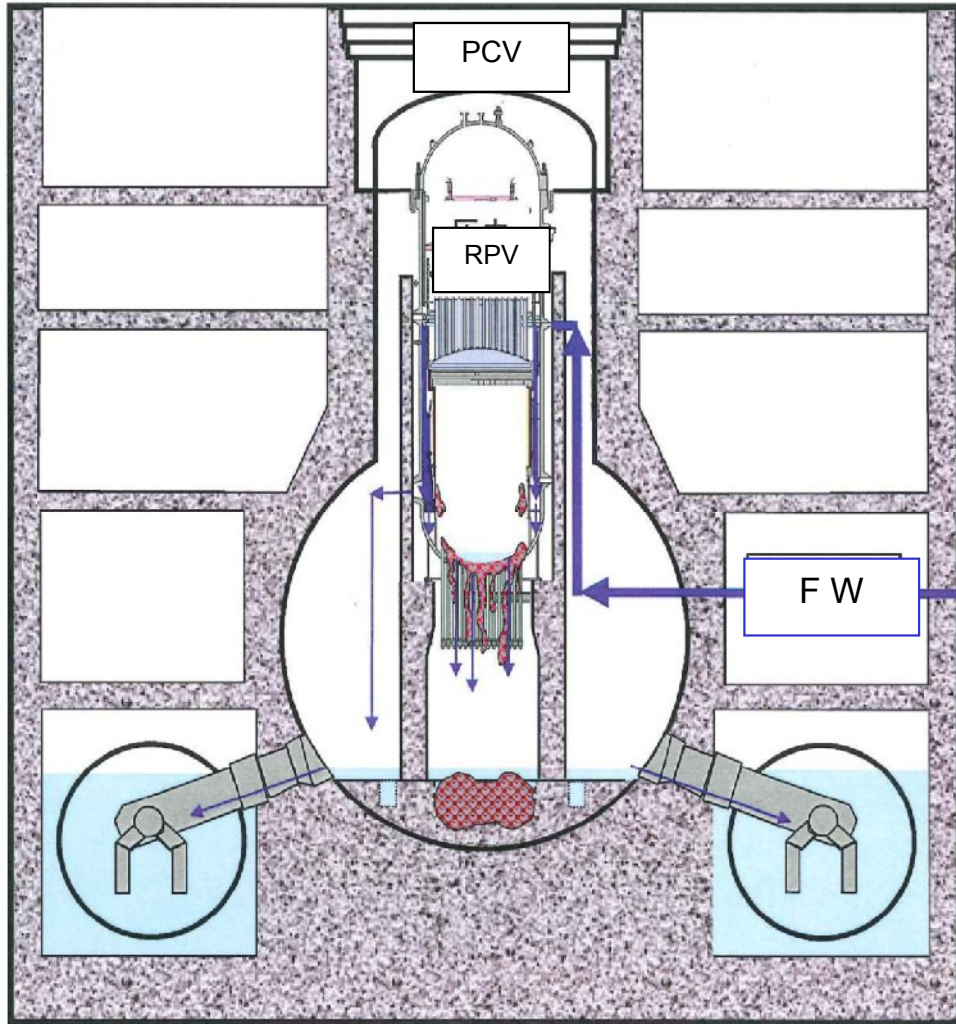
Unit 1

# Estimated Damage of Reactor Core
