Single-Shell Tanks Leak Integrity Elements/ SX Farm Leak Causes and Locations - 12127

ABSTRACT

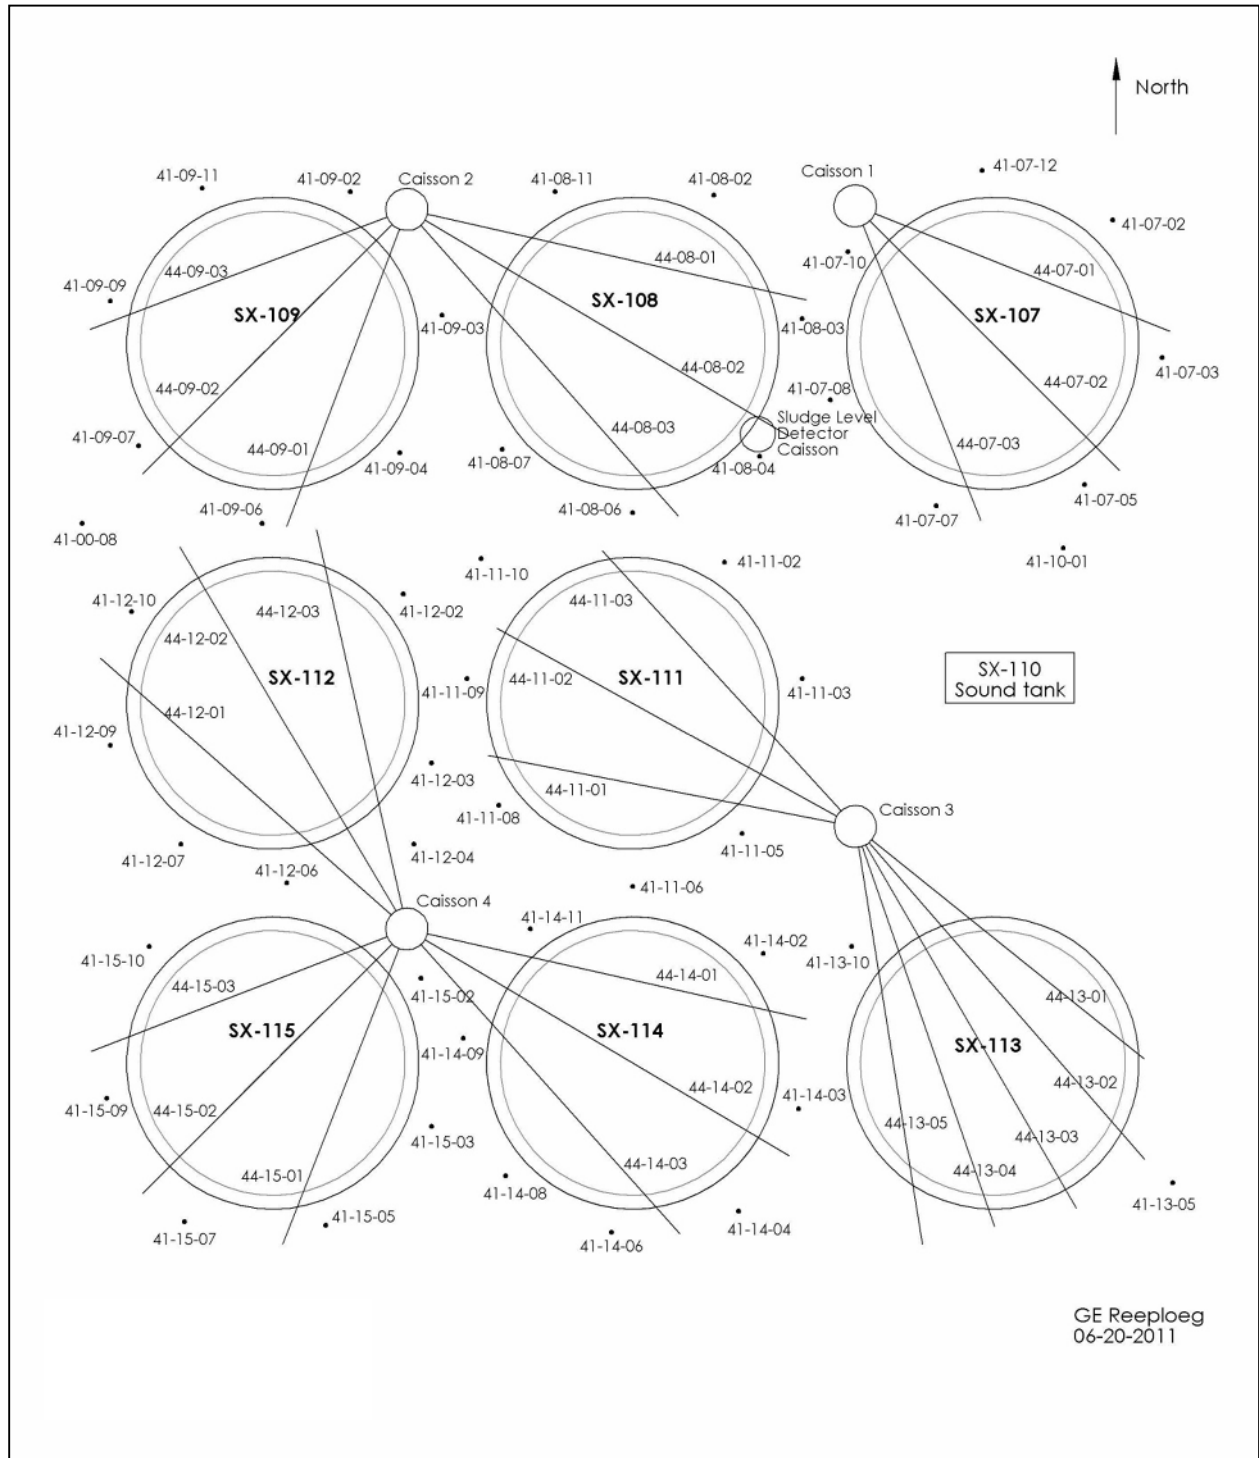
Figure 1. SX Farm Leaking Tanks with Laterals and Drywells
Tank inner ring is steel liner, outer ring is outer edge of tank footing [5-8]

Note: Sound tanks SX-101 to SX-106 lie to the north of tanks SX-107, SX-108, and SX-109. Solid straight lines extending from the caissons represent laterals and solid black dots represent drywells.

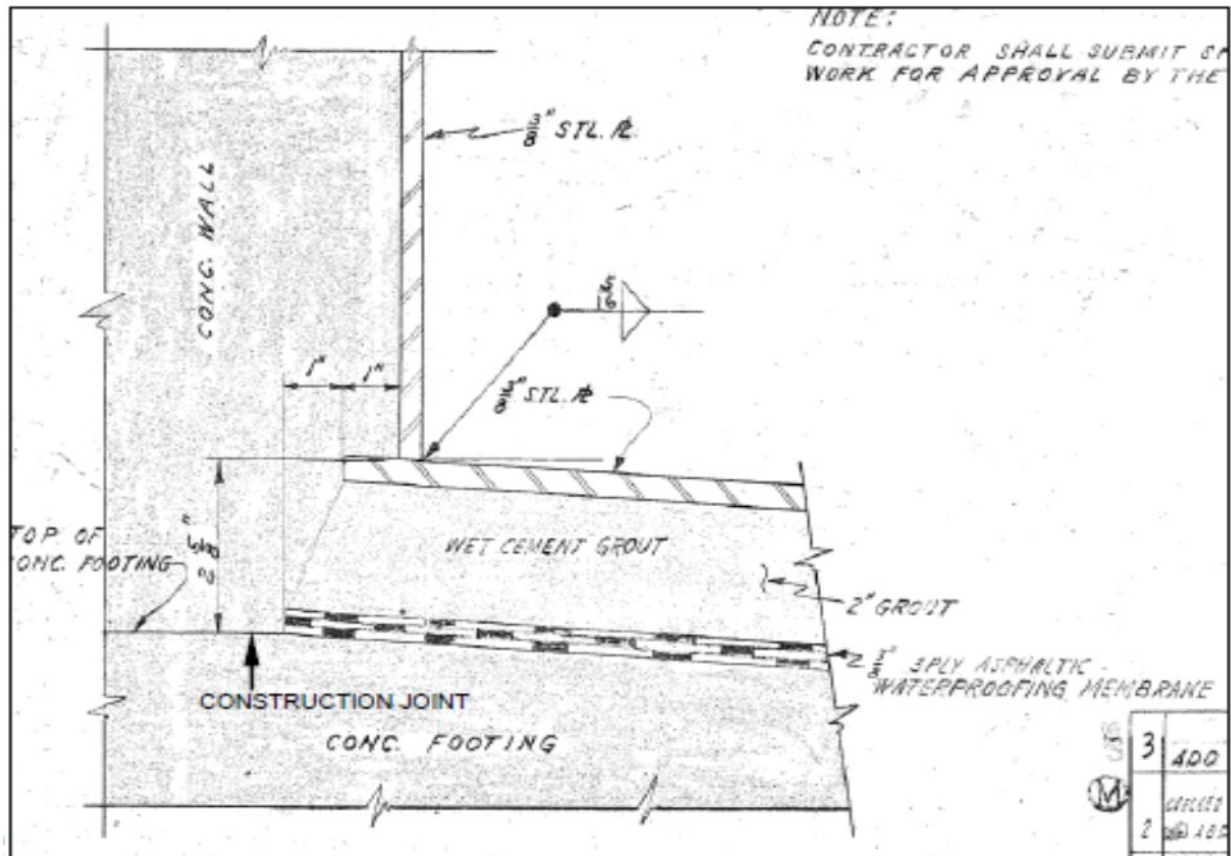
Figure 3. SX Farm Tank Bottom Liner to Sidewall Design Detail [6]

Figure 3 shows the detail of the orthogonal intersection between the bottom and the sidewall with a fillet weld between the bottom and sidewall orthogonal intersection [6]. Full penetration butt welds for BCTU Farm tanks are shown in Figure 4 for the rounded knuckle configuration [9].

The three ply asphaltic membrane waterproofing between the liner and the concrete shell was eliminated from the design of the SX Farm tanks (see Figure 3). An asphaltic membrane was incorporated between the concrete footing and the grout below the liner. The design for BCTU Farm tanks for comparison is shown in Figure 4 which shows the rounded knuckle configuration with the bottom, knuckle, and sidewall three ply water proofing.

Note: The water stop at the construction joint between footing and middle of the concrete wall is to the left of the above detail.

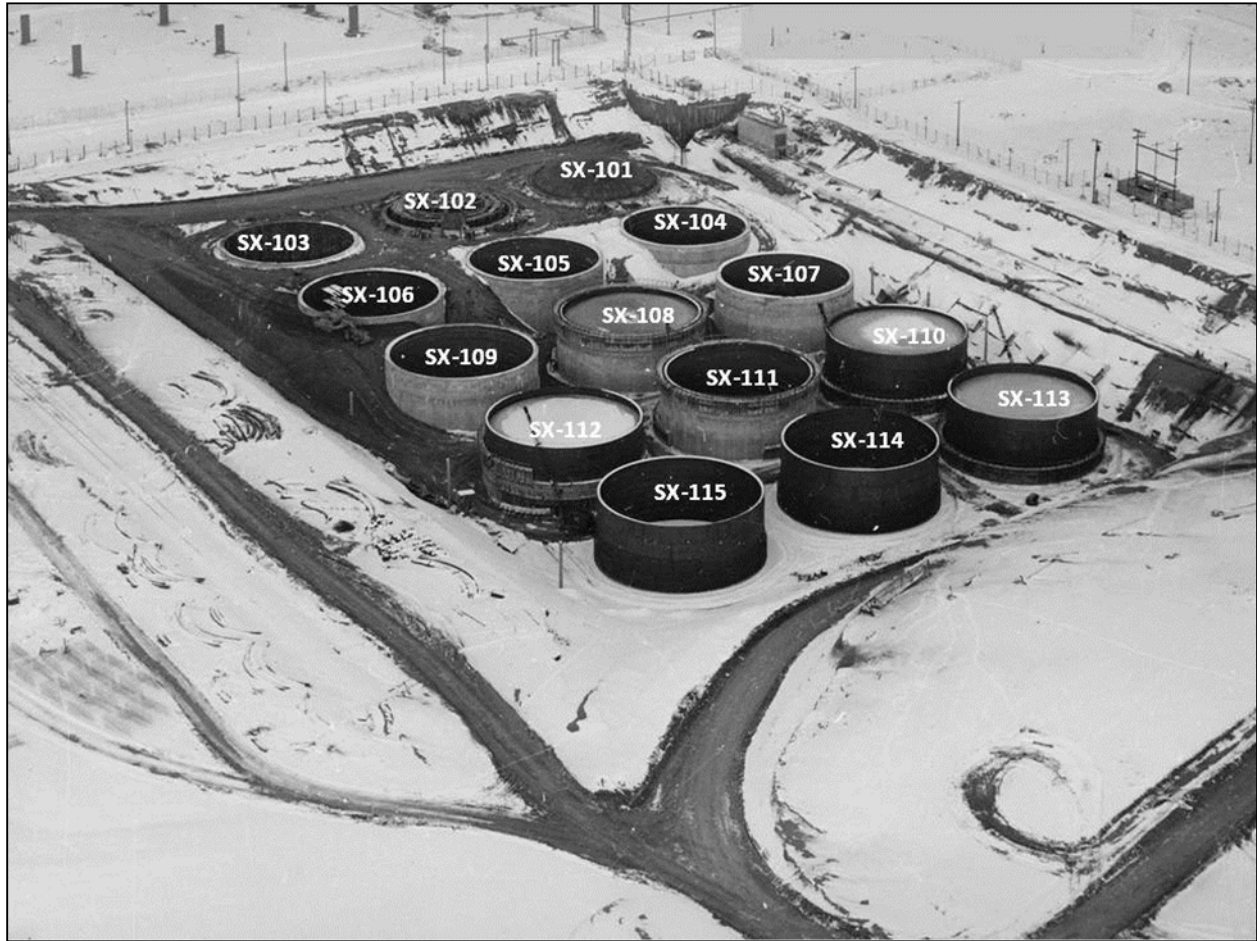
**Figure 5. SX Farm Construction Photograph
January 20, 1954 (N1D00585052)**

The outside temperature between January 16, 1954 and January 30, 1954 ranged from an average high of 24°F to an average low of 9°F. A photograph of the SX Farm under construction (see Figure 5), taken January 20, 1954 (high 11°F low -6°F), shows several of the tanks full of water either undergoing leak testing or for concrete wall pouring. During this cold period snow covered ice is seen in the water filled tanks. Some question exists on the ductile-brittle transition temperature during construction of the SX Farm at these low temperatures. There was also a delay on tank work pending installation of a high capacity vent system for tanks SX-107 through SX-115 based on S-104 steam eruptions [14, 15]. These tanks could have been exposed to the elements for a significant period of time.

Winter temperatures as low as -6°F occurred during the period when the SX Farm tank liners were being constructed and leak tested (see Figure 5). The limitations of carbon steels to resist impact at low temperature was perhaps not well understood when SX Farm was constructed. Issued only recently, the ASME B31T-2010 Code indicates that a ≤ 10 -mm thick Type A 283 steel plate had an unrestricted low temperature service limit of 20°F [17]. The SX Farm tank liners are 9.53-mm (3/8-in) thick A 283 carbon steel. The SX Farm tank construction specification stated that the storage tank liner shall conform to ASTM A-283-52T, grade A or B, with additional specific requirements on carbon composition are stated as “0.26 % maximum”

The low temperatures experienced during construction were less than the 20°F allowable temperature where impact loading had the potential for creating micro-fissures. The load of the steel liner wall on itself and the bottom liner along with filling the tank with water or other impact occurrences may have triggered the fissures in the steel liner that were not detected during liner leak testing.

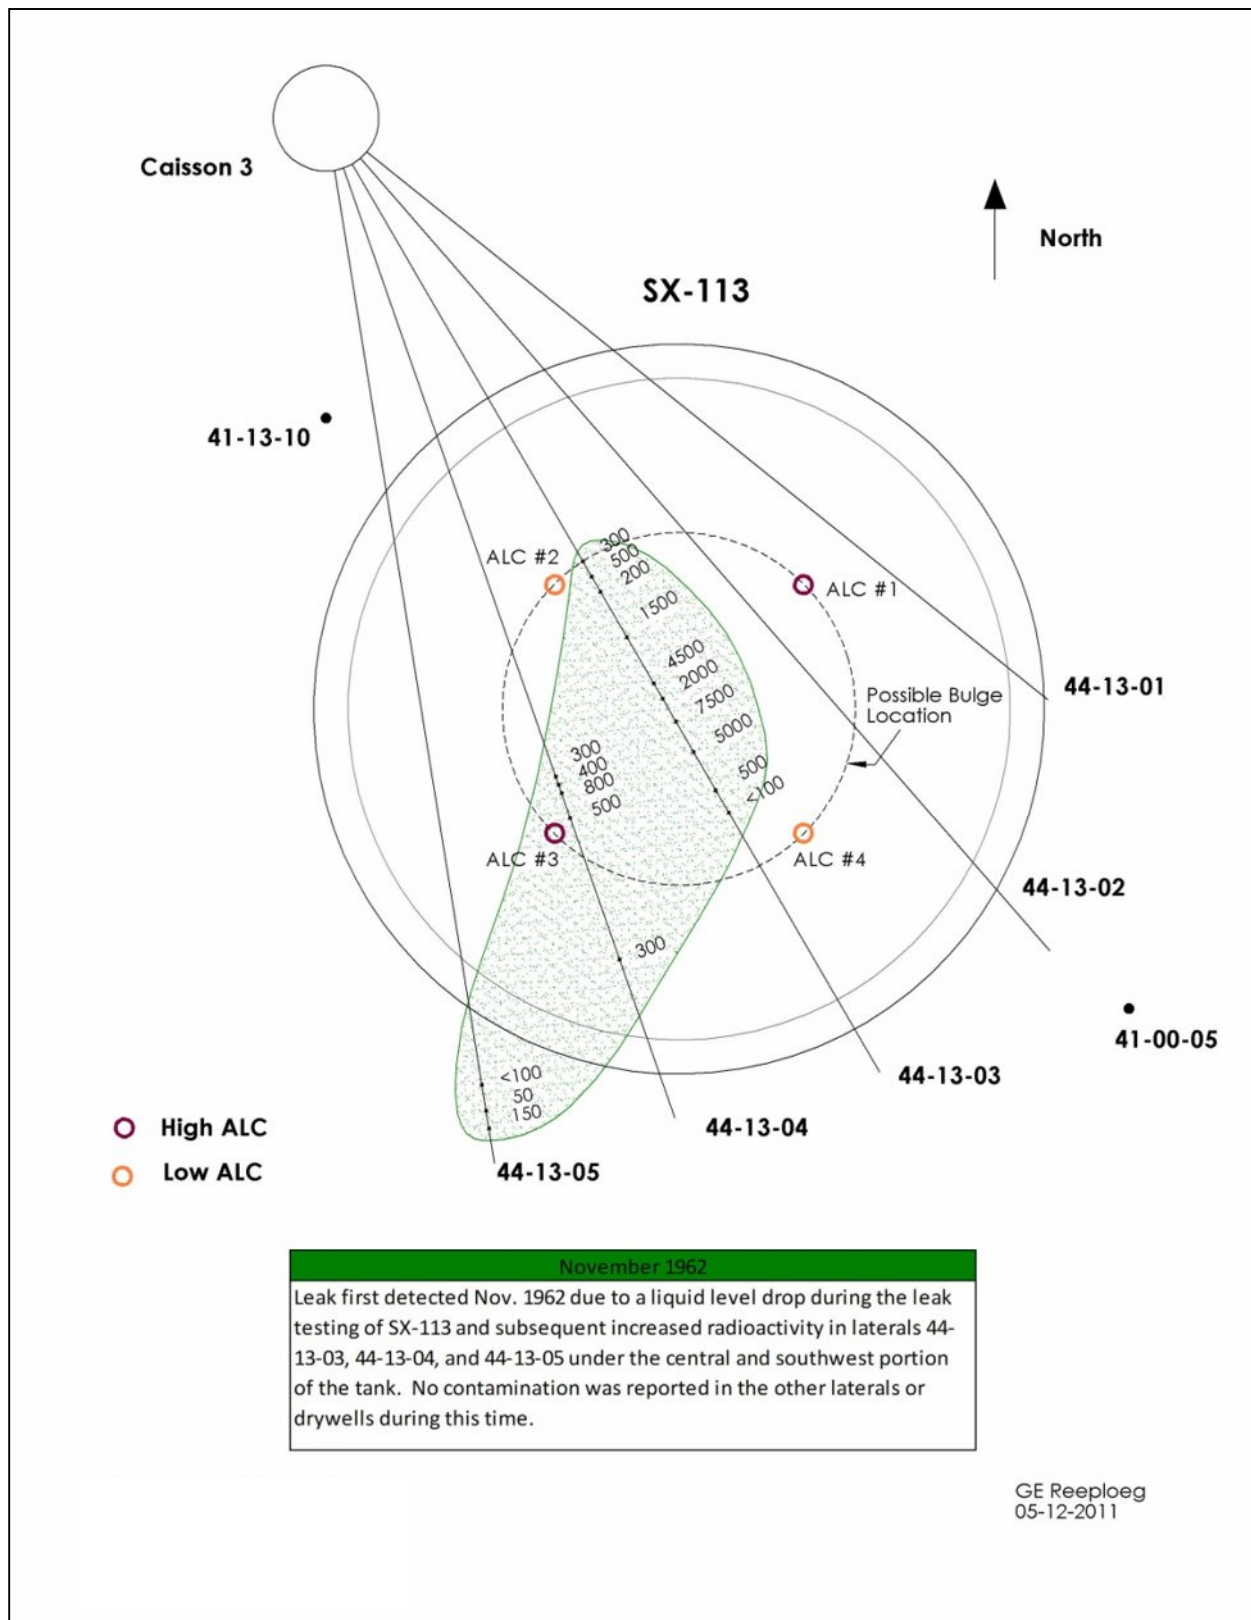
Figure 6. Tank SX-113 Possible Radial Leak Locations with Estimated Bulge [6-8, 29]

A bulged tank bottom was present or possible in all of the eight leaking SX Farm tanks. A bulge of the tank bottom imparts stresses in the liner that could have predisposed it to stress corrosion cracking. A bulge of 4-ft developed when tank SX-113 was filled with a temperature rate of rise at more than 4.5 times the recommended rate. Tank SX-113 could have experienced a weakened sidewall and bottom liner to such an extent that the liner failed. In addition, the added effect of nitrate leachate stress corrosion cracking on an already stressed tank liner could have contributed to liner failure. The possible leak and bulge location for tank SX-113 is shown in Figure 6. Tank SX-113 was the first tank to fail in SX Farm in November 1962, shortly after waste was first added to the tank.
