**Critical Drivers for Safety Culture:
Examining Department of Energy and U.S. Army Operational Experiences - 12382**

Elizabeth A. Lowes
The S.M. Stoller Corporation, Broomfield, Colorado

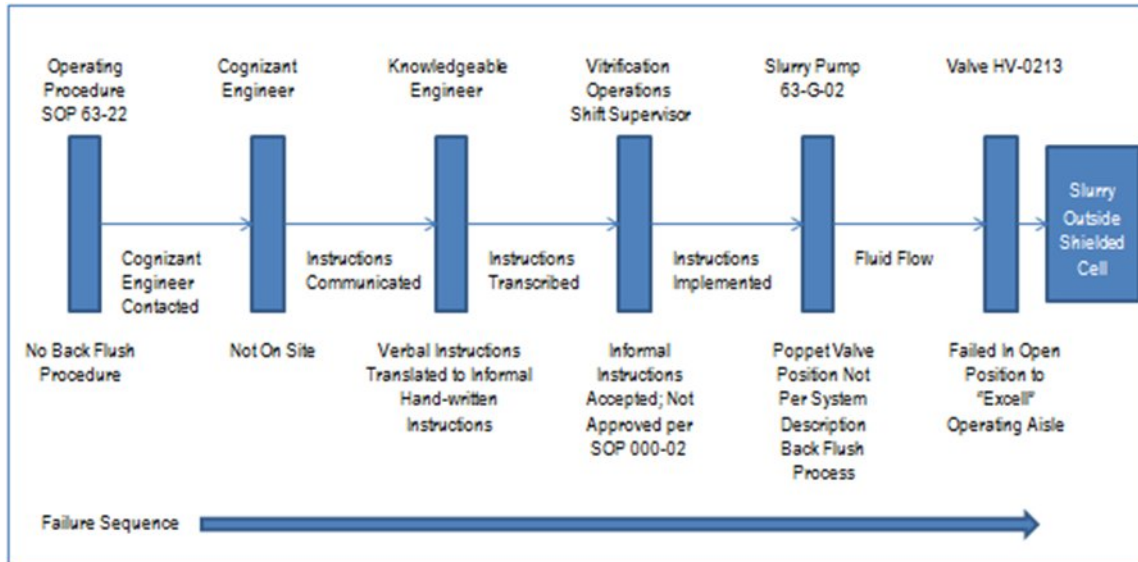
reconstruction of the event confirmed that with alignment of the valves to back flush through the sample station piping and slurry pump to the slurry waste tank via Valve HV-0213, HV-0213 malfunctioned and resulted in an incorrect position that allowed flush water to pass up through the demineralized water line and out of the shielded cell into the operating aisle. Figure 1 provides a summary of the failure sequence and barrier analysis.

Fig. 1. 1996 WVDP Vitrification Backflow Event – Barrier Analysis.

“An approved procedure was not used to perform the back flushing procedure. The informal instructions provided did not consider the risk of failure of Valve HV-0213 nor were they properly reviewed by appropriate technical disciplines.”

- There was a perception of management pressure to complete the sampling operation.
- The engineer available on site for providing work instructions was not as familiar with the system as the cognizant engineer.
- A decision was made not to base the back flush instructions on a method described in the existing System Description.
- Uncontrolled drawings were used to verify valve line-up for the back flushing operation.
- The System Description did not reflect the current configuration of the sampling station.
- The location of Valve HV-0213 made verification of valve position very difficult.

The primary corrective action put in place following the event was the development of procedures for the sampling operation and other similar operations that included the

appropriate hazard analyses to ensure that the necessary defense-in-depth and controls were established.

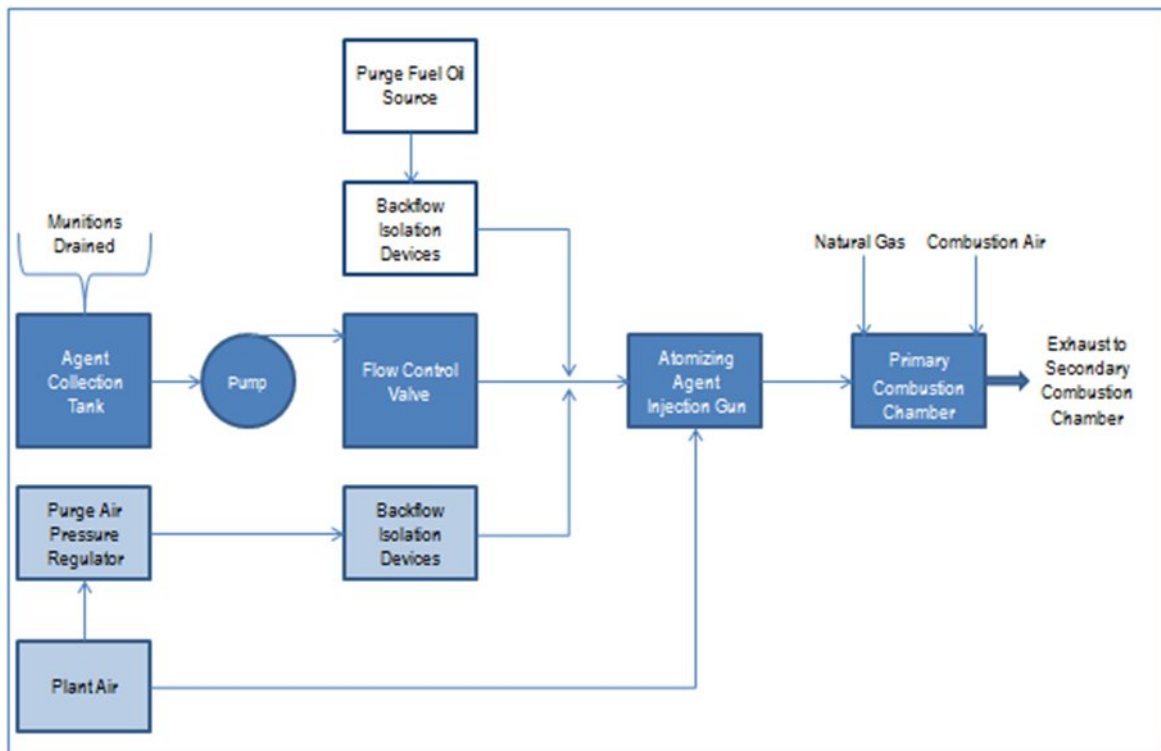
LIC 2 was configured with the same backflow isolation devices (Figure 2 provides a simplified schematic of the LIC Feed System). Since the maintenance work on LIC 1 was conducted during agent operations, there was more rigor in work planning and associated PPE selection; the LIC 1 pressure regulator replacement work was conducted in a fully encapsulated chemical protective suit with supplied air, referred to as a Demilitarization Protection Ensemble (DPE). Unfortunately, the lessons that could have been learned from the LIC 1 work did not get transferred to support the work planning for the similar maintenance on LIC 2. In addition, the work planning for the LIC 2 job was done primarily by the maintenance department and did not include sufficient involvement or review by the Engineering and Safety organizations. A bad assumption was made by those planning the work that TOCDF was in a decontaminated configuration; in fact, only external surfaces had been cleared and this particular maintenance evolution required breaking into the internal piping, with no steps for confirming the integrity of the internal air system. PPE specified for the job was a full face industrial respirator, overalls, and leather boots and gloves, which did not adequately account for the potential presence of agent.

Fig. 2. Simplified schematic of the LIC Feed System.
