Remediation of Uranium Impacted Sediments in a Watercourse - 12486

E. Shephard, N. Walter, H. Downey, and P. Collopy, AMEC E&I, Inc., 511 Congress Street,
Suite 200, Portland, ME 04101.
J. Conant, ABB, Inc., 5 Waterside Crossing, Windsor, CT 06095

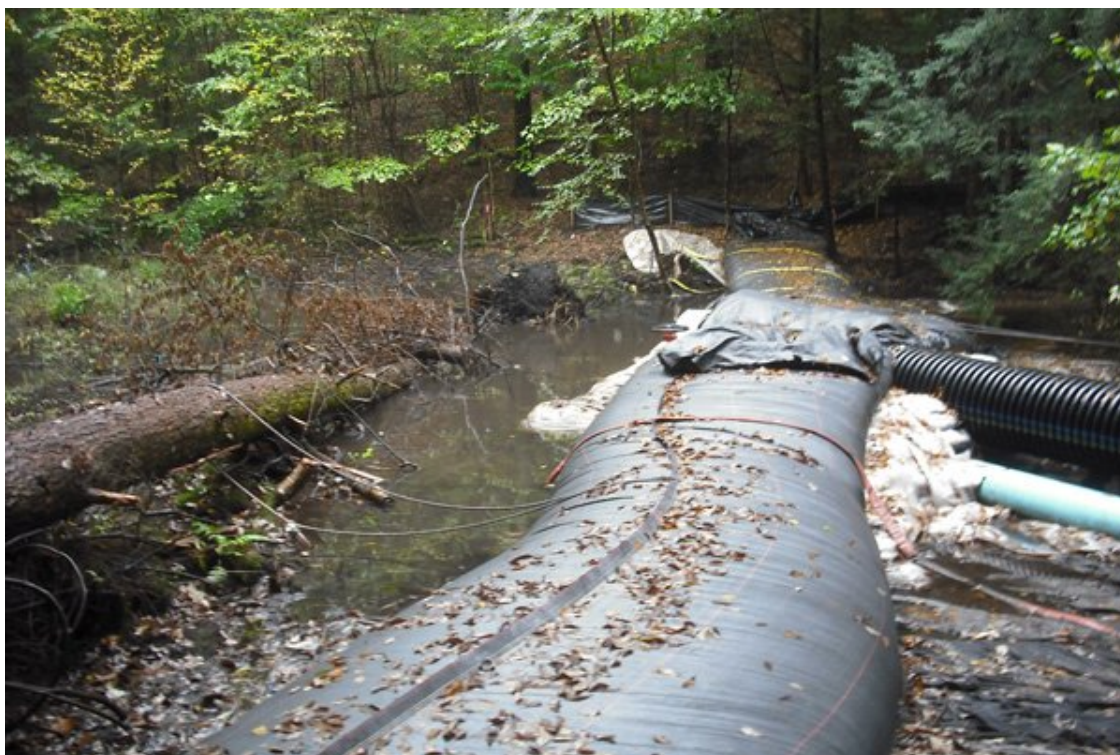
Fig 1. Water diversion using bladder berms.

The water diversion system (Figure 1) consisted of temporary bladder berms installed upstream (to divert surface water flow in the stream channel) and downstream (to prevent groundwater infiltration from flowing out of the remediation area) and surface water conveyance piping consisting of 90-centimeter diameter corrugated polyethylene pipe. The water diversion system was supplemented with the installation of sand bags to seal leaks around the bladder berms. In order to control scouring from the water discharging from the surface water conveyance piping, 10-millimeter thick plastic sheeting with block diffusers was installed at the discharge end of the pipe. At the Site Brook outfall to the receiving river, a 5-centimeter deep turbidity curtain was installed as an additional measure to control any sediment that may have migrated past the primary control measures installed upstream.

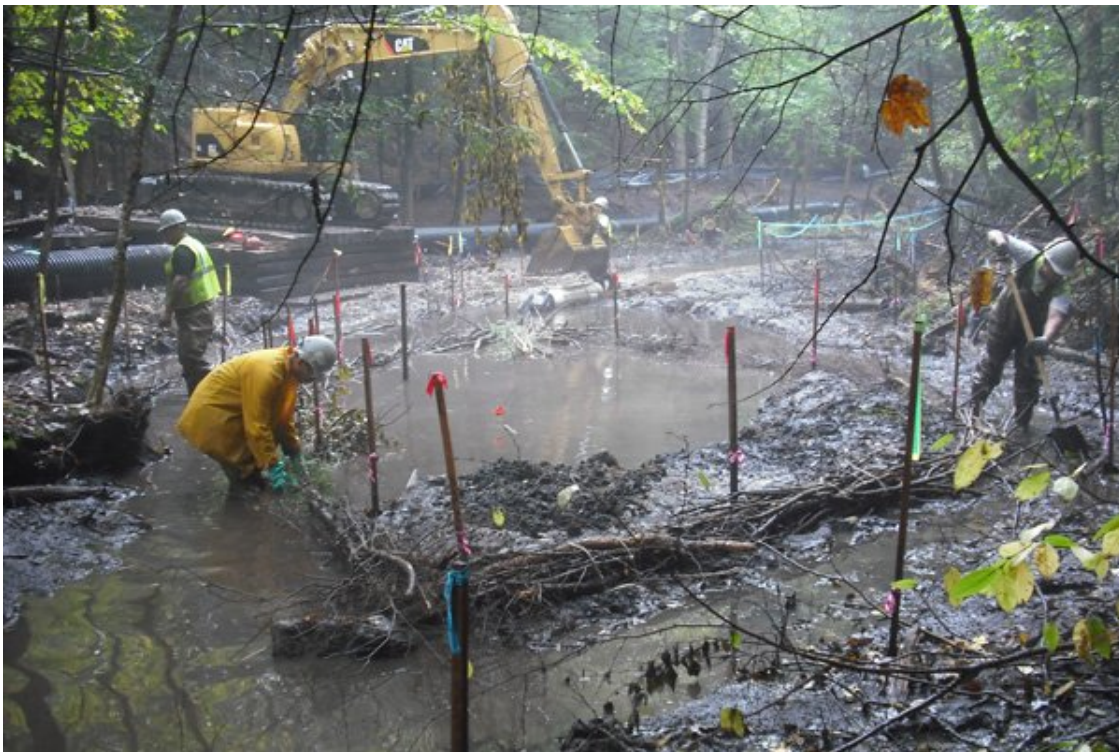
Fig 2. Excavation activities in an area of Site Brook.

The issued permits allowed the use of a vacuum system, small excavation equipment, and/or hand tools to excavate material from the Site Brook. The vacuum system was the initial method attempted for excavation of contaminated soil/sediment in an effort to reduce the impact of equipment in the wetlands (and reduce the amount of restoration needed). The vacuum system was positioned approximately 150-meters outside of the remediation area and a long suction hose was used to vacuum impacted material from the remediation area. It quickly became apparent that due to the mix of root mass material, the presence of trees and stumps, and other debris in the remediation areas, the vacuum system was not effective. The excavation methodology was changed to use small excavators that were “walked” into the remediation areas atop high-density polyethylene inter-locking mats to protect the ecological setting and minimize impacts from the excavation equipment. Excavated material was placed into 0.8 cubic meter shipping bags and the bags were transferred to a waste storage area for dewatering and off-site disposal. Figure 2 shows excavation activities in an area of Site Brook.

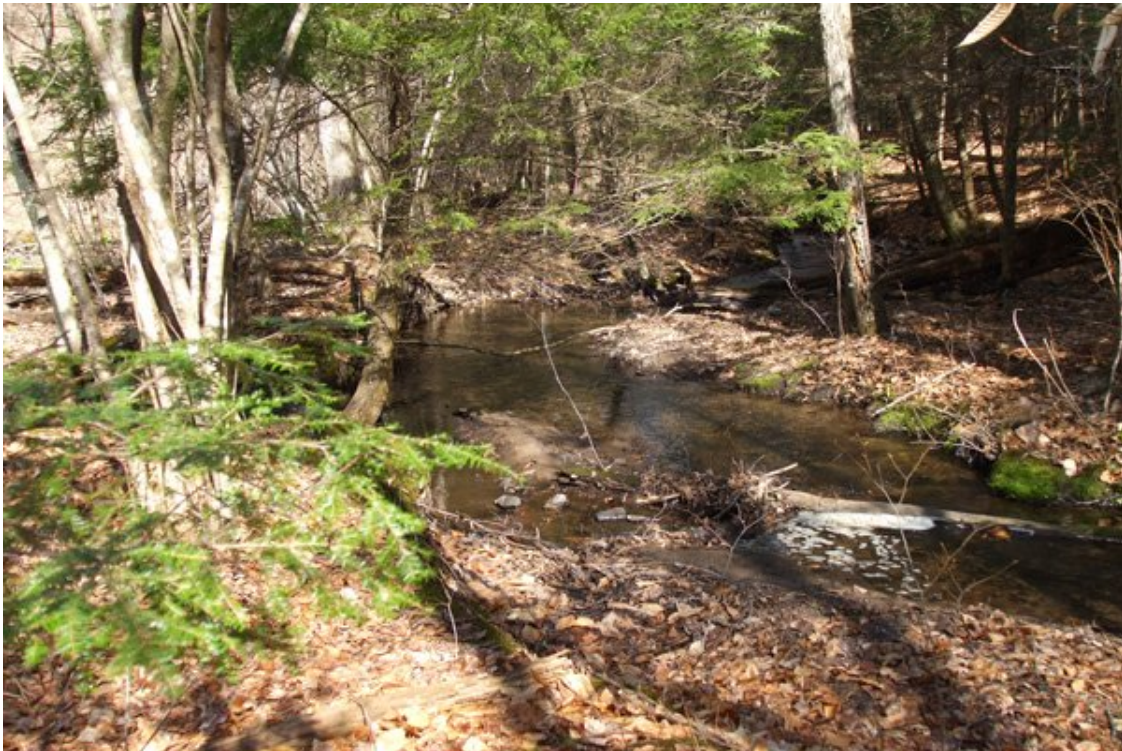
Fig 3. Site Brook conditions before remediation.

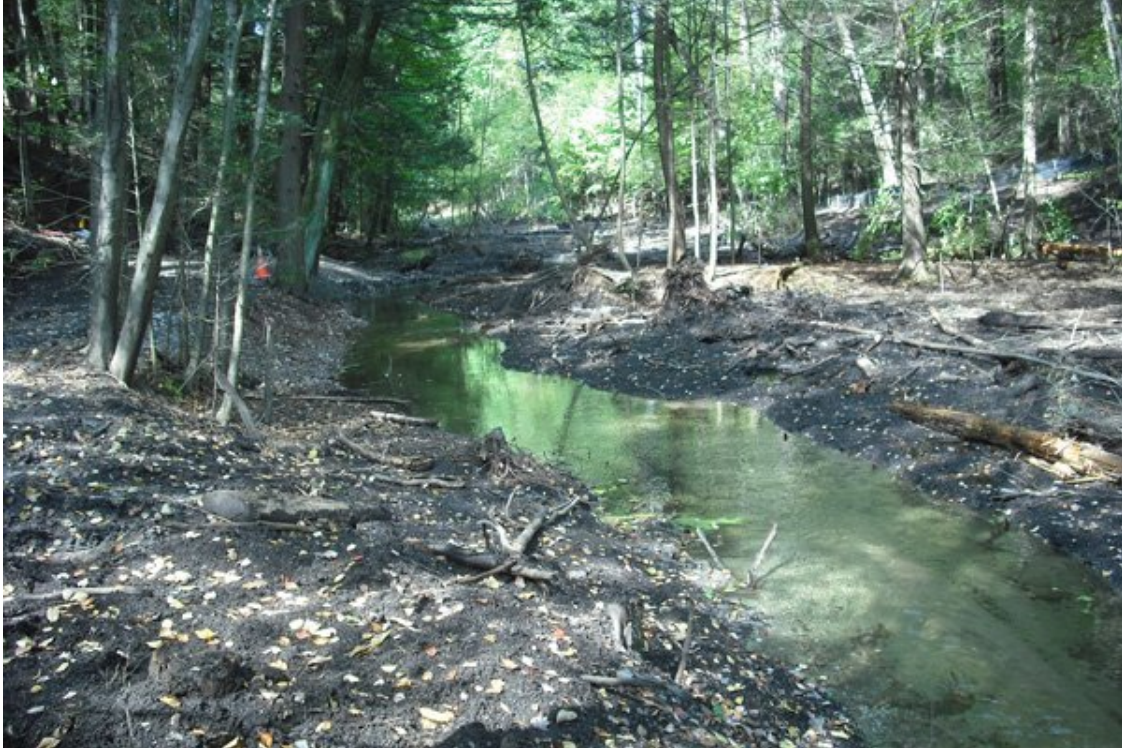
Fig 4. Site Brook conditions after remediation and restoration.

The excavated and disturbed segments of the Site Brook were restored with substrate closely matching that which had been removed. Backfilling of the stream channel was performed using materials that were similar to those within the existing stream bed (i.e., similar grain size and material type). The stream channel was reconstructed to closely match the existing channel, taking into consideration the flow path, entrenchment, and sinuosity of the existing channel. Wetland soil was blended using a mixture of organic material and mineral soil. Equipment used to transport wetland and stream channel backfill was limited in size to minimize impacts during the wetland and upland restoration. A wetland seed mixture was sown to promote re-vegetation of disturbed areas and woody debris was used to stabilize the wetland soil. Mulch and leaf litter
