“The Accident at Fukushima: What Happened?”

February 27, 2012

Takao Fujie
President and Chief Executive Officer
Japan Nuclear Technology Institute (JANTI)

WM2012 Conference, February 26 – March 1, 2012, Phoenix, AZ, USA

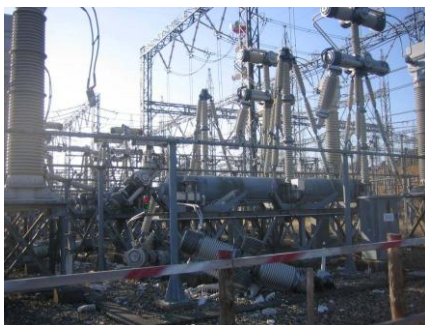
275kV Circuit Breaker of Substation

Although the seismic motion recorded at the power station exceeded the design basis in some areas, the integrity of the power station facility structures was maintained and the automatic scram of the reactors activated as designed. However, damage to substation equipment and switchyard equipment at the power station caused all of Units 1 through 6 to lose off-site power. For example, this 275 kV circuit breaker at the substation connected to the Fukushima Daiichi was damaged. A circuit breaker for the Unit 1 power transmission lines at the power station was also damaged.

Example of Damage by Earthquake

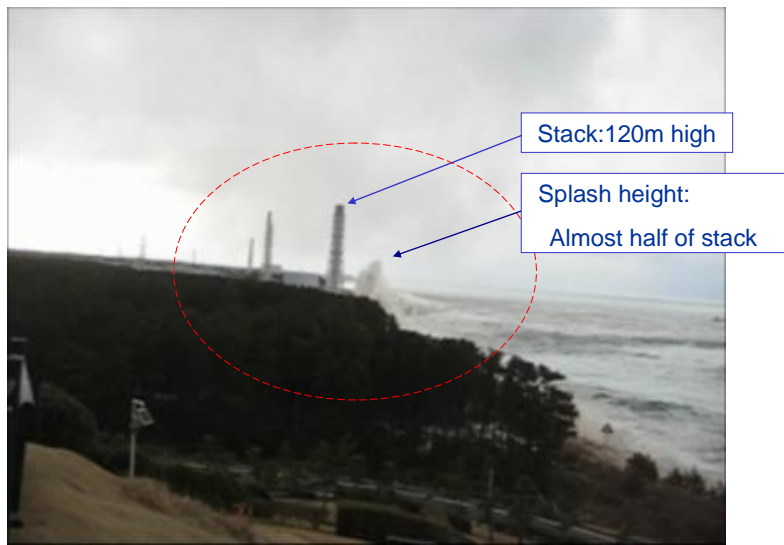
Tsunami Strikes Fukushima Daiichi NPS

Within about 50 minutes of the earthquake striking, the enormous tsunami engulfed the power station. This photograph taken from the observation deck shows a wave that has crashed into the breakwater and reached a height half of the 120-meter tall stack.

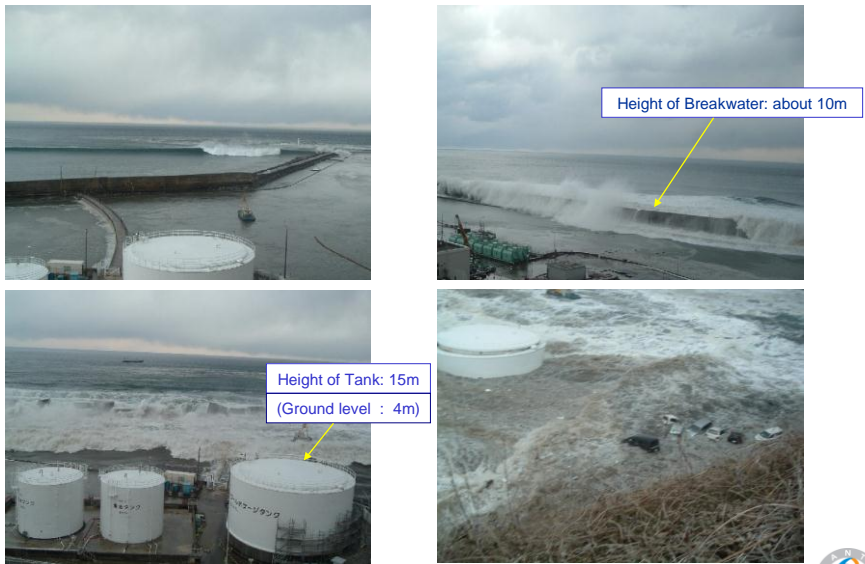
Tsunami Striking North Breakwater

I will show you a series of photographs of the tsunami striking the north breakwater. This wave rode over the 10-meter high breakwater and covered two-thirds of the 15-meter tall surge tank.

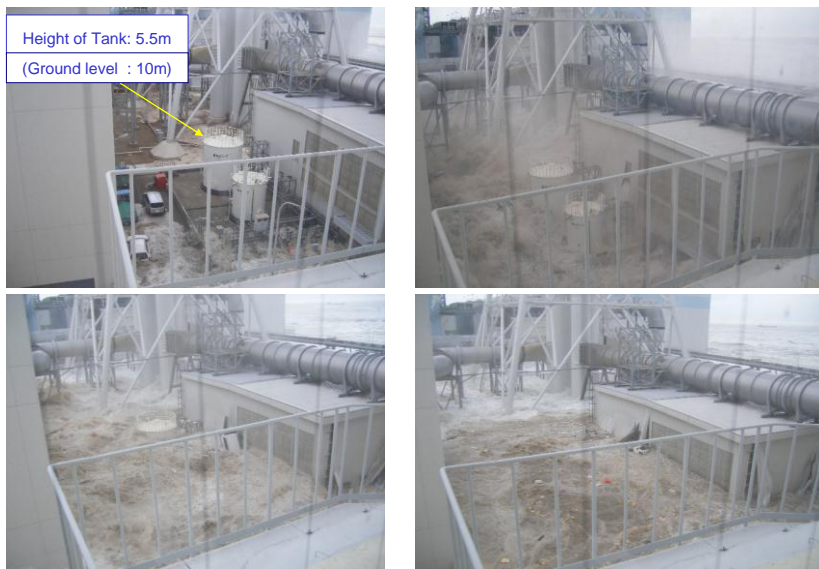
Flooding by Tsunami around R/W Treatment Facility

The next series of photographs show submerged oil tanks in the area surrounding the radioactive waste treatment facility, the ground level of which is 10 meters above sea. The 5.5 meter tank has been completely submerged. This indicates that the flood height has reached more than 15 meters.

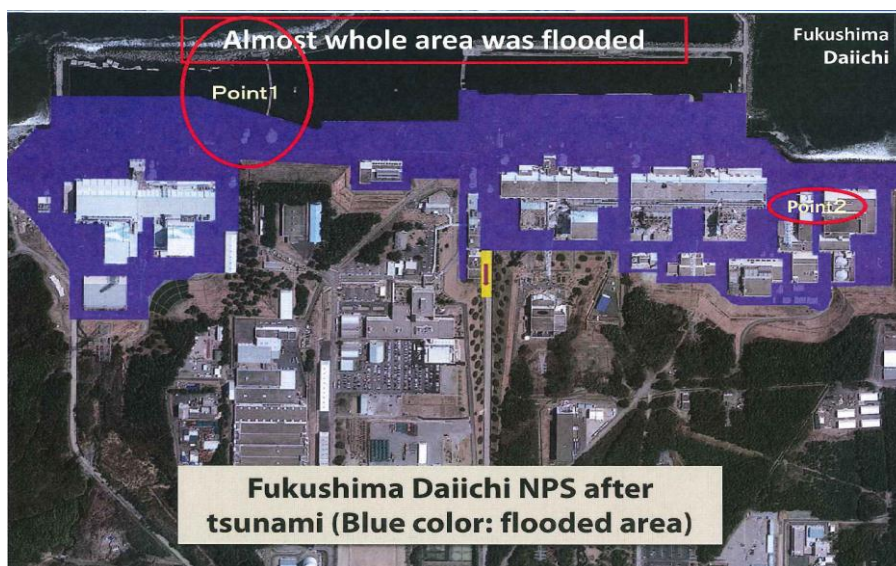
From an aerial photograph of the Fukushima Daiichi Power Station, the flooded areas can be seen in blue. In addition to the seaside area, the area around the reactor buildings and turbine buildings of all units has flooded. The devastation after the tsunami withdrew is apparent.

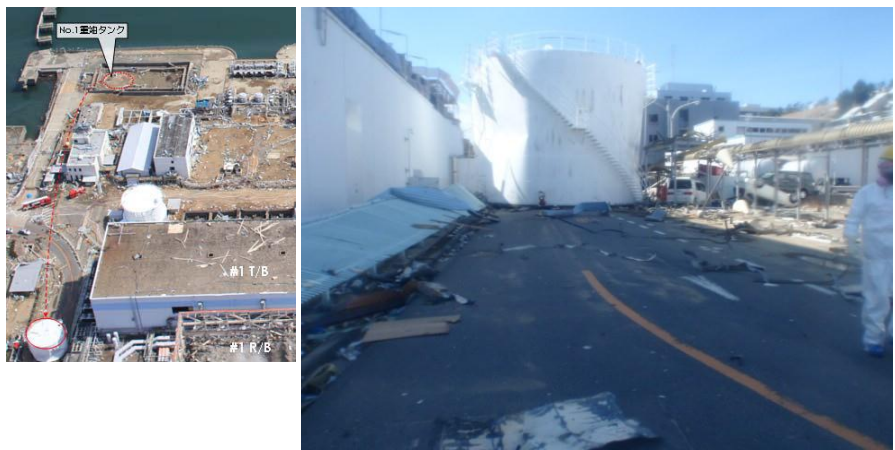
Example of Damage by Tsunami - Oil Tank

One of the oil tanks that had been on the seaside of Unit 1 was pushed 180 meters inland by the tsunami. The tank was carried to the Unit 1 turbine building and blocked the road. This road was a main access route to other Units. Because it was now blocked, a huge obstacle was created for accident response.

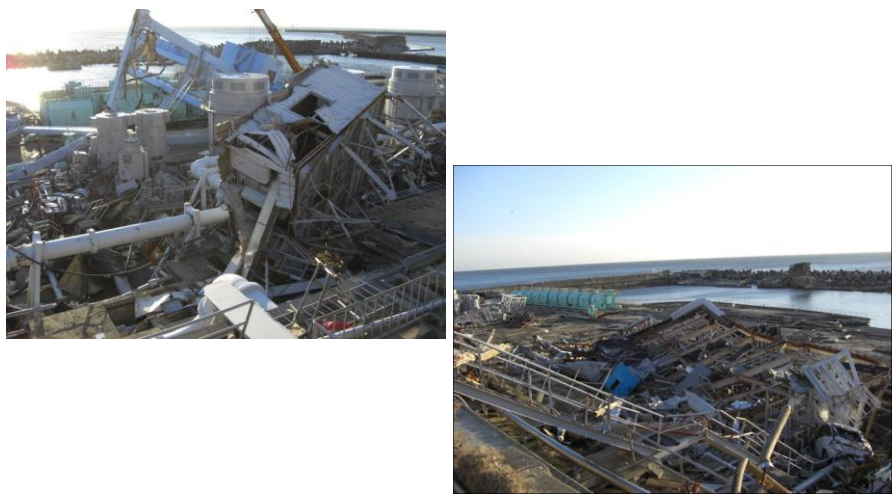
Example of Damage by Tsunami - Seawater Facility

Because of the power of the tsunami, equipment in the yard has been destroyed and all that remains is a pile of rubble. Seawater pumps were also damaged.

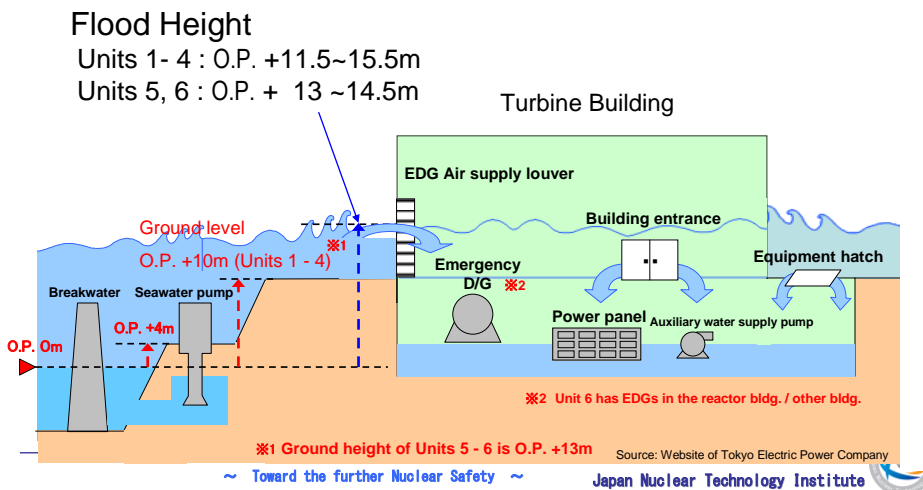
Flood Pathways into Turbine Building

The ground level of the main buildings are 10 meters above sea , but the flood height by the tsunami was 15 meters and it left the surrounding area submerged under 5 meters of water. As a result, water entered the turbine buildings through the entrance and “openings” such as the air supply louver. Equipment in the basement of the turbine building, including the emergency diesel generator, power supply panels, and batteries, was damaged by the water, or flooded.

As a result, the emergency diesel generator stopped, and a station blackout occurred at Units 1 through 4. Moreover, with the exception of Unit 3, DC power, such as batteries, were simultaneously rendered inoperable, which caused instruments monitored in the main control room to stop working. It became impossible to observe the status of the plant. All functions of the primary cooling system were lost, with the exception of some equipment which remained partially functional.

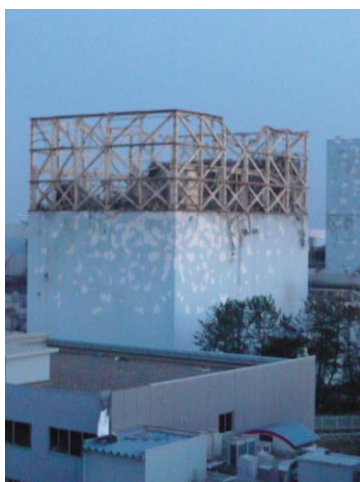
Hydrogen Explosion at Unit 1

It was then at 3:36 PM on March 12, that a hydrogen explosion occurred in the reactor building.

This explosion blew off the roof and the wall panels of the top floor, leaving its metal frame exposed. In the Unit 1 main control room, the explosion caused the ceiling light molding to fall to the floor. The explosion also caused debris to fall on the road next to Unit 1 and blew out the windows of the office building.

March 12 15:36 Hydrogen Explosion Occurred at R/B.

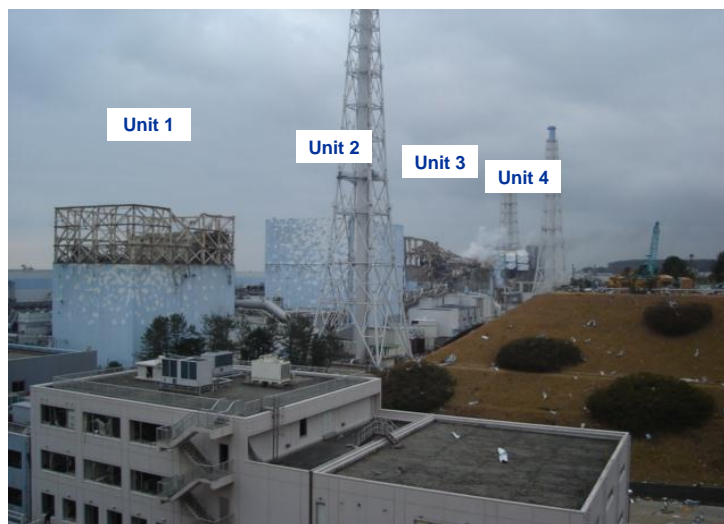
Units 1 - 4 after Hydrogen Explosions

This was taken on March 15, four days after the accident, and shows the condition of the reactor buildings of Units 1 through 4. With the exception of Unit 2, other reactor buildings all show extensive damage due to the hydrogen explosions.

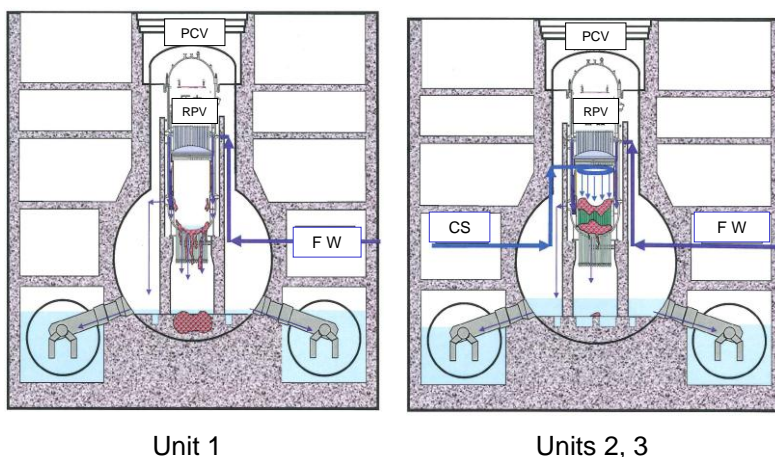
Estimated Damage of Reactor Core

The results of an analysis of core damage by TEPCO show that at Unit 1, where core meltdown occurred the quickest, almost all of the fuel melted and fell from the pressure vessel onto the concrete of the containment vessel. However, even though the accuracy of this analysis remains unclear, it is believed that the containment vessel prevented fuel debris from penetrating the concrete. Furthermore, at Units 2 and 3, a large amount of fuel accumulated within the pressure vessel due to the water injection into the reactor that continued for some time after the accident, and it is predicted that only some of the fuel that fell dropped into the containment vessel.
