Observation and Responses to Post-Closure Instances of Localized Instability and Subsidence at the DOE Legacy Management Rocky Flats Site, Colorado—13052

ABSTRACT

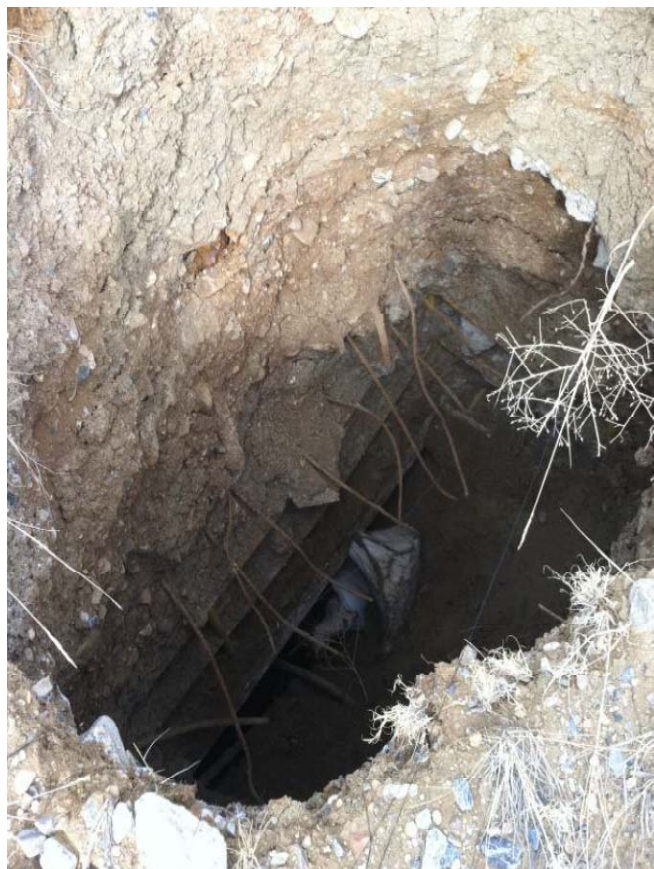
An annual inspection and monitoring of evidence of significant erosion and violation of institutional controls in the Central OU is conducted as required by RFLMA. During the annual inspection conducted on March 15, 2011, a deep hole (approximately 1.8–2.4 m (6–8 ft) in diameter; actual depth unknown) was found near the southwest corner of former Building 881 (881 hole) (see Figure 3). Figure 4 is a photograph of the observed hole.

Figure 4. 881 hole observed in 2011

The 881 hole was not present in inspections prior to 2011 and was significantly larger and deeper than other observed depressions and holes in the vicinity of buried building remnants. The area was fenced off temporarily while the evaluation of the exact location, approximate size, and approach to filling the hole was completed. Because of safety concerns related to working close to the hole to take precise depth measurements and visually observe the deeper reaches of the hole, determining the possible cause of the hole and the planning to fill the hole were based on conclusions drawn from documentation of the demolition of the building.

The approximate location of the observed hole was determined using a hand-held Global Positioning System (GPS) unit. A comparison of the GPS coordinates to survey coordinates for the building location indicated that the hole was near the southwest corner of the former building.

Prior to demolition of Building 881, a stairwell was located on the southwest side of the building leading to the basement level near the loading dock area. Rebar and what appear to be metal railings are evident in Figure 4. The hole appears to be due to settling of fill material into an area at the bottom area of the staircase that did not fully collapse during explosive demolition, creating voids.

The general area surrounding the hole was fenced off with temporary fencing, and the hole was filled on March 30, 2011, with 25.4 metric tons (28 tons) of structural fines and 18 metric tons

Based on the depth of the 881 hole and the possible safety hazard from holes that could form above subsurface building basements and tunnels that had been filled, site operations personnel

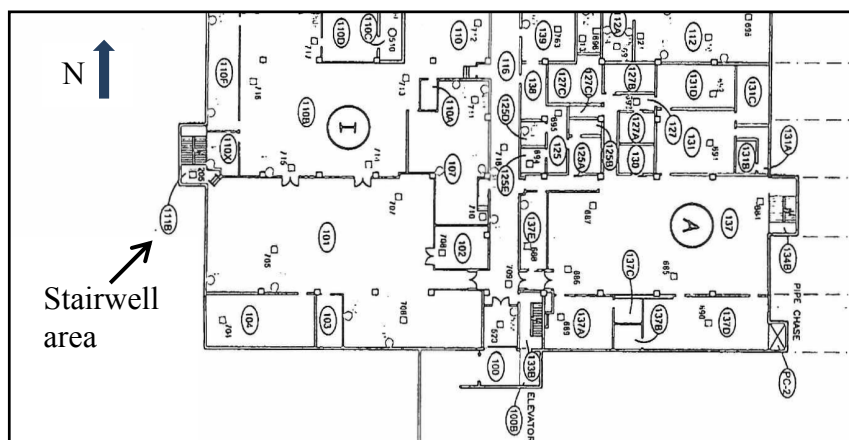
Figure 5 is a copy of the building first floor footprint taken from the Building 881 Pre-Demolition Survey Report[6] showing the stairwell location. Figure 6 is a photograph of Building 881 showing the western wall of the building after explosive demolition and before backfilling. A photograph of the wall looking east could not be located in the archives, but the general location of the stairwell is thought to be behind the standing wall as indicated on the Figure 6 photograph.

Figure 5. Stairwell shown on first floor layout drawing. Stairwell leads from second floor to basement level below first floor.

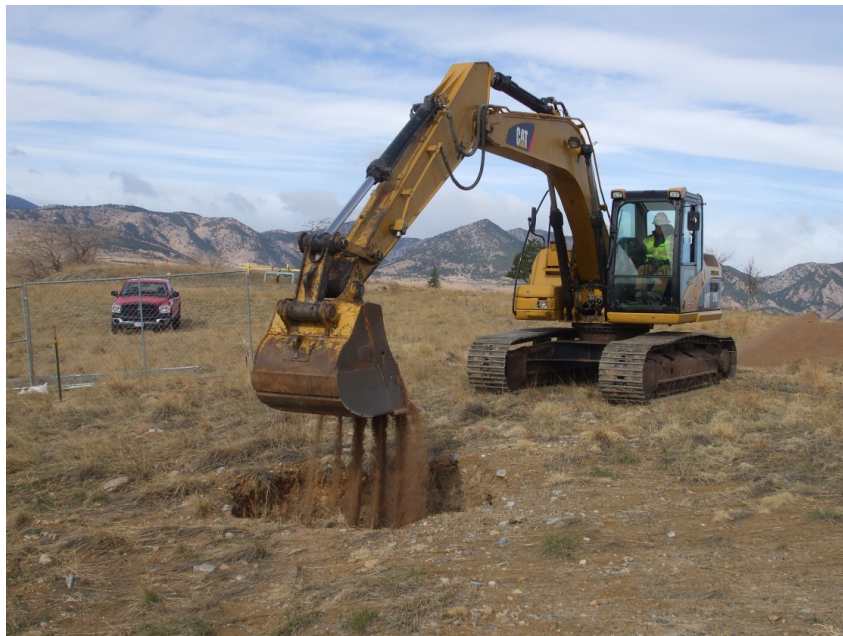
Figure 7. Backfilling the 881 hole in 2011 (excavator provides comparison for the hole size).

(20 tons) of Rocky Flats Alluvium. Fill material was hauled to the site and staged approximately 18 m (60 ft) away from the hole. An excavator was then used to move the material from the staging area directly into the hole. Fill material was mechanically compacted using the bucket of the excavator. Final grade of the compacted fill was left approximately 30 cm (1 ft) above the surrounding grade to allow for further settling.

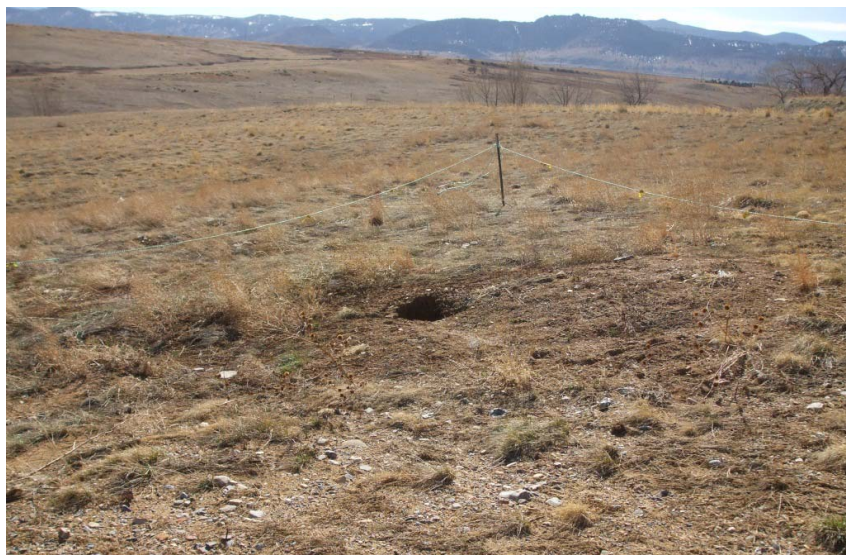
By the 2012 annual inspection, conducted March 13, 2012, a small hole had formed in the area that was filled in 2011, which is consistent with observations at other holes that have been filled. Figure 8 is the hole observed during the 2012 inspection. This small hole was filled, and periodic inspection of conditions is continuing.

Figure 8. 881 hole approximately 1 year after backfilling.

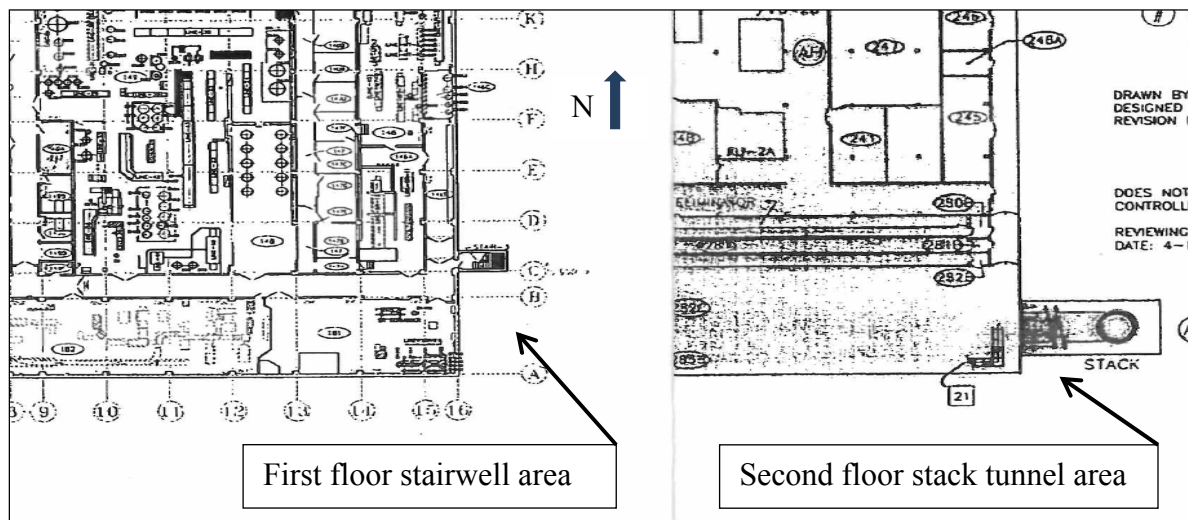
The southeast corner area of Building 771 is the location of the building exhaust stack tunnel that was left in place and backfilled. This location also had a stairwell on the first floor, and the stairwell is believed to have been left in place. Figure 9 is a copy of sections of the building's first and second floor footprints taken from the Building 771 Decommissioning Closeout Report[10] and showing the stairwell and stack tunnel locations. No photographs of this area of the wall and tunnel could be found in the archives.

Figure 9. Building 771 stairwell and stack tunnel locations.

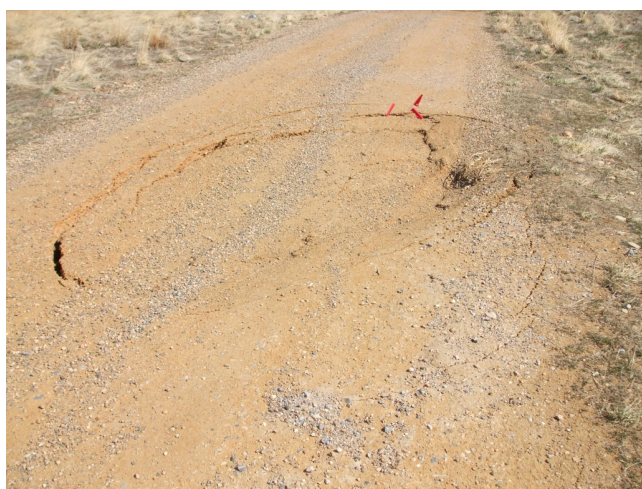
Beginning in late 2011, a noticeable depression formed in the gravel road that runs generally south of the buried remnants of Building 771. This building consisted of two stories constructed into a north-facing hillside, with the south and east walls buried into the hillside. Building 771 was mechanically demolished with most of the south and east walls, the first floor, and a portion of the second floor backfilled in place after removal of all equipment, dismantlement of interior walls, and completion of decontamination to the extent feasible. The remaining building components are deeper than 1.8 m (6 ft) below the final surface elevation. Some portions of the remaining concrete have fixed radionuclide contamination above free-release limits.

Figure 10 is a photograph of the cracks that formed in the road in early 2012. Since the general location of this depression and cracking has characteristics similar to those of the 881 hole and appears to correlate to subsurface building remnants, the gravel road was permanently relocated to the south, and the depression area and road was filled, graded, and revegetated in May 2012. Periodic inspection of conditions is continuing.

Figure 10. Depression and cracking in gravel road south of Building 771.

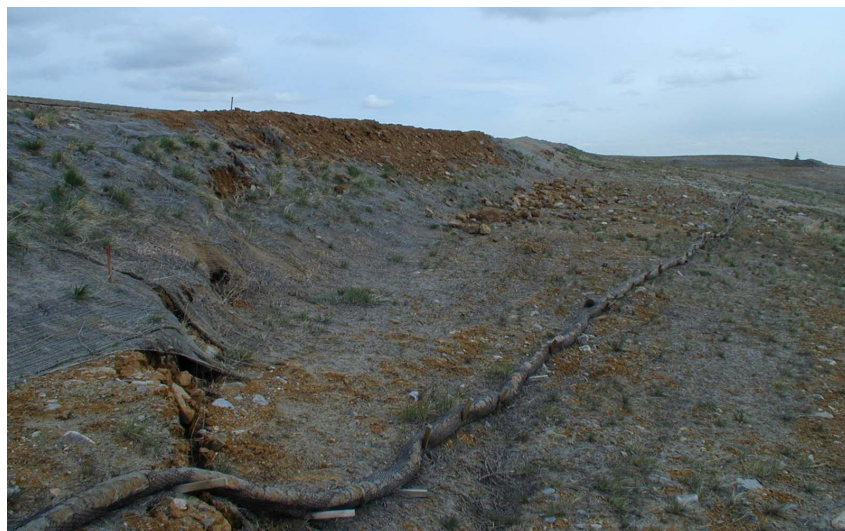
Beginning in 2007, localized slumping and settling of the soil cover and intermittent seeps expressing on the cover surface were observed during required monthly inspections. Surface cracking and differential settling, which provided a preferential path for precipitation below the cover, was most noticeable near the western perimeter channel. Figure 11 is a photograph of the cracking observed in 2007.

Figure 11. Cracking along downgradient side of the Original Landfill diversion berm.

In addition, field measurements showed that significant portions of the diversion berms no longer met the minimum M&M Plan–specified 0.6 m (2 ft) height. DOE notified CDPHE and EPA of the observed conditions, and the parties consulted regarding appropriate actions to address them. DOE continued monitoring berm conditions and made minor repairs as specified by the M&M Plan, adding and compacting soil to localized areas to maintain berm and cover integrity.

A geotechnical investigation report[9] concluded that an organic-rich clay layer at or near the bedrock contact appears to be a weak interface area. Modeling predicts small-scale instability due to percolating moisture that lubricates this weak interval. The Original Landfill buttress is providing stability as intended, and there is no large-scale instability predicted; therefore, the observed conditions did not appear to indicate a need for urgent or major responses.

Modifications to certain features were recommended, and the construction to complete the necessary repairs and to implement design changes was completed in November 2008. These steps included changes to the minimum diversion berm height, regrading and inclinometer monitoring.

Minimum diversion berm heights were originally based on the drainage area served by the entire berm length. To simplify monitoring and inspection, the calculated minimum berm height for each berm was originally adjusted up to a 0.6 m (2 ft) minimum uniform height, even if this height was unnecessary (i.e., excessive).

Approximately 24 percent of the total berm lengths had minor amounts of Rocky Flats Alluvium added at the top using light construction equipment to meet this new minimum height in September and November 2008. Inspections in subsequent years have resulted in the need to add soil to a progressively smaller percentage of berms to maintain the minimum heights. Erosion control matting is installed over the added soil, and the areas are reseeded.

The west perimeter channel was recontoured by cutting and filling to lessen the grade of the side slope, add backfill where the channel was excessively deep, and improve stability of the adjacent hillside. An existing subsurface gravel drain at the southern end of the channel was extended and tied into an existing subsurface gravel drain at the north end of the channel to help manage seepage in this area.

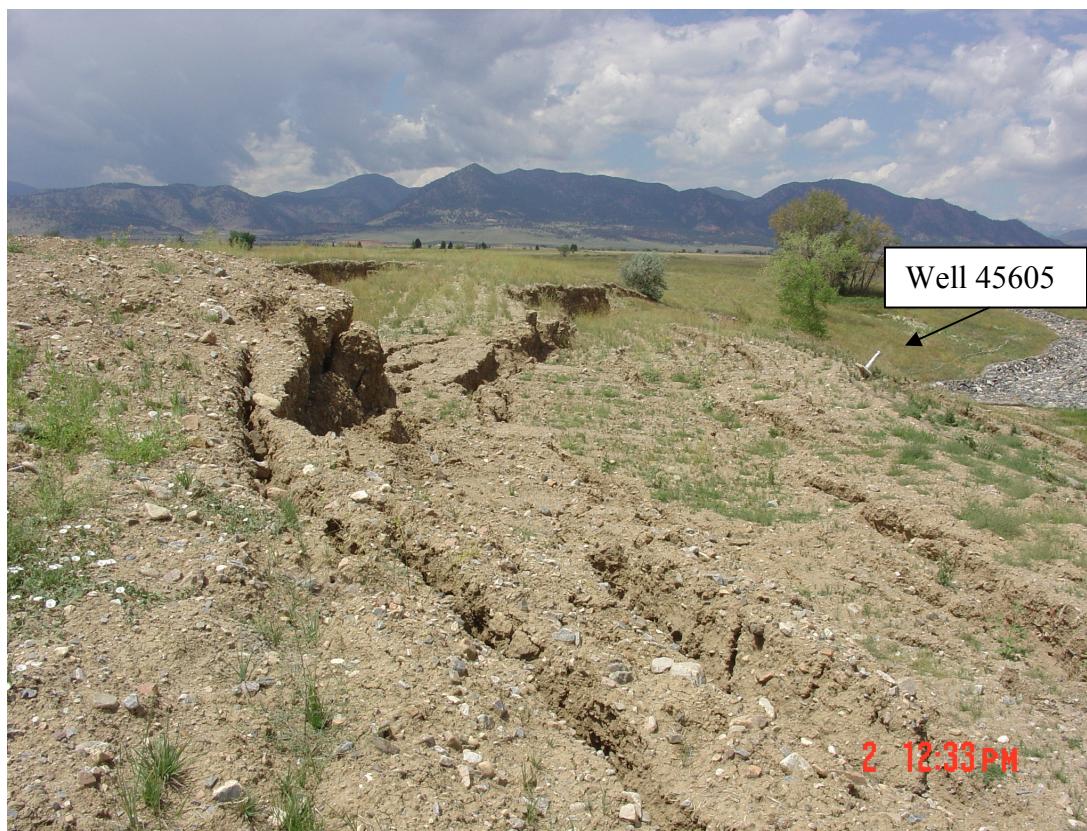
Slumping on the hillside was first apparent in early January 2006, when small cracks were observed across the surface of the backfilled excavation. These cracks broadened, extended, and multiplied throughout 2006, accompanied by increasing horizontal and vertical displacement and severe protrusion and kinking of the well 45605 casing.

Observations of the developing slumping indicated that the removal of the French drain outfall had allowed collected groundwater to saturate the hillside, causing it to destabilize. The hillside

Figure 12 shows the condition of the slump and well 45605 in 2007, shortly before construction work to address the slump and to replace the well began.

Figure 12. Hillside slump and cracking.

The stabilization regrading was designed to remove about 5,350 m³ (7,000 yd³) of the fill material and return the hillside to a closer approximation of the hillside topography that existed prior to filling of the valley area. No adjustment to the abandoned French drain was made, because the original goal of promoting wetland formation in FC-4 was being met.

Well 45605 was abandoned, and as soon as the hillside was recontoured, the well was replaced. Soils that were removed during this 2008 regrading work were hauled to an area just south of the project area, where the former 903 Pad had been located. This material was spread to provide approximately 30 cm (1 ft) of soil over what had mostly been poorly vegetated road base. The
