Case Study of Urban Residential Remediation and Restoration in Port Hope, Canada – 13250

Brian Geddes*, John DeJong**, Michael Owen***

ABSTRACT

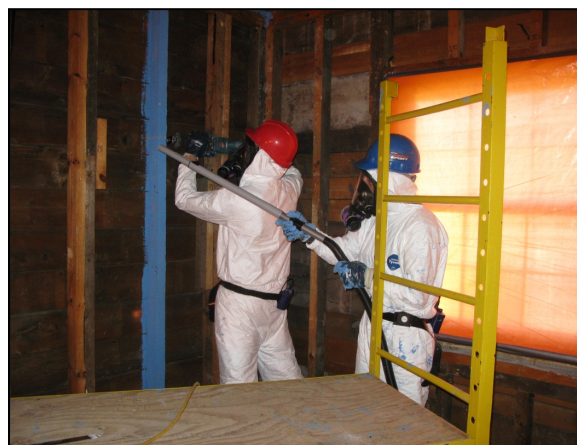
Fig. 3. Removing impacted stud (note HEPA vacuuming at cut)

The remediation involved removing lumber and associated building materials, and replacement with new materials to maintain the structural integrity of the building. All load bearing members scheduled for removal were reviewed by a licensed structural engineer and individual removal protocols developed to maintain a structurally safe environment during the removal and replacement stage of the work. The contaminated material inventory included floor board members that had been characterized from the bottom only. All floor boards were removed during remediation to access the impacted members.

Before any impacted material was remediated or removed, all accessible surfaces of the materials were cleaned of loose material with a HEPA vacuum and then painted with an encapsulant to prevent inadvertent transfer of contamination to workers or other surfaces. Cutting of materials to dislodge them or facilitate removal was completed by three workers. One worker did the removal while the second applied the HEPA vacuum at the dust generating points. A third worker encapsulated the recovered pieces at the newly exposed surfaces and packaged each for disposal (see Fig. 3). At the points of contact, a worker vacuumed the newly exposed surface and the area was monitored by a Radiation Protection (RP) technician with a pancake Geiger. Any residual activity above background was then scraped, cleaned and vacuumed as required until near background values were achieved (60-80 cpm) (note that ~200 cpm is approximately equivalent to 1 Bq/cm² total alpha/beta/gamma).

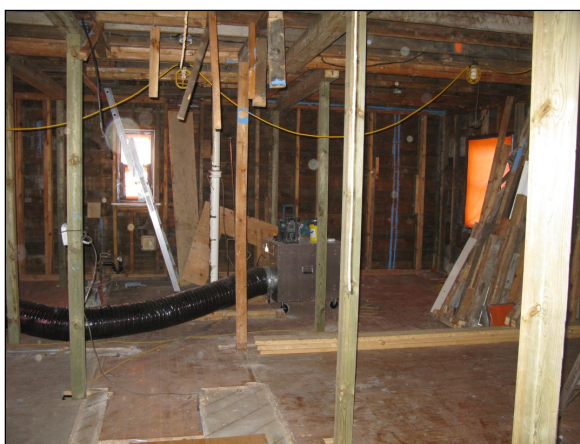
Fig. 4. Main floor with all walls removed (note HEPA depressurization unit)

The Type 3 enclosure (see Fig. 4) was maintained until all impacted materials had been removed and disposed of off-site and verification monitoring completed. All filters, tarps, and other enclosure materials were scanned for possible contamination in addition to all personnel PPE.

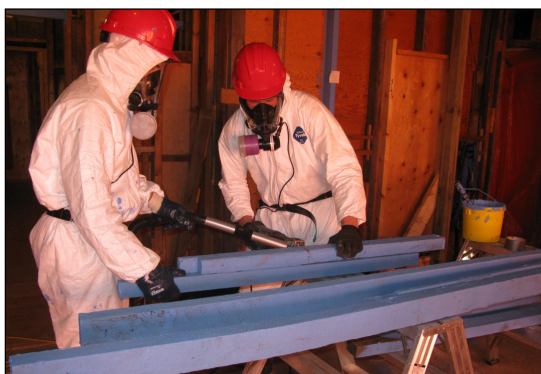
Fig. 5. Reducing the size of materials prior to packaging (note HEPA vacuuming at cut)

double-wrapped in plastic film and taped securely for transport to a storage site operated by the LLRWMO (i.e., the Pine Street Temporary Storage Site (TSS)) (see Fig. 5). All recovered and packaged contaminated materials were removed from the work site at the end of each working day. The permanent disposition of materials from this site is included within the scope of the Port Hope Area Initiative (PHAI) remediation program.

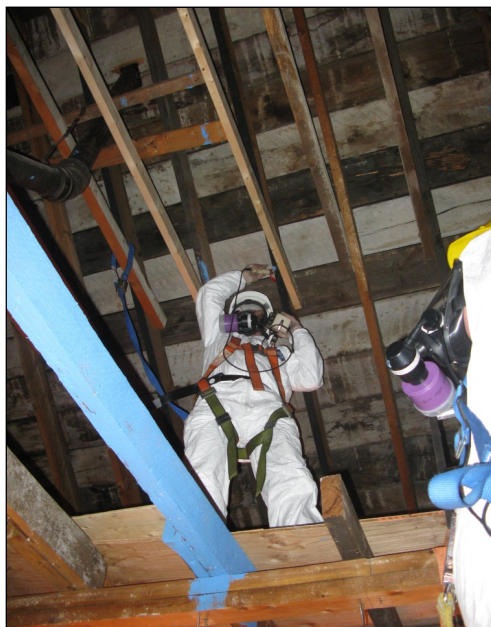
Fig. 6. Monitoring contact areas after removal of cross ties

After the removal of the impacted materials, gamma radiation measurements were made throughout the house, focusing on the remediated locations (see Fig. 6), and all observed levels were consistent with the ambient background levels within the house (i.e., there were no gamma radiation measurements indicative of levels approaching the interpreted PHAI criterion of $0.5 \mu\text{Sv/h}$ at 0.5 m from the surface). A pre-restoration gamma radiation survey was conducted for comparison to pre-remedial conditions. The survey showed that pre-restoration gamma radiation levels were consistent with background levels for residences in Port Hope and not noticeably different from the pre-remediation surveys.

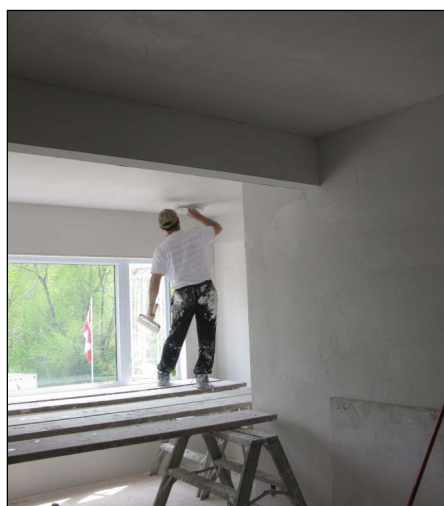
Fig. 7: Plaster work

Following completion of all remediation and verification activity, restoration of the residence was initiated. This work involved more traditional house renovation activities such as electrical wiring, framing, window and trim work, flooring, plumbing, painting and some minor duct work (Fig. 7).
