## Hanford Double-Shell Tank Extent-of-Condition Construction Review – 14174

### ABSTRACT

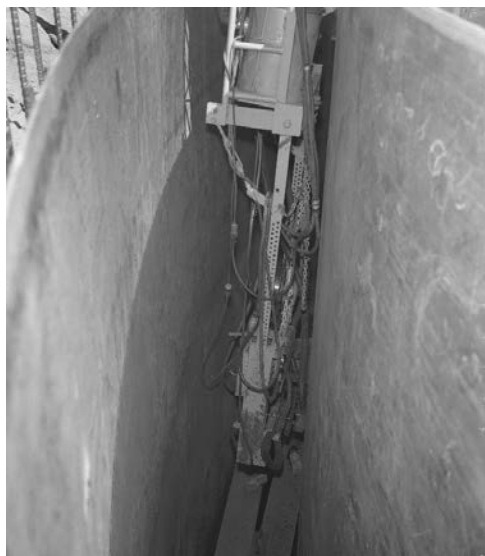
**Fig. 3. Challenges in access when welding 241-AY tank farm primary liners.**

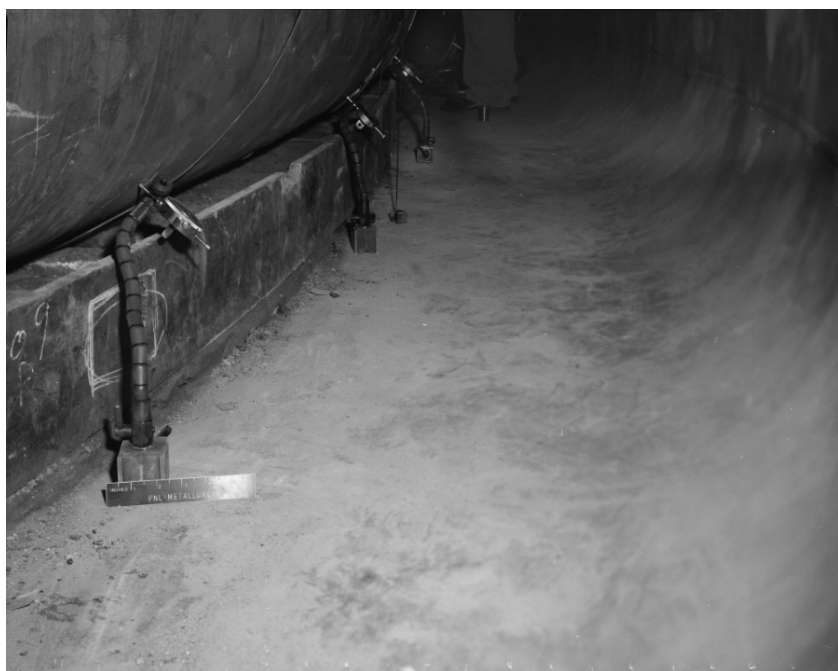
farm, the new contractor used a different plate layout for the bottoms and bulging problems were seen in all of the tanks. In tank SY-101, out-of-tolerance areas were noted and plate repair was attempted, which caused new out-of-tolerance areas to appear. A maximum bump height of 79 mm (3 inches) was measured in the primary tank bottom and the decision was made to support the bottom by filling the bulges with grout. After gaining access through the annulus, two 0.6 meter by 2.4 meter (2 foot by 8 foot) deep sections of the refractory were cut out and refilled with grout. In tank SY-103, out-of-tolerance bulging in several areas was found, up to 6 mm per meter (13/16 inch per foot). Computer modeling of the bulge indicated that excessive stresses might be seen in the lower knuckle. Eventually an empirical solution was used which included strain gage monitoring and acoustic testing during the hydrostatic test. These tests determined that stresses from flattening the bulges were acceptable. A picture of the strain gage monitoring is shown in Figure 4. Additional non-destructive testing was conducted on the primary tank during and after hydrostatic testing such as liquid penetrant examination, magnetic particle testing, and visual examinations.

**Fig. 4. Strain gage monitoring in tank SY-103 to assess impacts from primary bottom bulges.**

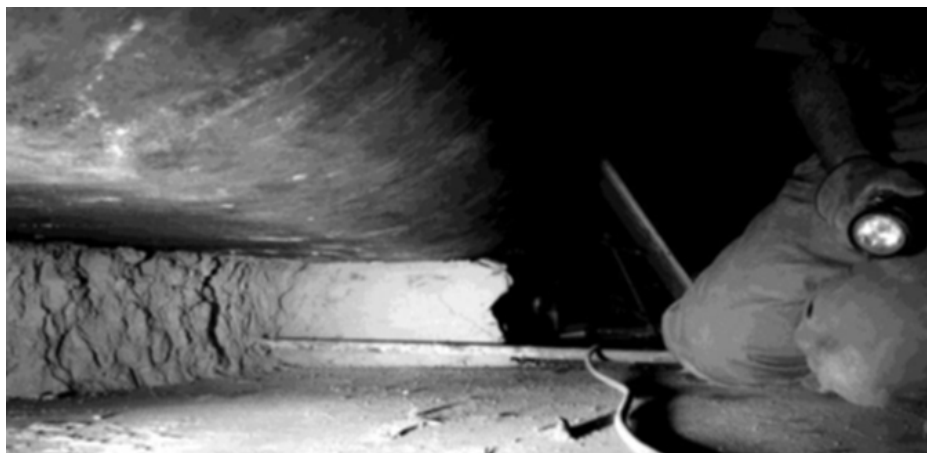
Castable refractories are typically poured or “gunned” into place. After air drying or “curing,” the refractory is then “fired” or heated to high temperatures to convert hydrated compounds into a more durable, de-hydrated, ceramic structure. During the initial air-drying and until the firing is completed, protection from freezing and water saturation is important. During construction of the 241-AY tank farm, there were problems with both of these protections. After heat treatment and hydrostatic testing, the refractory material in both tanks was found to be badly cracked and degraded, caused in some part by poor weather protection. Concerns about lack of support in the high-stress knuckle region led to the decision to remove ~533 mm (21 inches) of the refractory and replace it with structural concrete in both tanks. Given the location and access constraints, the effectiveness of this repair and proper concrete placement was identified as a concern during the leak assessment of tank AY-102. As previously mentioned, voids from primary bottom bulging that were beyond the ~533-mm (21-inches) perimeter were filled with foam prior to placement of the structural concrete repair. See Figure 5 for pictures of the refractory repair in progress on tank AY-101.

**Figure 5. Refractory repair under bottom knuckle of tank AY-102.**

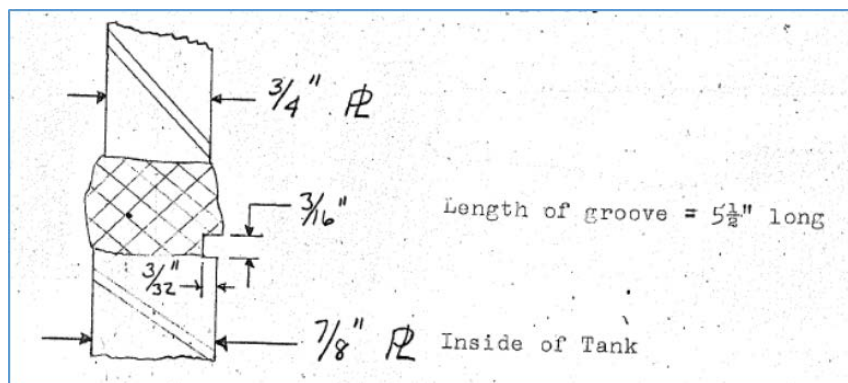
Both tanks AZ-101 and AZ-102 had leaks found during hydrostatic leak testing in the upper knuckle section above the maximum waste level. As the tank had already been subject to stress relieving, these weld repairs were performed without additional stress relief. An unrepaired weld grind-out was found in the lower knuckle weld seam in tank AZ-101 during final inspection. The groove, sized at approximately 140 mm long by 5 mm wide by 2 mm deep (5-1/2 in. long by 3/16 in. wide by 3/32 in. deep), (see Figure 6) was accepted based on expert opinion. The logs also mentioned that two fires occurred during construction in the annulus of tank AZ-102 and in the bottom of the primary tank in tank AZ-102, but the job logs did not indicate that any significant damage was caused by these two fires. The fire issues are not expected to significantly affect the tank integrity.

**Figure 6. Unrepaired weld grind-out at lower knuckle of tank AZ-101 (construction deficiency report).**
