## **Forensic Investigation of Hanford Double-Shell Tank AY-102 Radioactive Waste Leak – 14178**

D. J. Washenfelder  
Washington River Protection Solutions LLC  
P. O. Box 8501  
Richland, WA 99352

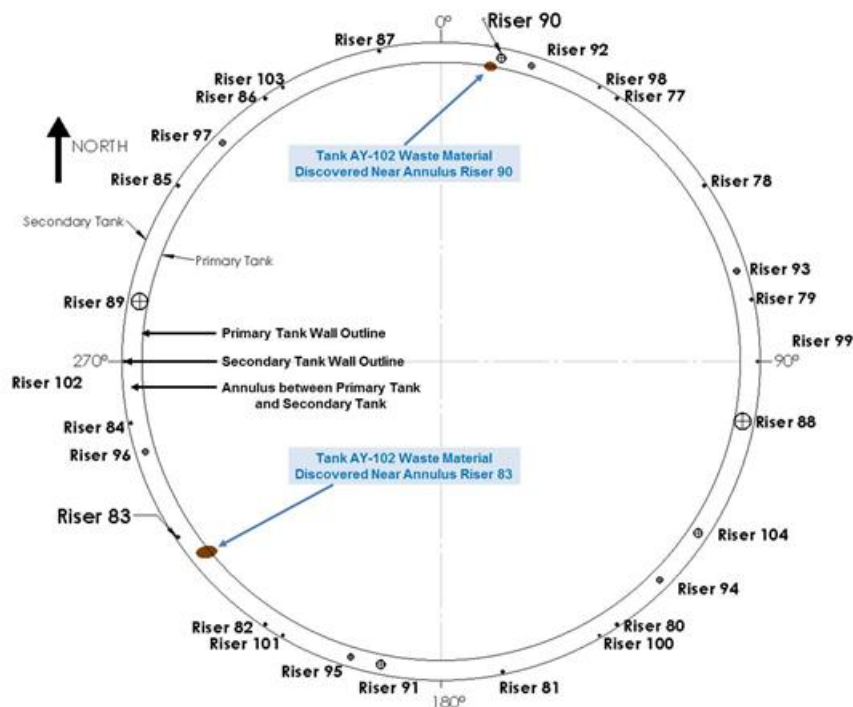
In August 2012, an accumulation of material was discovered at two locations on the annulus floor of Tank AY-102 (Refer to Figures 3, 4 and 5). None of the material was present during video inspections completed in December 2006 and January 2007. A formal leak assessment panel was established to review Tank AY-102 and determine whether the material found on the annulus floor resulted from a primary tank leak.

Fig. 3. Tank AY-102 Leak Accumulation Sites

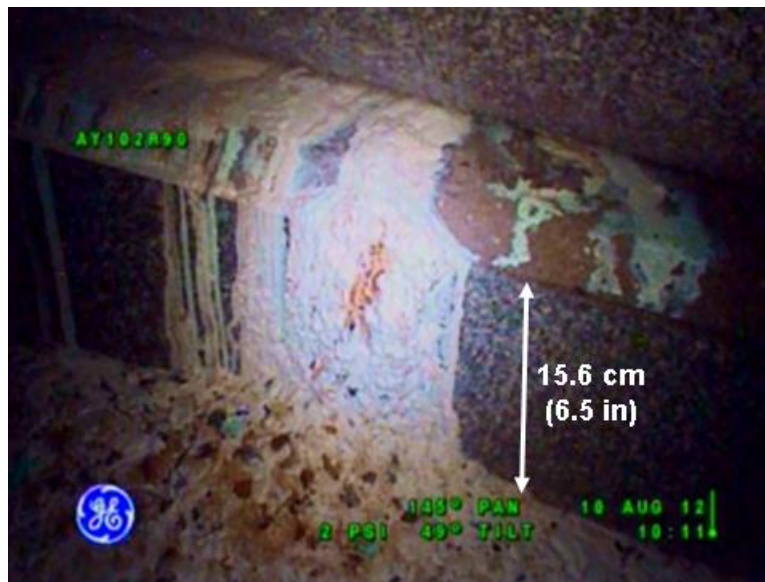
Fig. 4. Tank AY-102 Waste Material Discovered Near Annulus Riser 90

Laboratory results from material collected near Riser 90 in October 2012 were consistent with the results obtained from the Riser 83 sample

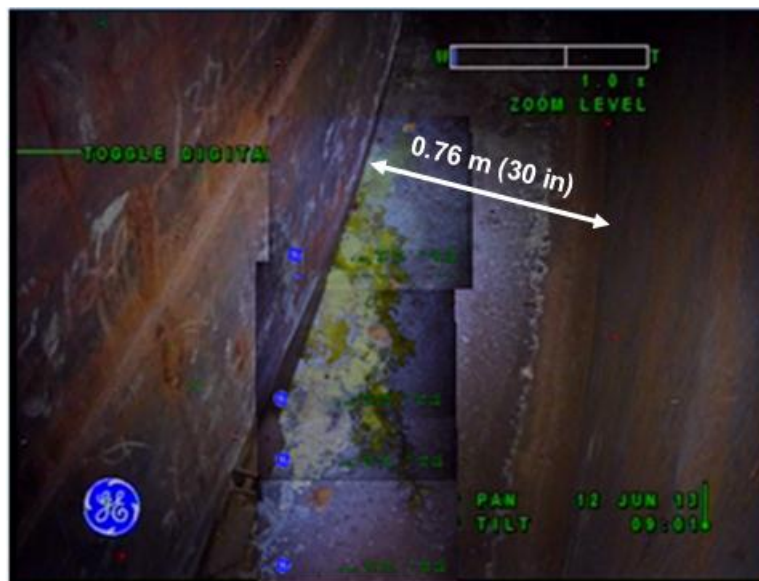
Fig. 5. Tank AY-102 Waste Material Discovered Near Annulus Riser 83

The sample radiation dose rates were much lower than predicted by the tank contents – about 1.3E-04 mSv/sec (~ 45 mrem/hr) for the Riser 83 sample. The principal fission products remaining in the Tank AY-102 waste are Sr-90 and Cs-137. The Cs-137 is soluble and typically found in Hanford tank waste supernatant. The Sr-90 is insoluble and typically associated with tank waste sludge. If supernatant had leaked from the tank, then the sample radiation dose rate would be expected to be much higher than measured.

Laboratory tests of the Riser 83 floor material also showed an unusually high concentration of potassium. Potassium is a unique chemical marker because it exists in significant quantities in only a few Hanford waste tanks. In 1994, 15 m<sup>3</sup> (4,000 gal) of KOH, containing about 1,200 kg (2,600 lbs) of potassium, were added to Tank AY-102 to increase the pH. The Tank AP-101 supernatant transferred into Tank AY-102 during 2007 contained a significant potassium inventory as well. Tank AY-102 has second highest potassium inventory of any Hanford waste tank.

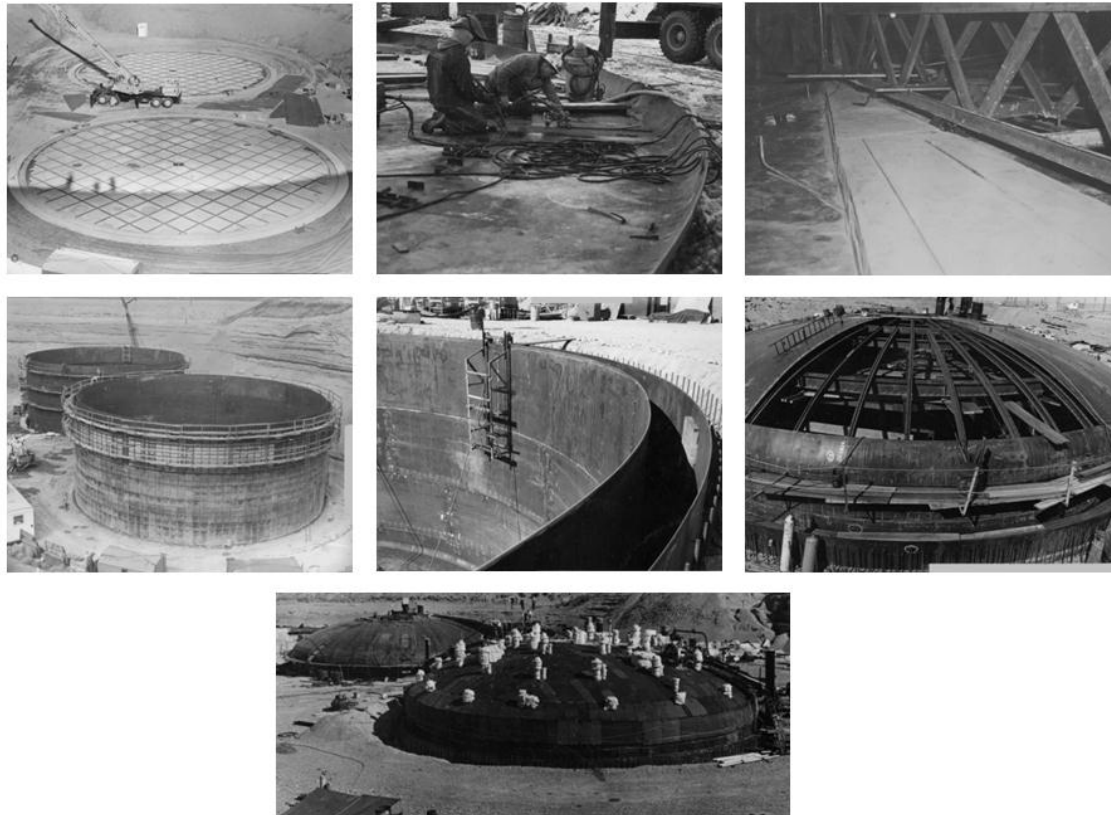
The use of thin 0.6 cm (0.25 in) metal plate for the secondary liner, complicated by welding in the open in extreme cold temperatures (-29° C to -23° C [-20° F to -10° F]) caused floor liner warpage. As the floor plates were preheated and welded, convex bulges and wrinkles appeared. Flame heating and water fast quench partially eliminated the wrinkles; however when the assembled floor plates were later heated by the sun new wrinkles appeared. These did not disappear as temperatures chilled. A February 1969 survey found 22 liner locations exceeding the allowable 5 cm (2 in) convexity. Root-to-crown slopes up to 2.5 cm per 30 cm (1 in per ft) were present, exceeding the allowable 0.95 cm per 30 cm (3/8 in per ft) specification. The bulges and wrinkles created in the secondary liner floor by welding the thin floor plates and by reworking rejected welds were eventually accepted so construction could proceed.

The rigid refractory insulation cast on top of the secondary liner cracked as the bulges moved, leaving the pad bridged in places. Cracks 2.5 cm to 5 cm (1 to 2-in) deep and up to 2 m (7 ft) long appeared in the cured refractory as pours continued. These were blamed on flexing of the secondary liner from movement of the bulges.

After post-weld stress relief and the hydrostatic leak check, part of the insulating refractory pad was found to be too damaged to be used. Full depth cracks 0.6 cm (0.25 in) wide extending several feet from the outer lip of the insulating refractory pad back underneath the primary tank were evident. The top surface was spongy (“punky”), had no compressive strength, and the affected depth increased as the outer lip was approached. The air channels cast in the top surface of the pad intended to pass cooling air under the bottom of the primary tank, were blocked with spalled refractory material. The damage was thought to result from alkali hydrolysis, skin friction as primary tank expanded and contracted across surface of refractory pad during stress-relief, and “oil-canning” of the tank on the outside perimeter of the pad.

Fig 6. Tank AY-102 Construction Sequence: Left to Right from Top: Concrete Foundation, Tank AY-102 in Foreground; Secondary Liner Lower Knuckle Fabrication; Insulating Refractory Placement; Primary and Secondary Tank Steel Erection and Concrete Sidewall Shell; Backfill to Height of Secondary Tank Steel; Placement of Primary Tank Dome Plates; Preparation for Primary Tank Post-Weld Stress Relief.

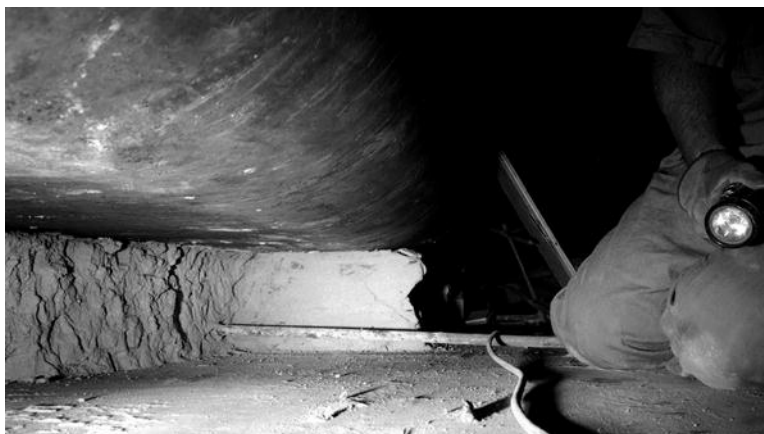
Fig. 7. Tank AY-102 Insulating Refractory Repair: Preparation for Placement of Reinforced Concrete

Eventually the outside 50 cm (21 in) of the refractory were excavated from beneath the primary tank and replaced with structural concrete (Refer to Figure 7). Inspections following insulating refractory removal found gaps between the refractory surface and the primary tank bottom as large as 3.8 cm (1.5 in). The gaps were filled with polyurethane foam when they were found. The initial pours of the structural concrete filled the excavated area beneath the primary tank knuckle, but did not flow to the back of the excavation. The slump was increased on later pours to ensure that the primary tank bottom was supported once the concrete cured.

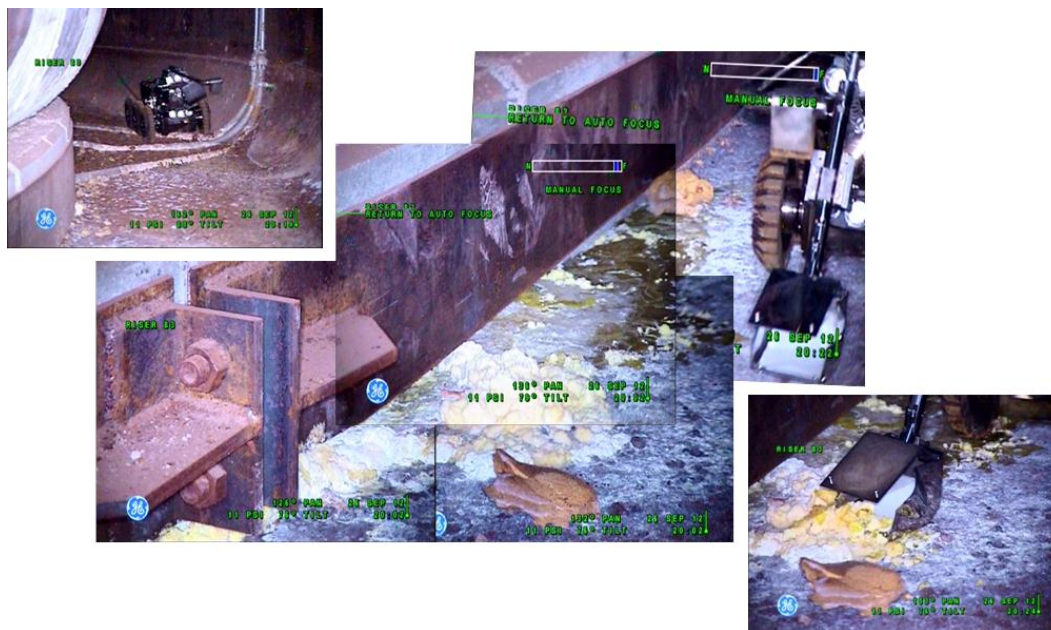
Samples of the annulus floor material were collected from the Riser 83 and Riser 90 locations during September and October 2012. The materials were radioactive, and their compositions were consistent with Tank AY-102 waste (Refer to Figure 8).

Fig. 8. Tank AY-102 Floor Material Sampling, September 2012: Left to Right from Top: Wheeled Robot Traveling to Sample Site; Sample Site; Sample Collection.
