**Double-Shell Tank Visual Inspection Changes Resulting from the Tank 241-AY-102
Primary Tank Leak – 14193**

Crystal Girardot *, Jason Engeman *, Dennis Washenfelder *, Jeremy Johnson **

* Washington River Protection Solutions, LLC

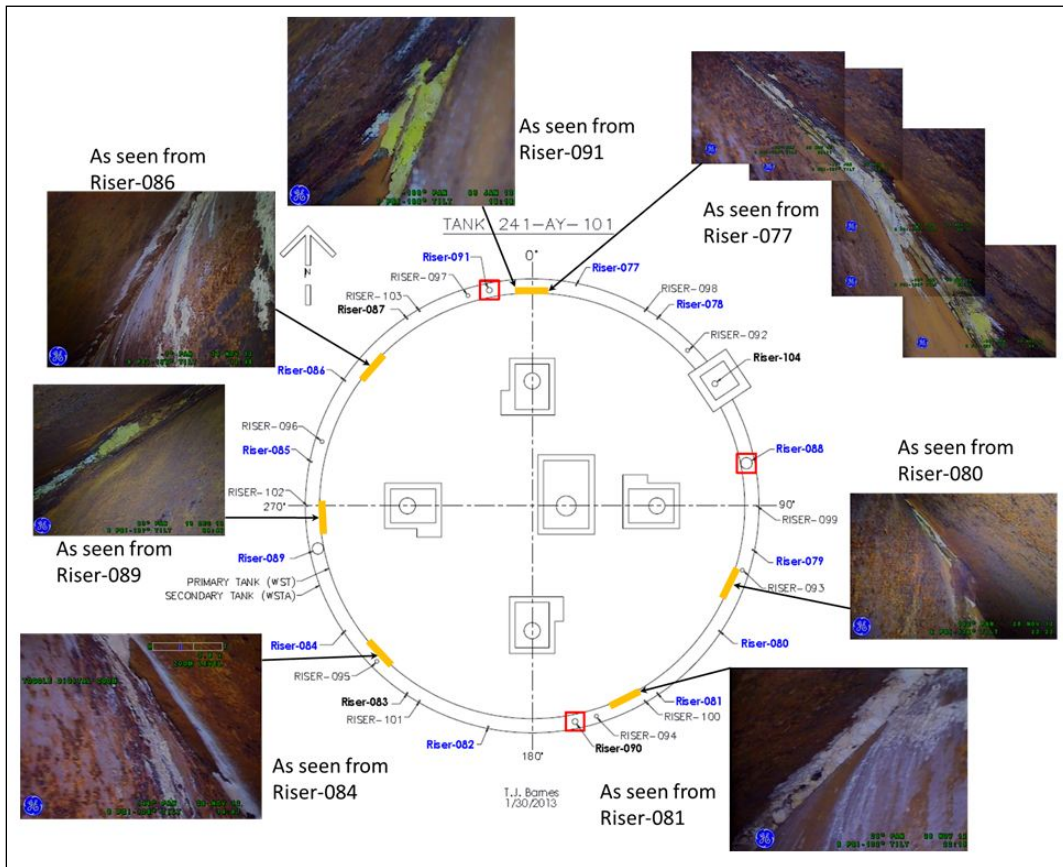
Annulus inspections identified small amounts of change in the white and yellow mineralization build-up on the top knuckle region in tank AY-101 (see Fig. 4) as compared to areas previously inspected. The presence of mineralization in the top knuckle has been attributed to water intrusion into both 241-AY Farm tanks from meteorological precipitation. The tank design does not specifically prevent water intrusion (e.g., waterproof membrane) and the extensive amount of excavation above the concrete dome and the use of controlled density fill potentially contribute to the rate in which the water passes through the soil enroute to the tank dome. These changes may be indicative of water intrusion through the outer concrete shell and into the annular space.

Though mineral formations are seen on the top knuckle, some of the changes in the condition of the white and yellow material in the top knuckle region cannot be determined because previous inspections did not view these areas. In regions which did show change, these portions of the top knuckle would be considered to have a small amount of water intrusion since the last inspection.

These indications were above the tank waste level and therefore do not indicate a tank leak.

Figure 4. Tank AY-101 Baseline Inspection Results Showing Additional Material in the Top Knuckle Region.

Despite the presence of foreign material in the annulus, there is no indication that any radioactivity is associated with the material. The annulus of tank AY-101 is operated at a lower pressure than the primary tank so any significant pathways from the primary air space should cause the continuous air monitor to alarm. To date, no clear evidence exists that would indicate either the containment or structural integrity have been compromised in tank AY-101. Future annulus visual inspections, ultrasonic testing, and continuous air monitor surveillance should be continued to identify any changes in the integrity of tank AY-101.

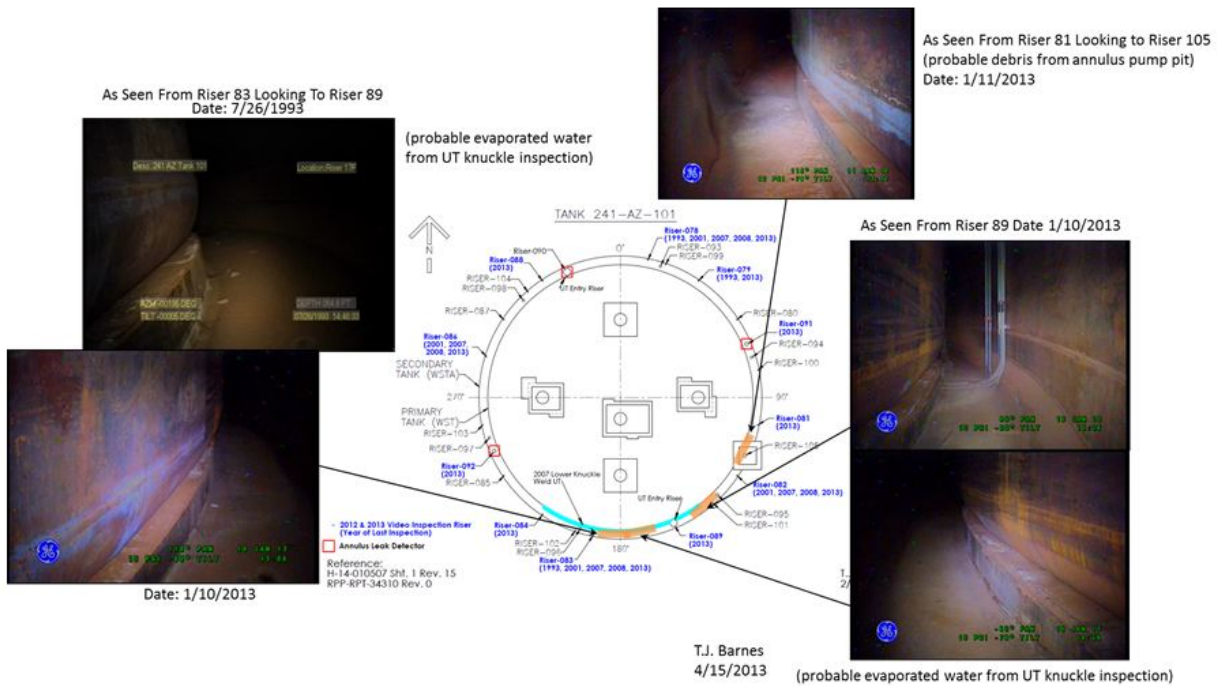
Annulus inspections identified small amounts of change on the annulus floor of tanks AZ-101 (see Fig. 7) and AZ-102 (see Fig. 8) as compared to areas previously inspected. These changes are likely attributed to evaporated couplant water from UT examinations that occurred in nearby risers after the previous visual inspection. Additional stains were also identified on the annulus floor of tanks AZ-101 and AZ-102, however, these stains can be correlated back to existing equipment locations (e.g., annulus pump pit, riser penetrations, ENRAFs, etc.). Despite the changes identified in the current inspection, there was no indication of active water intrusion or a primary tank leak for tanks AZ-101 and AZ-102.

In regions which did show a change in condition, these portions of the annulus floor were near risers utilized for UT examinations. To date, no evidence exists that would indicate either the containment or structural integrity have been compromised in tanks AZ-101 and AZ-102.

Fig. 7. Tank AZ-101 Baseline Inspection Results Showing Additional Material on the Annulus Floor Attributed to Ultrasonic Inspections, Leak Monitoring Equipment Installation, and Debris Accumulation.

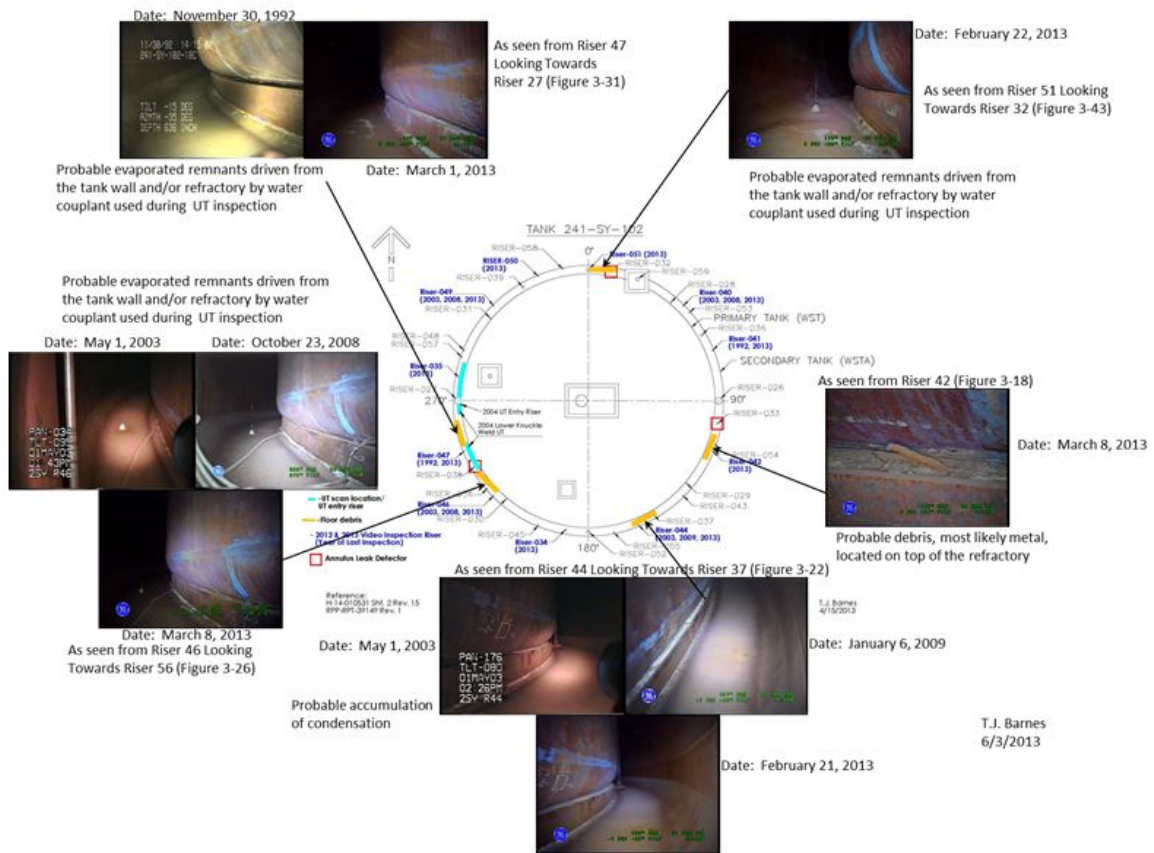
Eleven and twelve risers were used for the enhanced visual inspections performed in the tank SY-101, tank SY-102, and tank SY-103 annulus between May 2012 and March 2013 (see Fig. 9 through Fig. 11). Annulus inspections identified small amounts of change on the annulus floor of tanks SY-101 and SY-102 (see Fig. 12 and Fig. 13, respectively) as compared to areas previously inspected. Additional stains were also identified on the annulus floor of tanks SY-101, SY-102, and SY-103. These changes are attributed to couplant water used during UT examinations, accumulation of condensation on the annulus floor, and/or removal of the annulus pump (see Fig. 12, Fig. 13, and Fig. 14, respectively). The couplant water appears to affect most of the annulus floor as it collects on the annulus floor during UT examinations which can leave additional stains and beachlines after evaporating. Despite the changes identified in the current inspection, there was no evidence indicative of water intrusion or a primary tank leak for tanks SY-101, SY-102, and SY-103.

Previous cracking and surface degradation of the refractory in SY tanks was noted in prior inspections and the surface degradation of the refractory appears consistently on all three tanks. It is likely some of this loose surface layer has washed down and transported to the annulus floor during UT examinations. To date, no evidence exists that would indicate either the containment or structural integrity have been compromised in tanks SY-101, SY-102, and SY-103. Future annulus visual inspections and ultrasonic testing will continue to identify any changes in the integrity of tanks SY-101, SY-102, and SY-103.

Fig. 13. Tank SY-102 Baseline Inspection Results Showing Additional Material on the Annulus Floor Attributed to Ultrasonic Inspections and Condensation Accumulation.
