Washington State Department of Ecology's Evaluations of the 241-AY-102 Hanford's First Leaking Double Shell Tank – 14342

Michelle Hendrickson, CHMM, PE, Washington State Department of Ecology

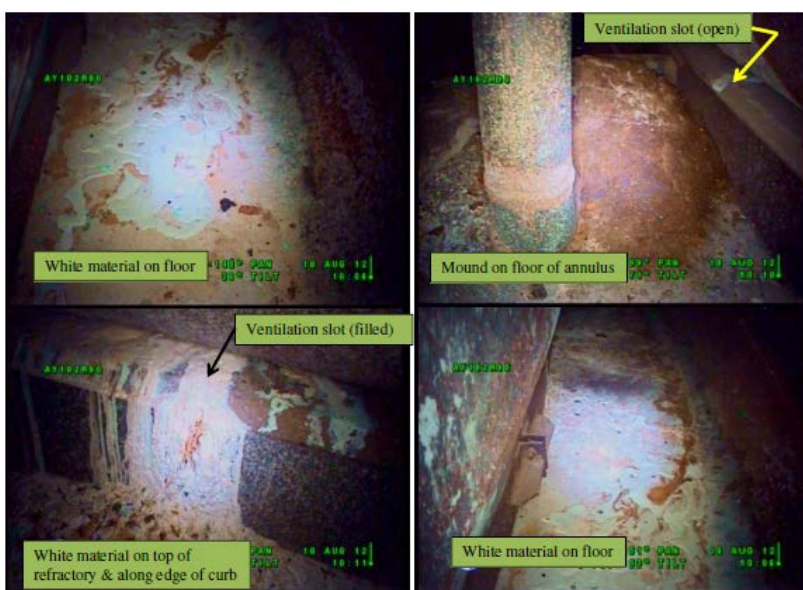
The Washington State Department of Ecology (Ecology) was notified August 8, 2012, by the United States Department Of Energy-Office of River Protection (USDOE-ORP) that their Tank Farm Contractor, Washington River Protection Solutions, LLC (WRPS) had discovered an "anomaly" in the secondary containment or annular space of DST 241-AY-102 (AY-102). The 241-AY-102 is the oldest DST at Hanford and the first to be constructed between 1968 and 1969. Figure 4 shows the anomalies found during the August visual inspections.

Figure 4 – Inspection Photographs taken from Riser 90 on 8/10/2012

USOE-ORP and WRPS had hoped and initially postulated that the anomalies were due to soil/sediment/water intrusion into the 241-AY-102 annular space, and not that the tank was

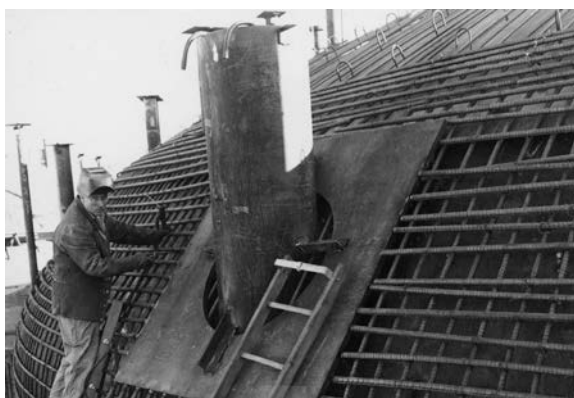
Figure 5 – Worker welding flashing to the risers and surrounding rebar in the haunch region

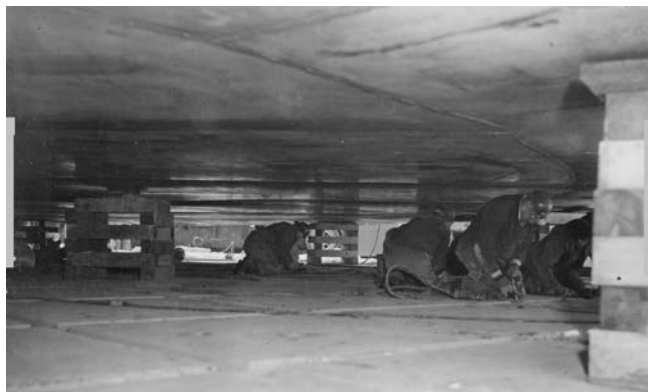
Figure 6 – Workers creating ventilation slots in the Kaolite pedestal once the primary tank has been lifted with cribbing

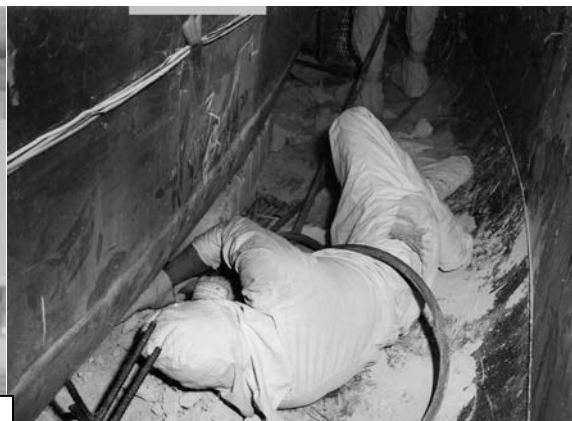
Figure 7 – Workers in the annular space removing 21 inches of Kaolite material under

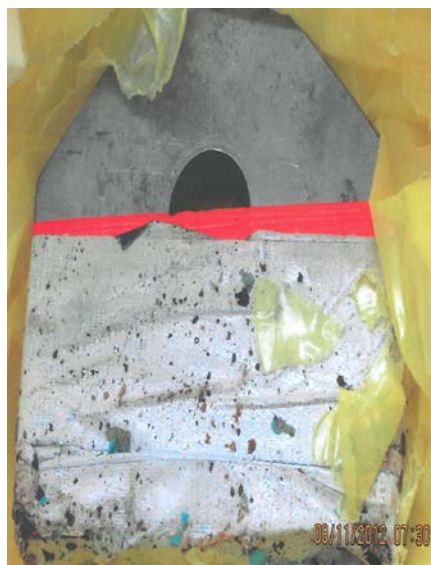
An initial sample was collected August 10, 2012 via duct tape on a weight from AY-102's Riser 90 annular space. Figure 8 is a photograph of this sample. Preliminary results on August 14th indicated that the anomaly was likely contamination due to a leak in the tank due to the high potassium signature. [19] These preliminary results were not shared with Ecology.

Figure 8 – Initial sample collected from the annulus space (Riser 90)

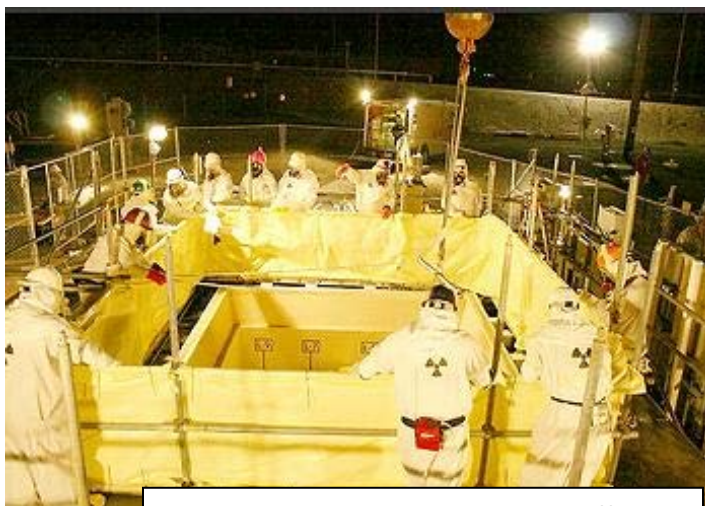
Figure 9 – 241-AY-102 Sampling Effort

Samples of the anomaly were collected via a crawler in late September from Riser 83 and early October of 2012 from Riser 90, and sent to the 222-S Laboratory for chemical and radionuclide analyses. Results included signatures of strontium-90, cesium-137, and potassium which indicated that waste from the 241-AY-102 was present within the secondary tank liner (annulus). [19] Figure 9 depicts one of the sampling efforts.

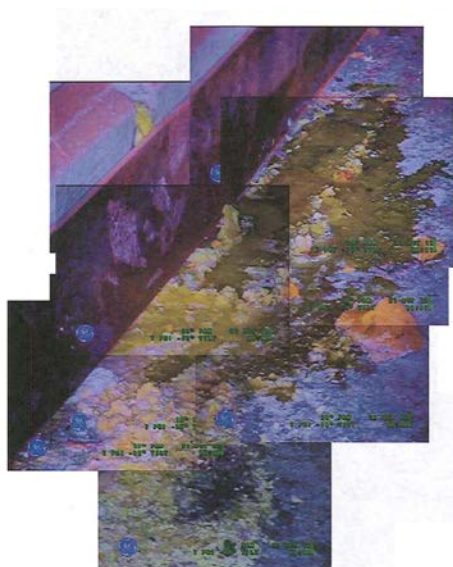
Visual inspections began to focus on the waste near Riser 80.3, to the exclusion of the waste near Riser 90. Visual inspection of the waste was performed on a weekly basis. After approximately six months, USDOE-ORP requested and Ecology approved changing the inspection frequency to one inspection every two weeks. Ecology DST Engineering Staff entered the 241-AY Farm to participate in the visual inspections 10/25/2012, 11/12/2012, 12/27/2012, 1/28/2013, and 3-14-2013. Figures 10 – 13 show the progression of the leak of waste near Riser 83.

Figure 10 – 241-AY-102 Waste in the Annulus near Riser 83 (October 2012)

The 241-AY-102 leak assessment report [1] concluded that 241-AY-102 was leaking from the bottom of the tank and the leak was likely due to poor welding practices and flooding caused by precipitation during construction. The flooding of the tank deteriorated the Kaolite pedestal that the primary tank is placed upon and most likely caused uneven settling and stresses upon the primary tank, possibly aggravating weak welds and joints.

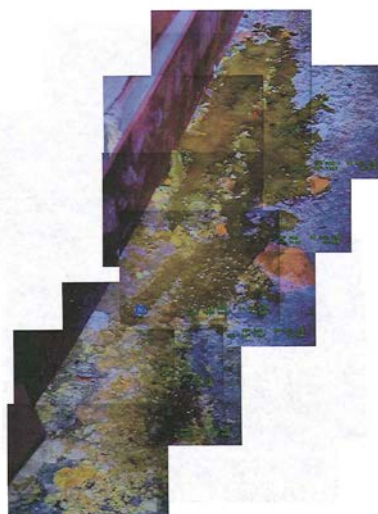
Figure 11 – 241-AY-102 Waste in the Annulus near Riser 83 (November 2012)

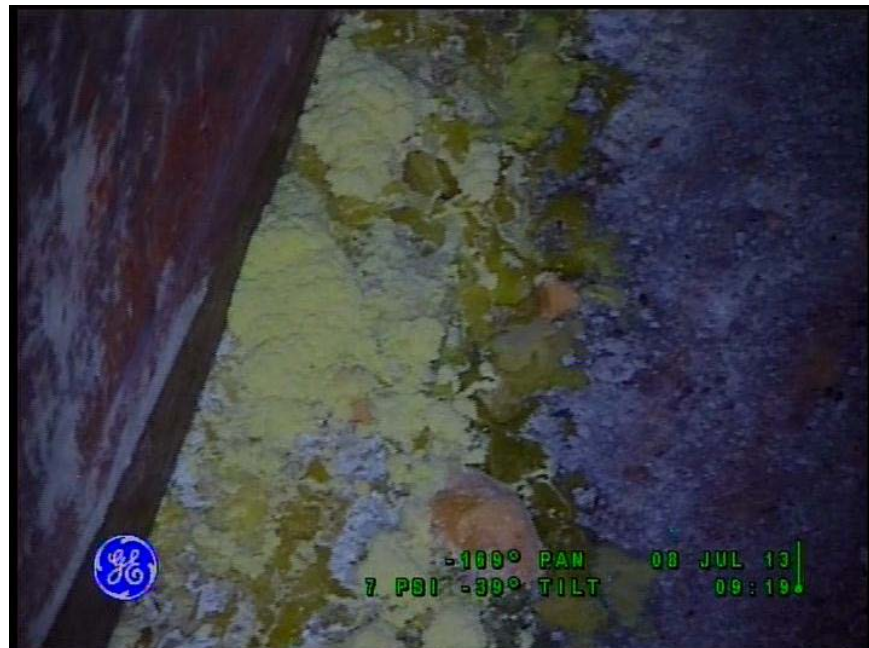
Figure 12 – 241-AY-102 Waste in the Annulus near Riser 83 (July 2013)

- The waste present in the annular space appears to cycle through "wetter" and "drier" periods. During the "wetter" periods, additional waste migrates further along the area of the annular floor and additional volume of waste appears to be added. However, no pattern or relationship to tank humidity, ventilation, ambient air temperature, seasonal climate parameters, etc. has been discovered as of date.

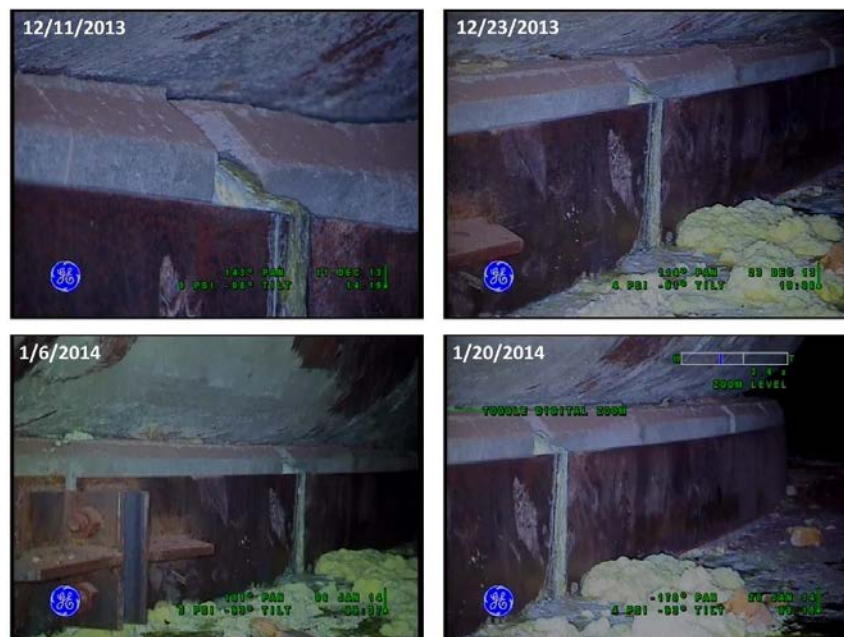
Figure 13 – 241-AY-102 Waste in the Annulus near Riser 83 (Jan 2014)
