**Detection and Monitoring of Cracks in a Concrete Buffer from DIC and AE
Measurements – 14439**

WM2014 Conference, March 2 – 6, 2014, Phoenix, Arizona, USA

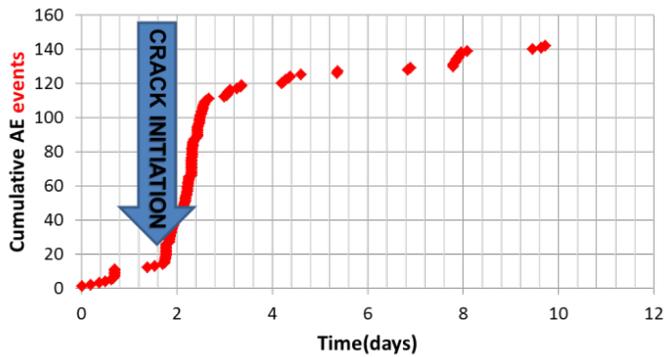
The first cracks detected by the AE and DIC installations appeared in Window 2, just one day after the start of the heating phase. The initiation of the first cracks was marked by the sharp increase in AE hits shown in Figure 7 and confirmed by the visible image of the cracks given in Figure 8.

Fig. 7. Cumulative AE hits recorded in Window 2 during the first days following the start of the heated phase.

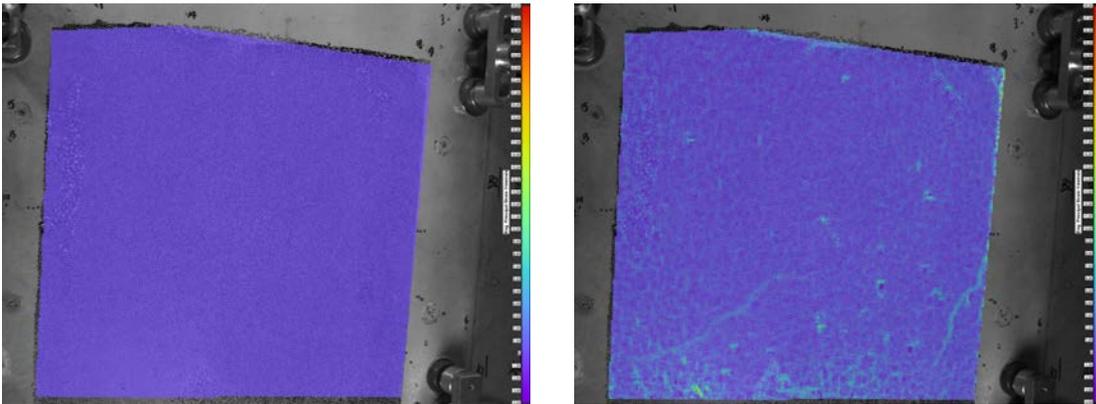
Figure 8 shows a digital image of Window 2 taken just prior to the start of the heating phase, showing the absence of cracks; and the same image taken the day after containing visible cracks. As mentioned, this image coincides with the sharp increase in recorded AE hits shown in Figure 7. Besides the detection of cracks in Window 2, other cracks appeared also in Windows 1 and 3 a few days later, as shown in Figure 9.

Fig. 8. DIC image taken at Window 2 just prior to the start of the heating phase [left] without cracks; and the same image taken a day after the start of the heating phase showing the presence of micro cracks [right].

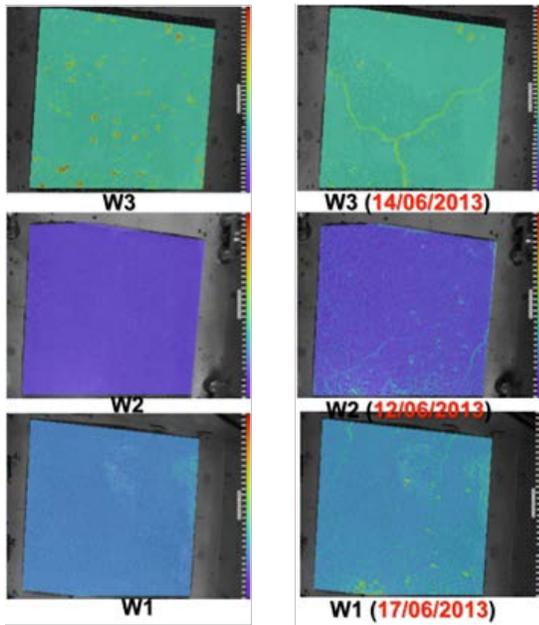
Fig. 9. [Left] DIC images of the three windows taken just prior to the start of the heating phase showing no cracks; and [right] same images taken at time of initiation of cracks, after the start of the heating phase.

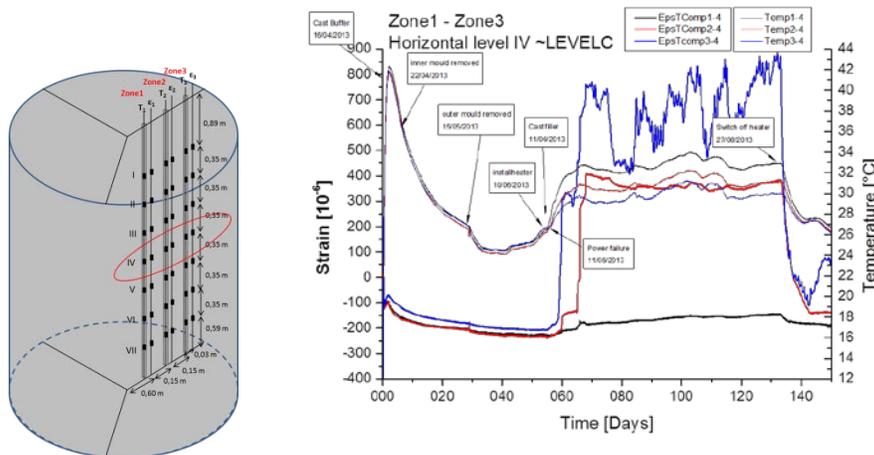
Fig. 10. Measurements of axial strain [lower curves] and temperature from three FBG sensors installed at the mid-level of the HST2.

The results shown in Figure 10 give the temperature as well as the axial strain profiles obtained by three FBG optical sensors installed at the mid height of the buffer. The sensors are located at three different radial distances in the concrete structure, as shown. The sharp increase in strain measured at the sensor in Zone 2, located approximately in the middle of the concrete buffer wall, and the one in Zone 3, close to the outer wall of the buffer, represent a crack at the level of Window 2.

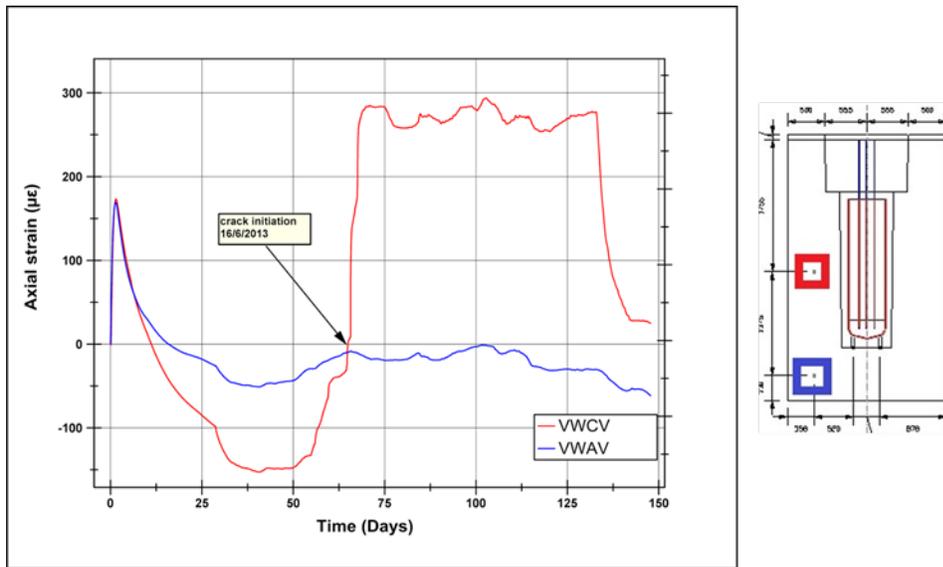
Fig. 11. Measurements of axial strain from two VW sensors installed at the mid and lower levels of the HST2.

Finally, the results in Figure 11, showing the measurements of axial strain from VW sensors located at the mid and low levels of the buffer, provide additional confirmation of the observations just presented. In particular, the VW sensor located in the middle of the buffer, which corresponds approximately to the location of the FBG sensor in Zone 2 in Figure 10, confirms the presence of a fracture and provides a good match of the strain profile measured by the same FBG sensor.
