The Windscale Pile 1 Accident in '57, subsequent clean-up & decommissioning

Presented at WM14, Phoenix, Arizona, USA, 6 March 2014

MT Cross, Principal Consultant
March 2014

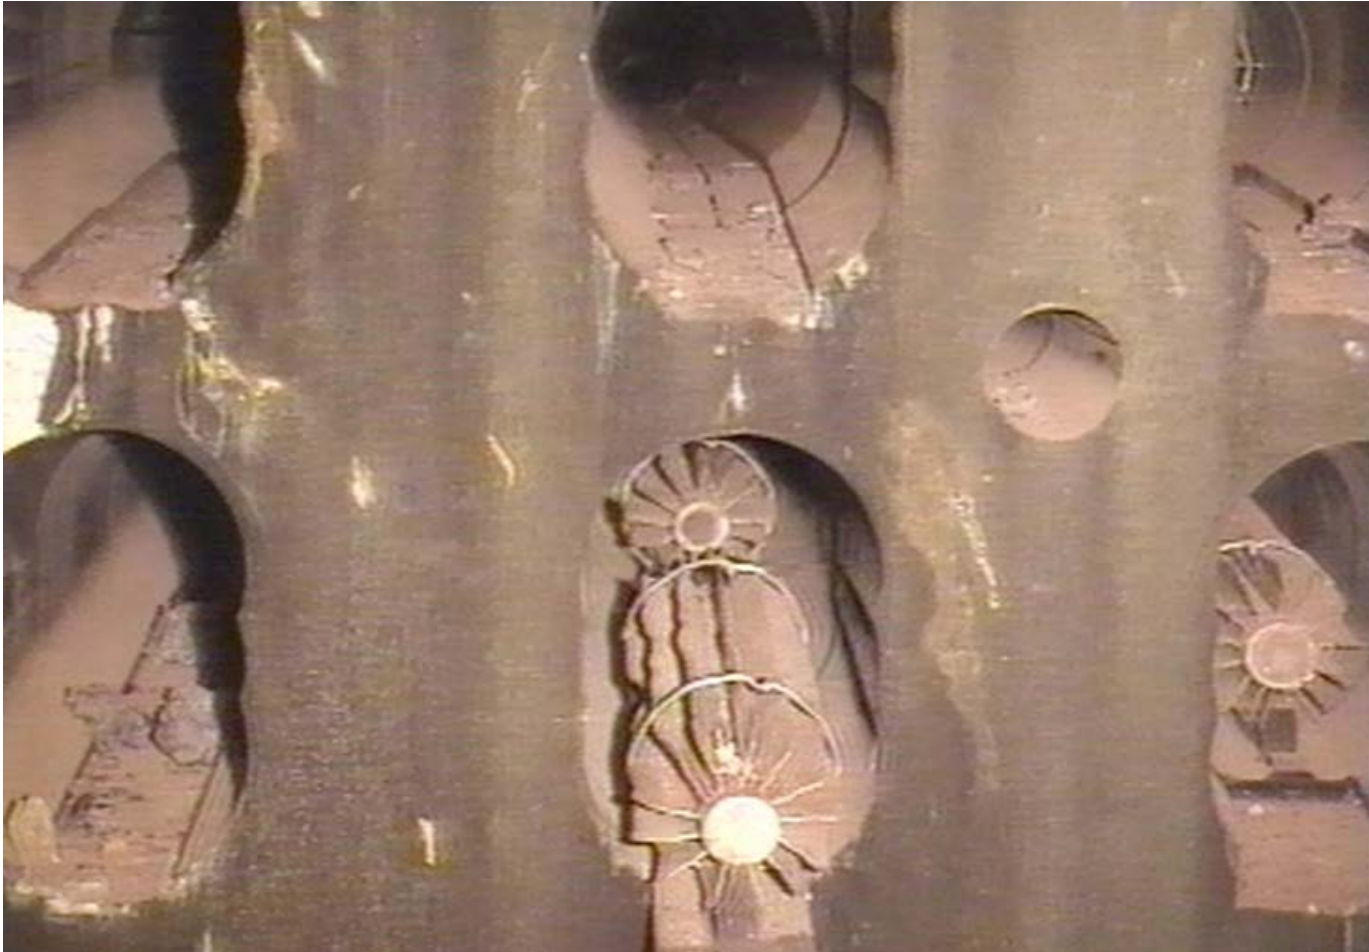
Apparently Pristine Fuel

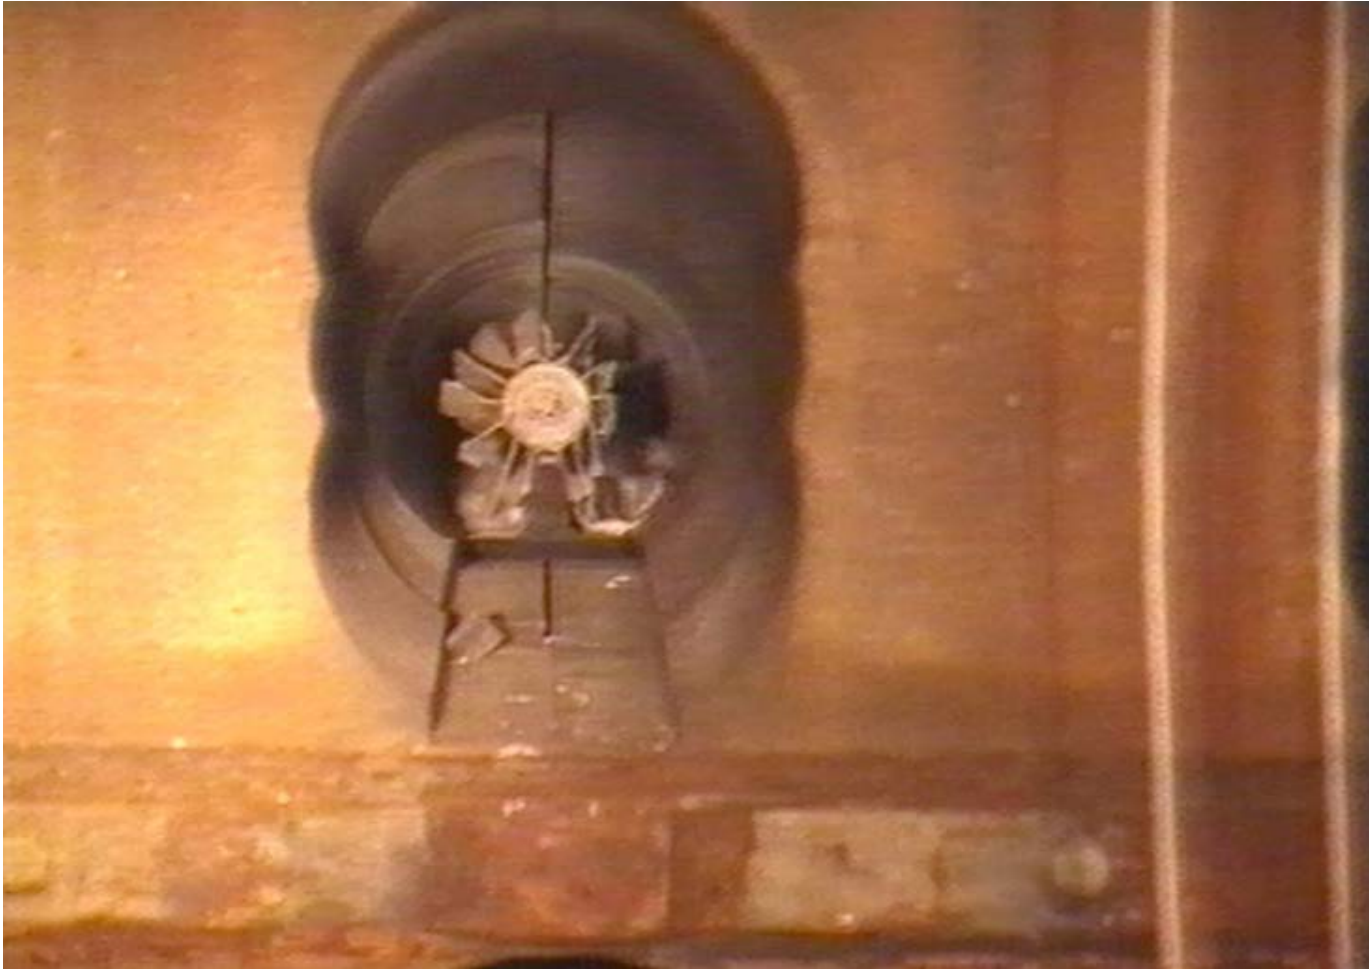
Slightly Damaged Fuel

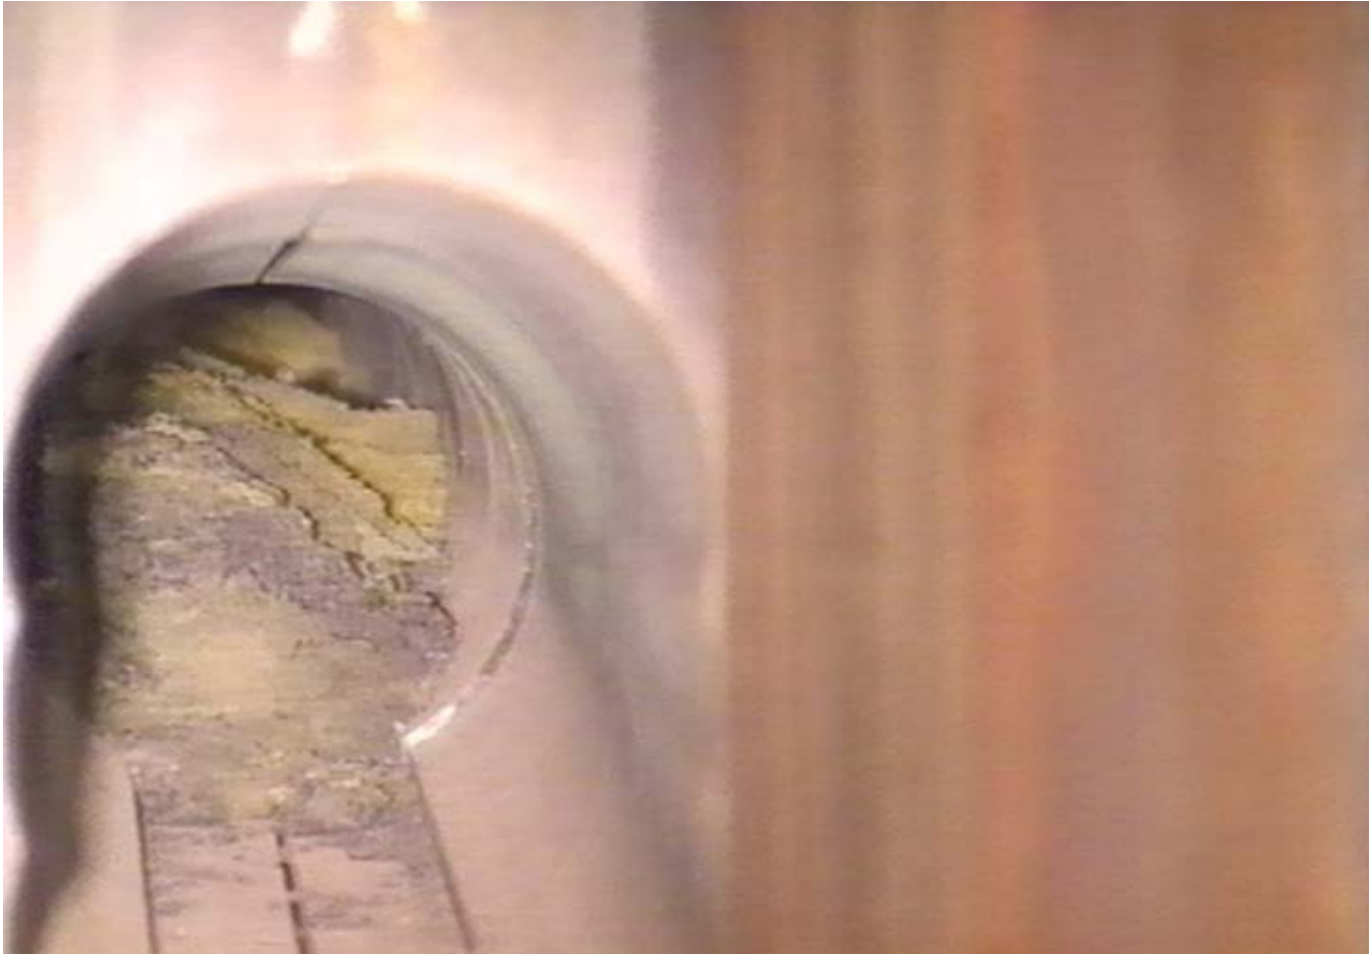
Destroyed Fuel – Channel 23.54

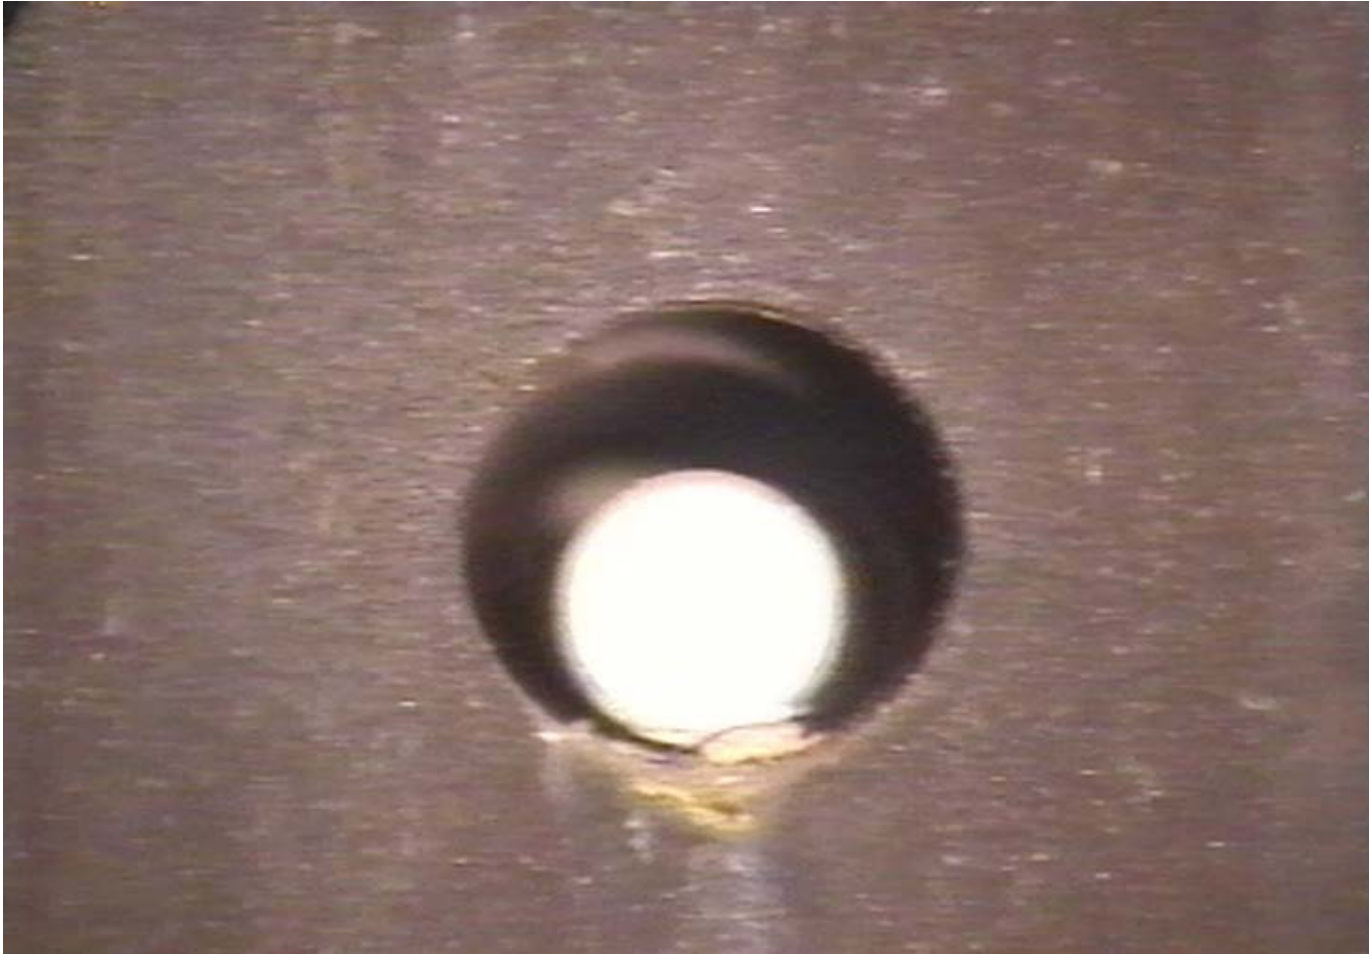
Intact Isotope Cartridge

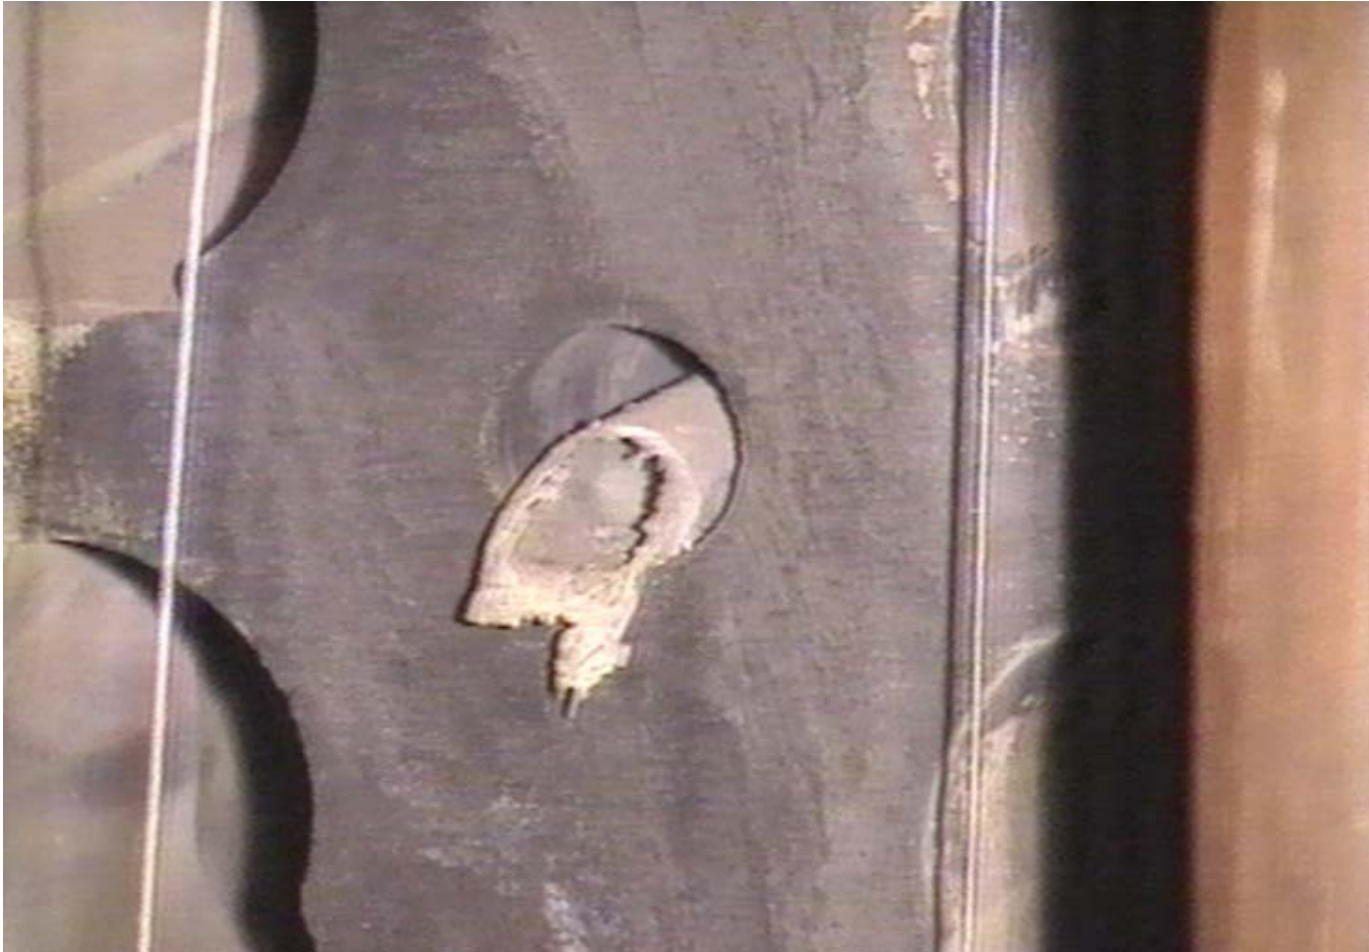
Damaged Isotope Cartridge

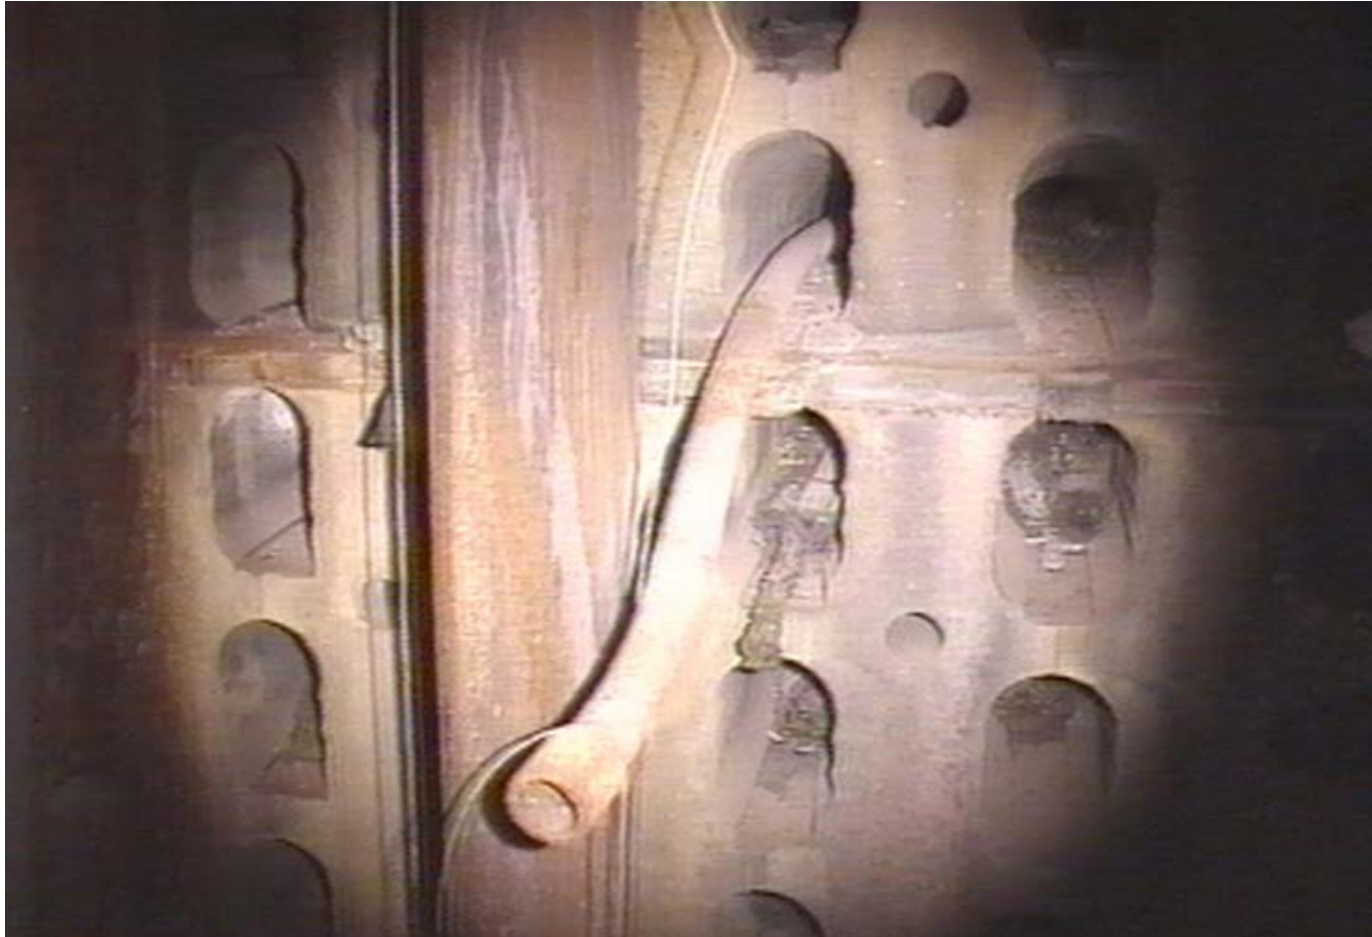
Metal Pipe - channel 21.55

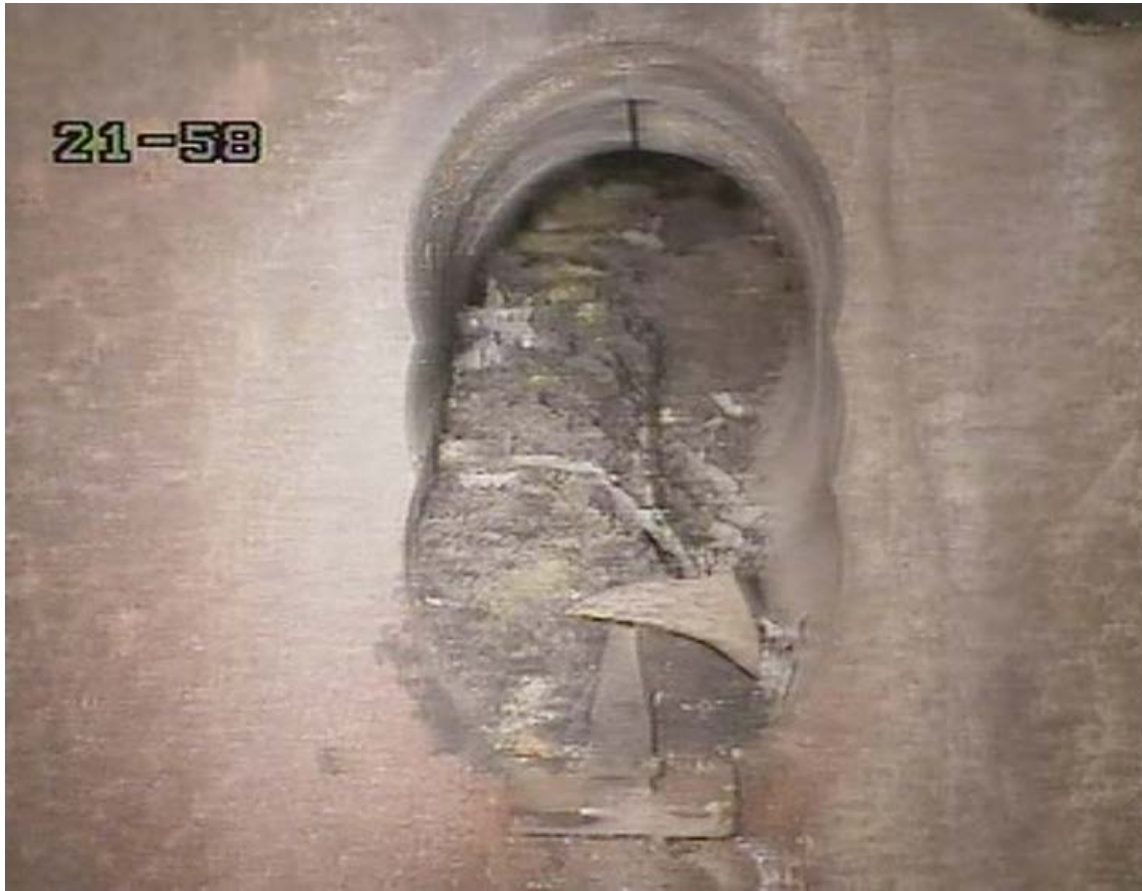
Fuel element condition - gross corrosion, Channel 21, 58 – hydride unlikely

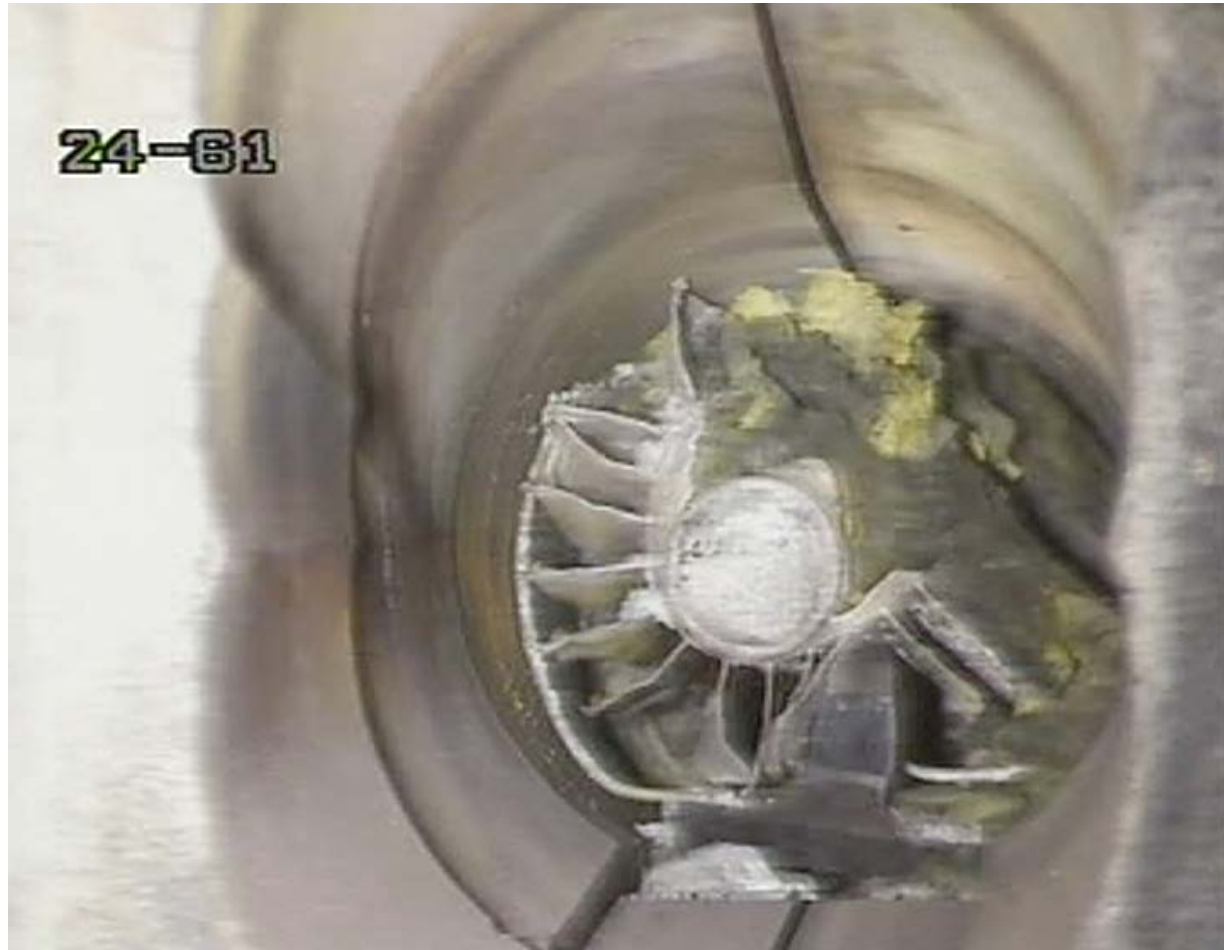
Fuel element condition - severe fuel damage, Channel 24, 61- hydride unlikely

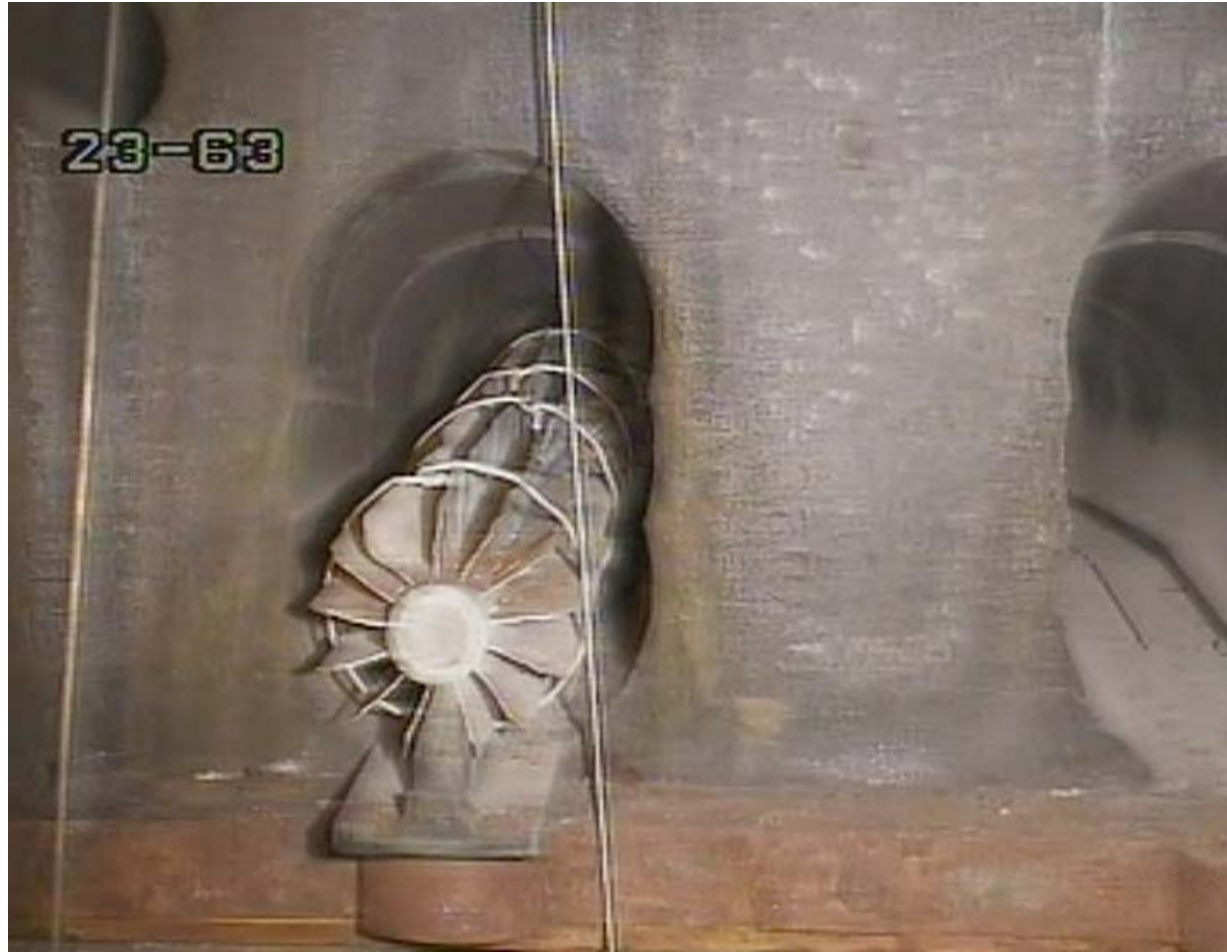
Fuel element condition - minor fuel damage, Channel 23, 63 –hydride possible?
