**The February 2014 Accidents at WIPP - 15024  
(What Happened and What We Know About Why)**

Roger Nelson, Russel Patterson, Abe VanLuik  
U.S. Department of Energy, PO Box 3090, Carlsbad, NM 88220  
(roger.nelson@wipp.ws)

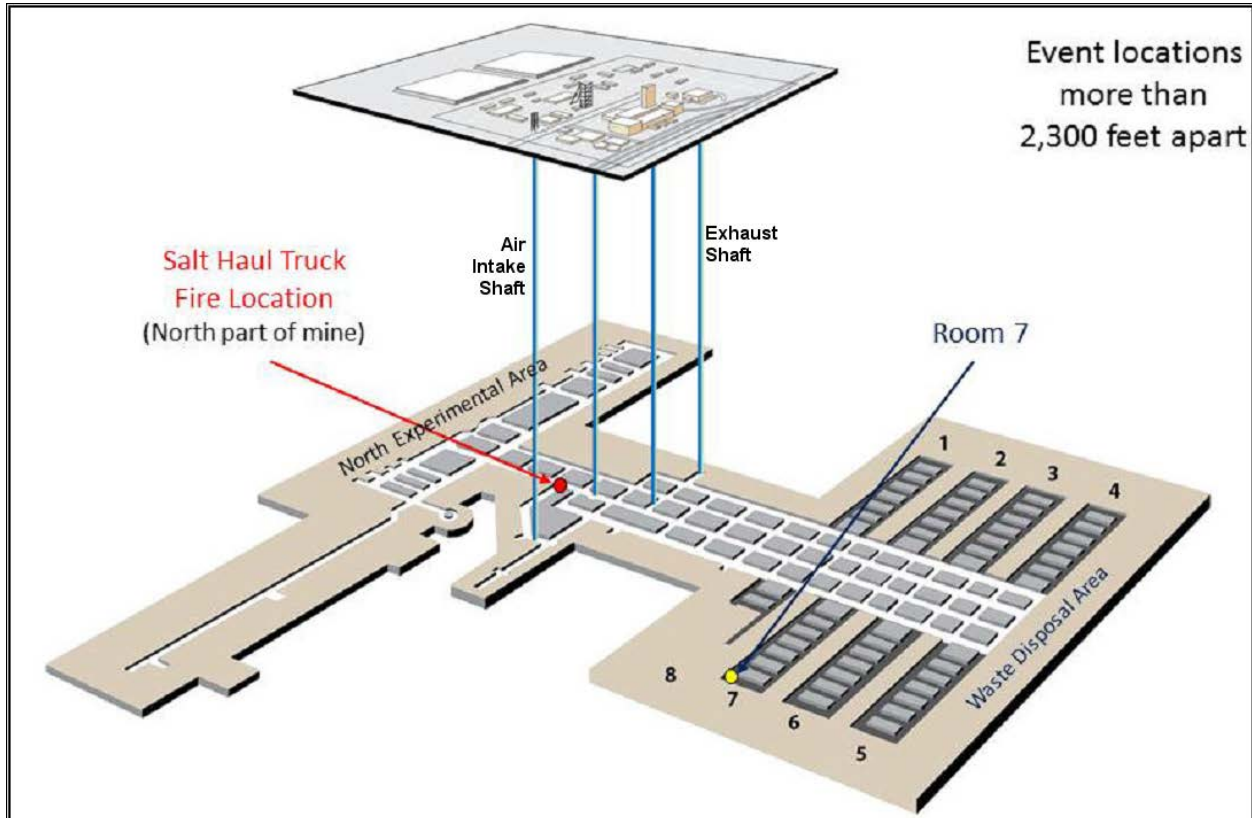
(2) the Department's ongoing response to the incidents, and (3) the effects on the WIPP facility. Figure 2 shows a schematic of the WIPP underground layout and where the two incidents occurred. Waste emplacement in Panel 6 had been completed about 3 weeks before the fire event, and emplacement activities had switched to Room 7 of Panel 7, which only contained 24 rows of waste containers when the incidents happened.

Fig. 2 Location of the Two Incidents at WIPP in February 2014

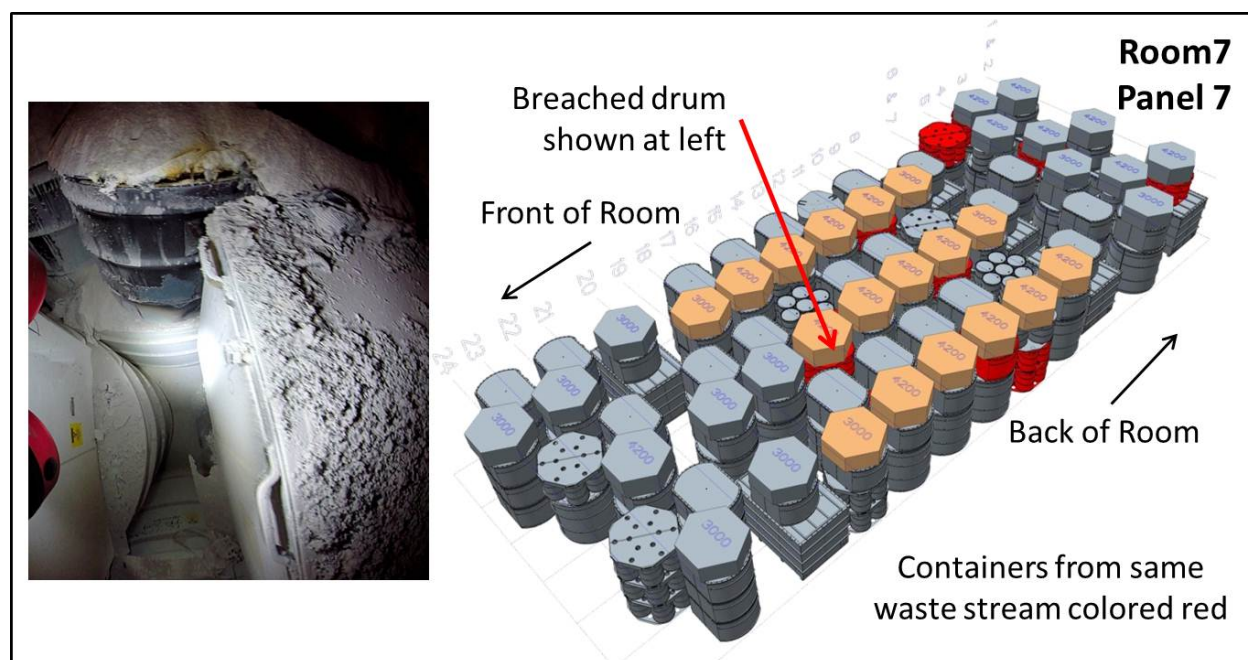
In May 2014, efforts to examine waste in Panel 7, Room 7 (using video cameras extended out on a long boom to view from above) identified that a waste container originating from LANL had been breached. Following identification of the waste container, samples were obtained underground, and analyses of those samples and other analytical and investigative work continues by both the AIB and the Technical Assessment Team. To date, only one breached drum has been identified, however, a more complete video camera inspection of Panel 7, Room 7 will be initiated in January 2015. A photograph taken in May 2014 of the breached drum is shown in Figure 3. Also shown is a schematic reconstruction of all waste containers in Room 7 of Panel 7, identifying all containers from the same waste stream. The waste stream of interest originated from repackaging nitrate salts by mixing with an organic-based absorbent to eliminate residual neutralized acidic liquids. This oxidizer and fuel combination was subsequently (post incident) found to exhibit the characteristic of ignitability under provisions of the Resource Conservation and Recovery Act.

Fig. 3 Photo of breached drum and schematic of its location within Panel 7 Room showing containers of the same waste stream from LANL. Orange hexagonal symbols represent plastic bags (containing granular chemical backfill) that melted as a result of the exothermic reaction that was the source of released radioactivity.
