## **Hanford Double-Shell Tank Ultrasonic Test Examinations – 15287**

Kayle D. Boomer\*, Wesley H. Nelson\*\*, and Allan F. Pardini\*\*\*

\*Washington River Protection Solutions

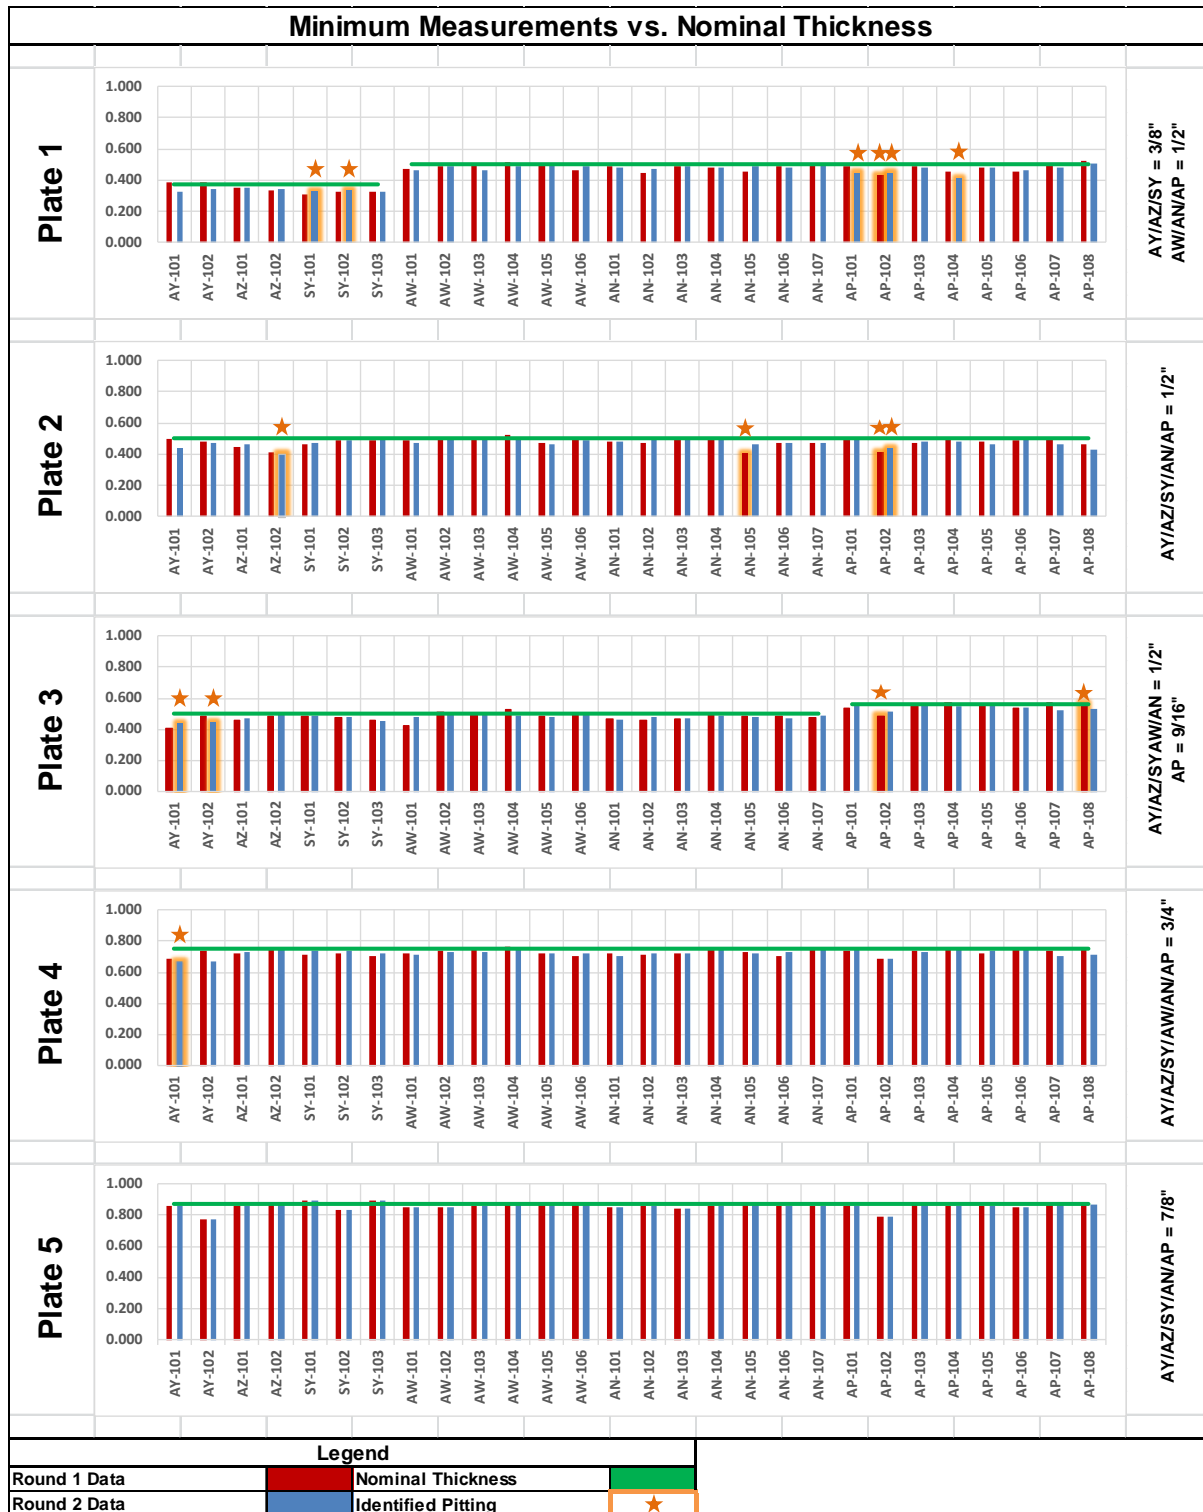
Fig. 6. Minimum Thickness Values (Primary Tank).

Fig. 6 shows the minimum thickness values for both the previous (original) and most recent for each plate and each tank. The average values actually show thickness above nominal values because steel plate is typically fabricated in thickness slightly above the nominal value.

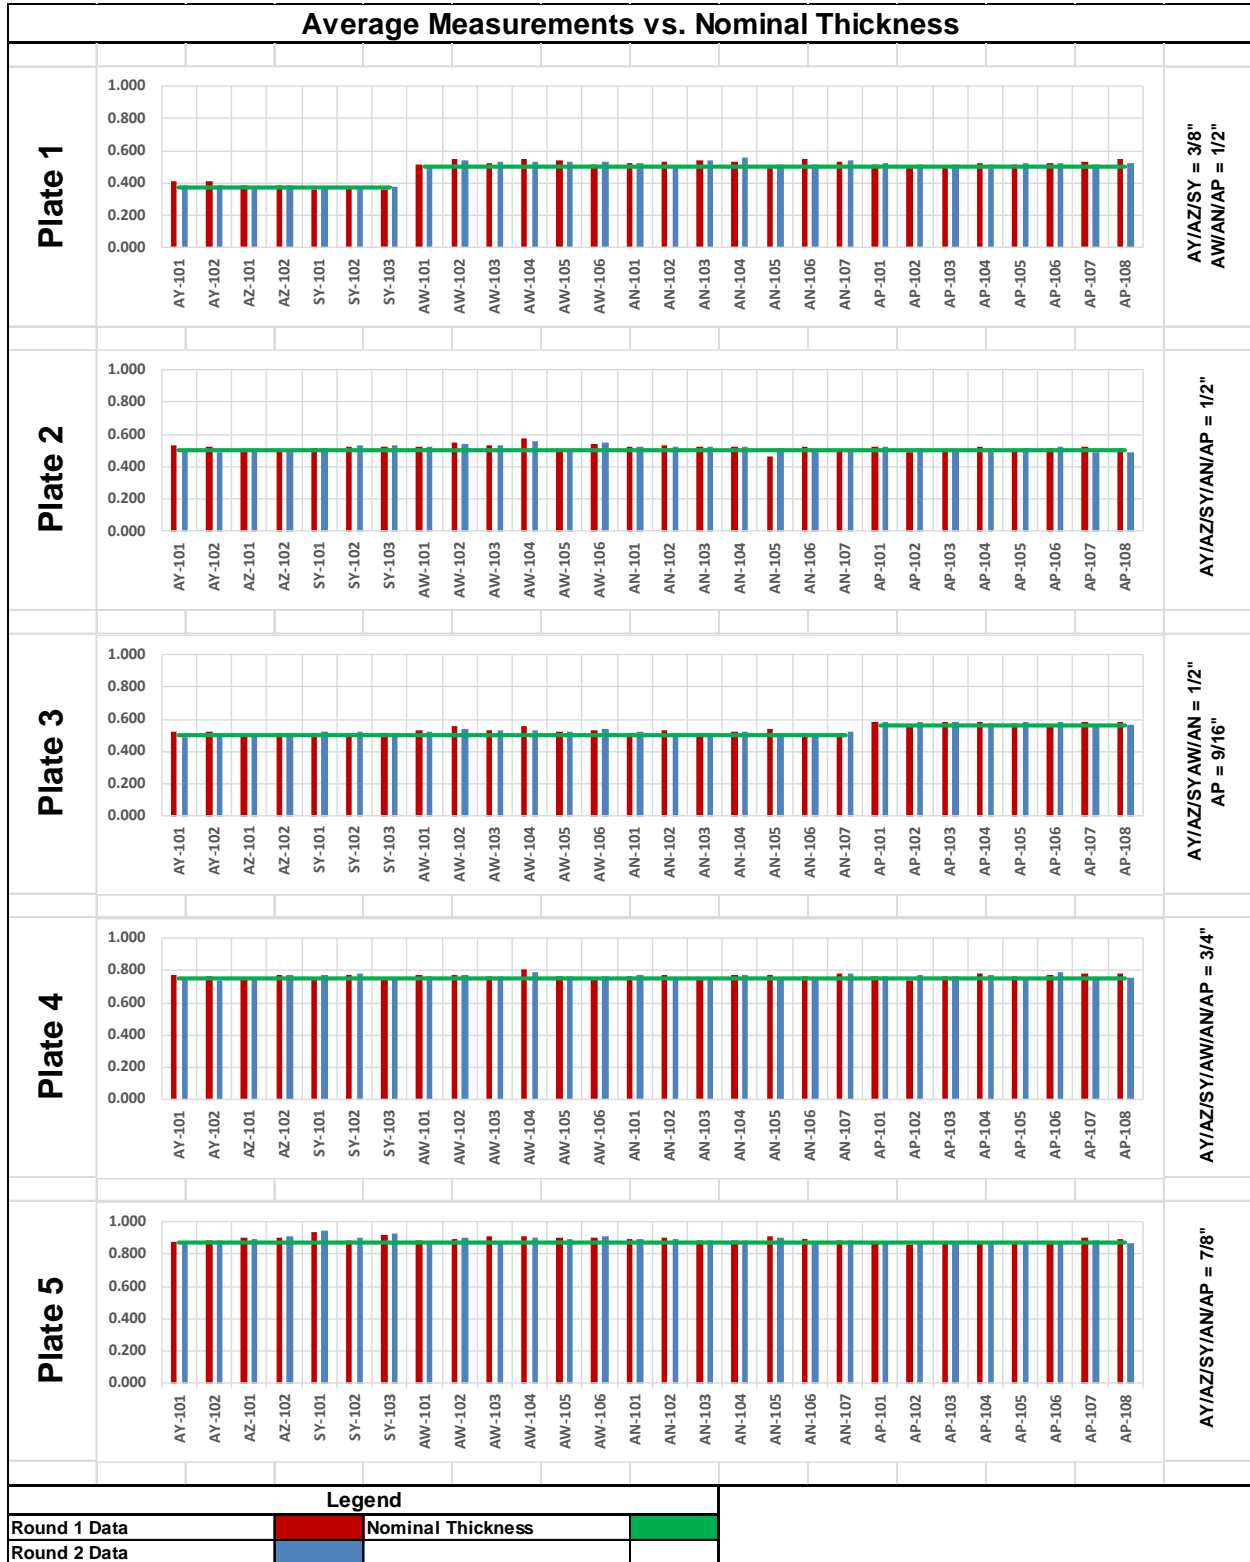
**Fig. 7. Average Thickness Values (Primary Tank).**

Fig. 7 shows the average measurements relative to nominal plate thickness.

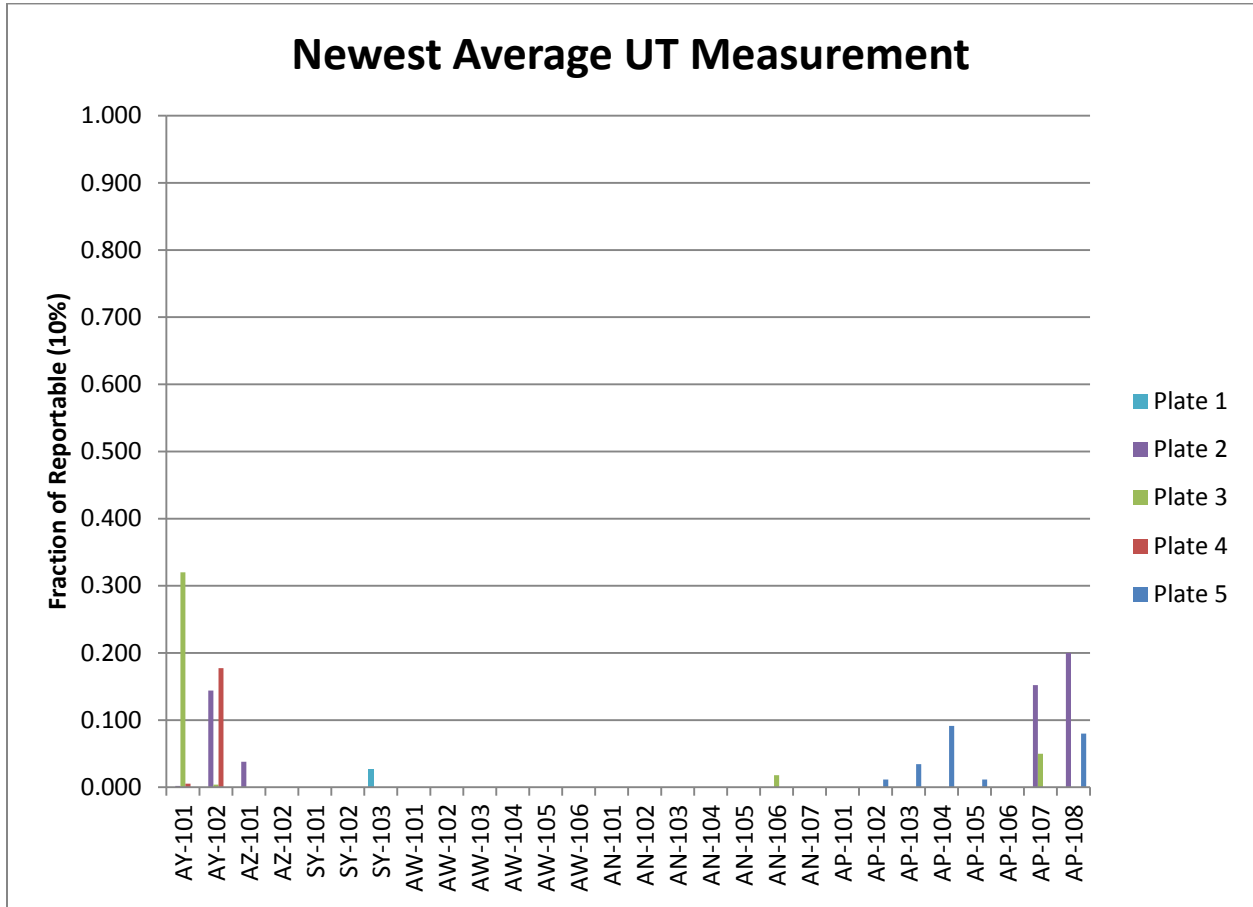
Fig. 8. Average Thickness Measurements (Round 2).

The average values for the measurements are shown in Fig. 8 in a bar chart as a fraction of the reportable values (10%). It should be noted that many of the values show no thinning as a consequence of the original plate material exceeding the minimum thickness specification. Of the 140 possible average values (28 tanks with 5 plates), only 21 values are below the nominal thickness. The four highest average thinning measurements are 20 to 30% of the reportable value (10% of the plate thickness).

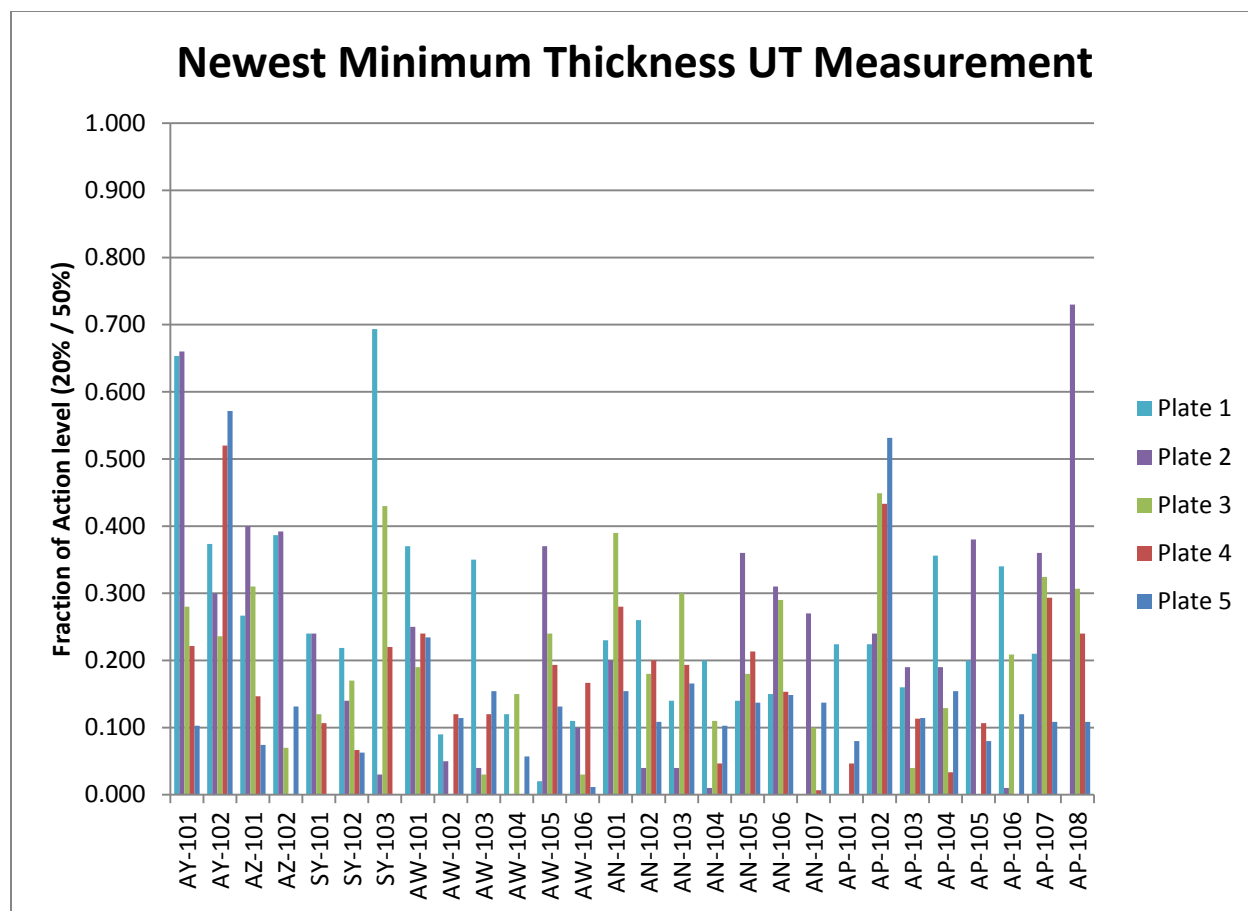
**Fig. 9. Minimum Thickness measurements (Round 2).**

The minimum thickness values are shown as a fraction of the action level (20% for thinning and 50% for pitting) in Fig. 9. These extreme values are within about 70% of the requirement as shown in Fig. 9. Six of the extreme values are above the reportable limit thinning.

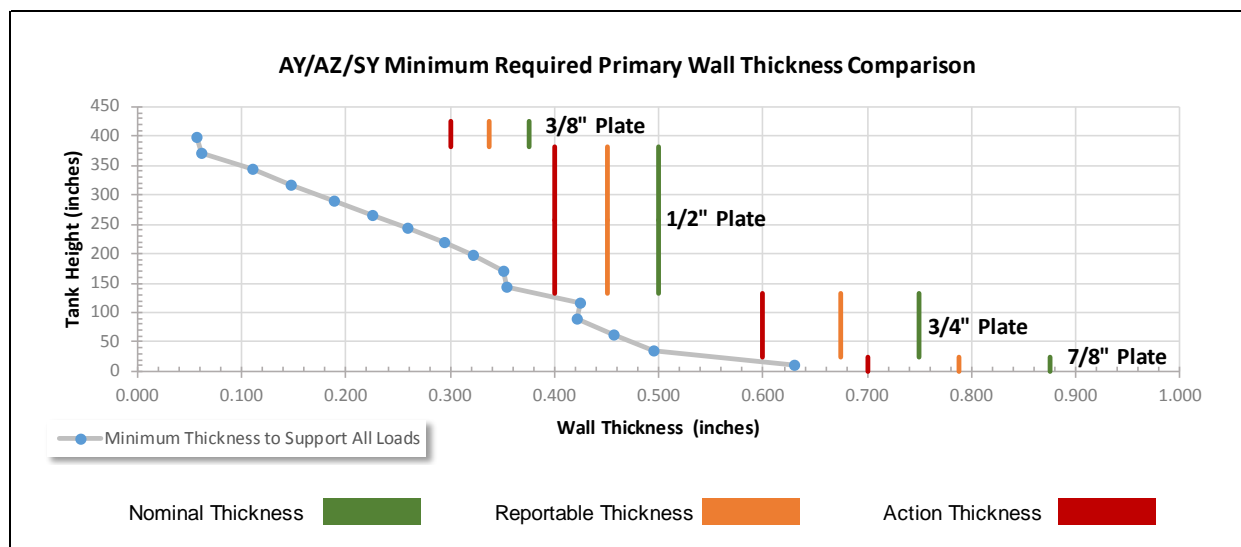
**Fig. 10. Minimum Wall Thickness Required for Structural Integrity.**

- A structural analysis was conducted on the primary tank steel to determine if wall thinning impacted structural integrity [6]. As shown in Fig. 10, the additional wall thinning necessary to challenge structural integrity is far below reportable and action levels.
