**Hanford Double-Shell Tank Extent-of-Condition Construction Review – 15498**

**ABSTRACT**

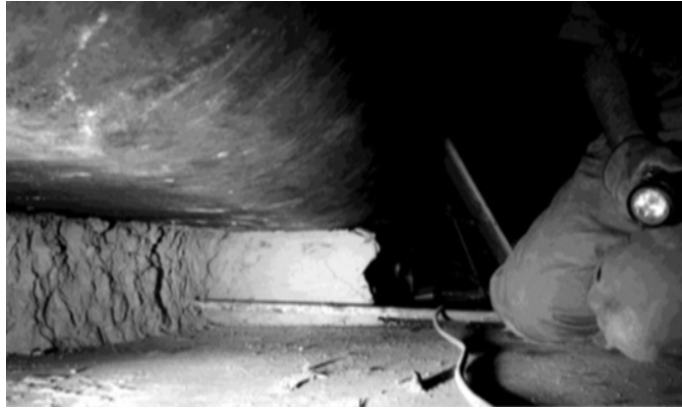
**Figure 3: Refractory Repair Operations in 241-AY Tank Farm**

Castable refractories are typically poured or “gunned” into place. After air drying or “curing,” the refractory is then “fired” or heated to high temperatures to convert hydrated compounds into a more durable, de-hydrated, ceramic structure. During the initial air-drying and until the firing is completed, protection from freezing and water saturation is important. During construction of the 241-AY tank farm, there were problems with both of these protections. After heat treatment and hydrostatic testing, the refractory material in both tanks was found to be badly cracked and degraded, caused in some part by poor weather protection. Concerns about lack of support in the high-stress knuckle region led to the decision to remove ~533 mm (21 in) of the refractory and replace it with structural concrete in both tanks. Given the location and access constraints, the effectiveness of this repair and proper concrete placement was identified as a concern during the leak assessment of tank AY-102. As previously mentioned, voids from primary bottom bulging that were beyond the ~533 mm (21 in) perimeter were filled with foam prior to placement of the structural concrete repair. See Figure 3 for pictures of the refractory repair in progress in the 241-AY tank farm.

During review of the construction history of the 241-AY tank farm, the most significant deficiency found in the review was the degradation and repair of the refractory in tanks AY-101 and AY-102. Both refractories were exposed to similar conditions of moisture and freezing temperatures during the curing stage, which is believed to have contributed to their friable nature and reduced vertical compressive strength. The refractory repairs required the outer 533 mm (21 in) of the periphery refractory to be chipped out all the way around the tank and replaced with reinforced structural concrete.
