## **Hanford Single-Shell Tanks Leak Causes and Locations – 15509**

### **ABSTRACT**

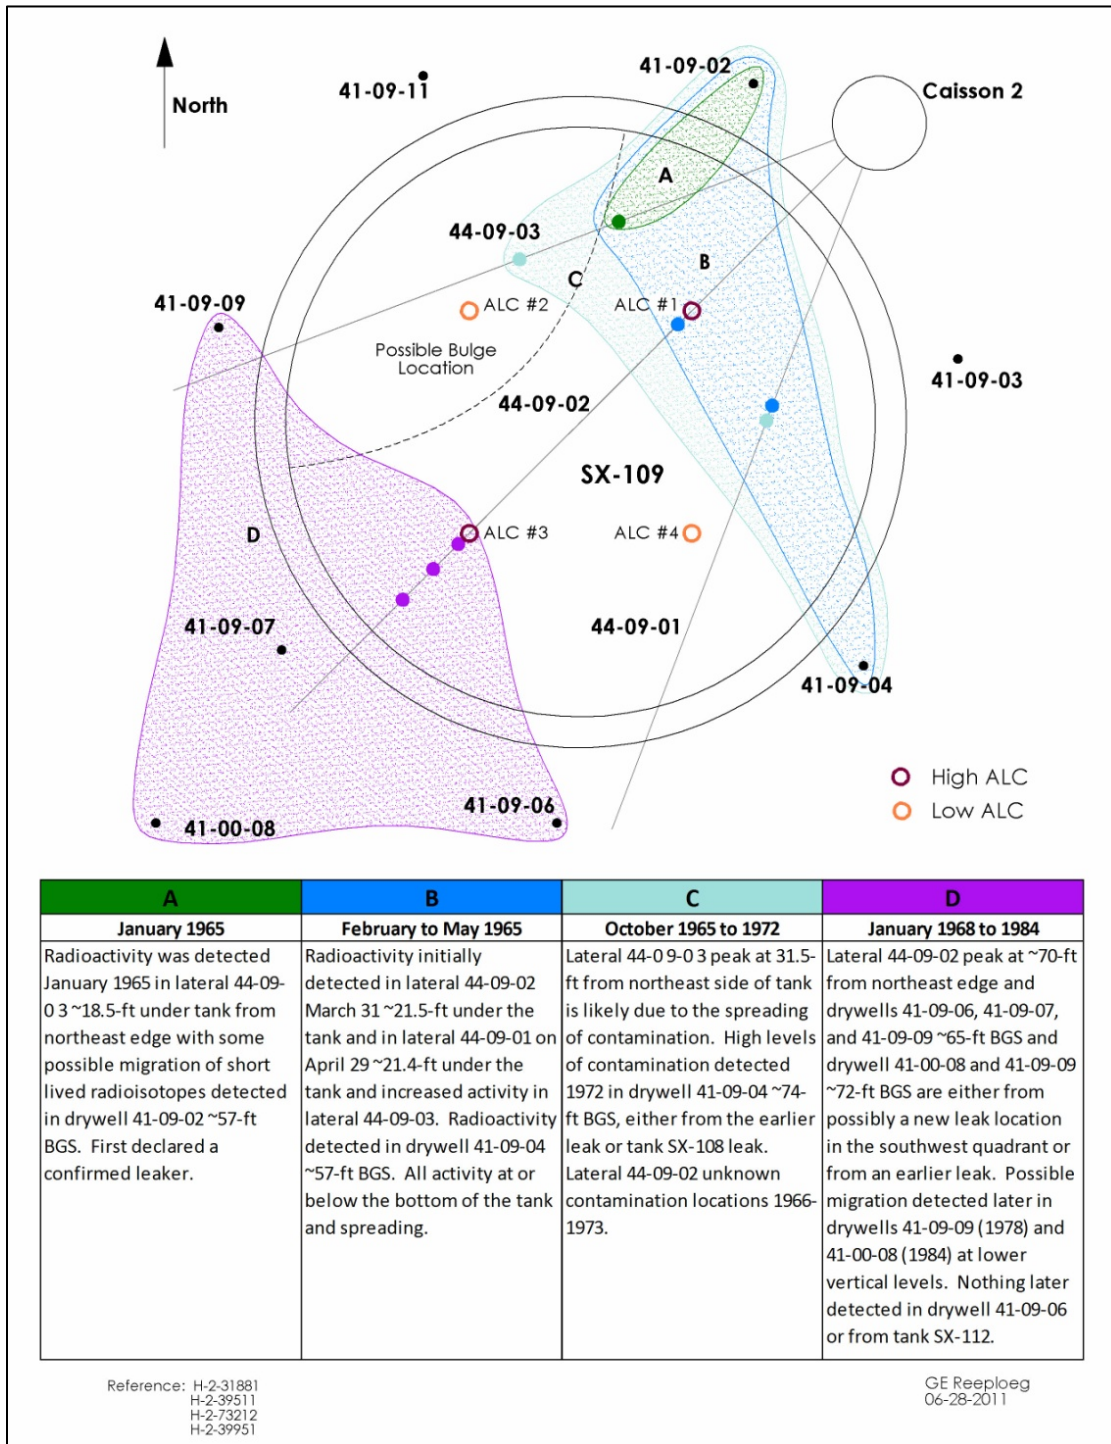
**Fig. 1. Example Leak Location Map for Tank SX-109 [9]<sup>1</sup>**

The location of the leaks was determined, based largely on logging radiological data from drywells installed around the tank and/or radiological data from laterals installed under select tanks. The drywells and laterals provide the best indication of the vicinity of the leak location, but not necessarily the exact location of the leak. Twenty of the 25 liner leaks appear to have occurred at or near the bottom of the tanks. Many of the tanks appeared to have multiple leak locations. Leak locations could not be determined for all tanks with the available data. Three of the tanks showed apparent sidewall leaks.

Twenty-five SSTs were analyzed to identify leak causes, leak locations, and leak rates [7]. Twenty of 25 of the liner leaks occurred at or near the bottom of the tanks. Many of the tanks appeared to have multiple leak locations. Three of the tanks showed apparent sidewall leaks only. Leak locations could not be determined for two tanks (T-111 and TY-104). See Fig. 1 for an example of a leak location diagram from tank SX-109. A similar figure was developed for each of the tanks (except for the two tanks that leak locations could not be determined) and represents the chronological time frame of the leak site(s) and the possible migration. If a liner bulge was reported or possible then the approximate location was also overlaid in this figure. It should be noted that Fig. 1 shows the leak detection laterals originating from Caisson 2. Leak detection laterals were installed approximately 10-ft underneath some of the SSTs containing self-boiling waste in A and SX Farms. Probes were driven to the end of the lateral with compressed air then slowly withdrawn to gather a radiation profile below the bottom of the tank. Laterals, where available, were used to determine leak locations and lateral radioactivity almost always indicates a leak at or near the bottom of the tank.

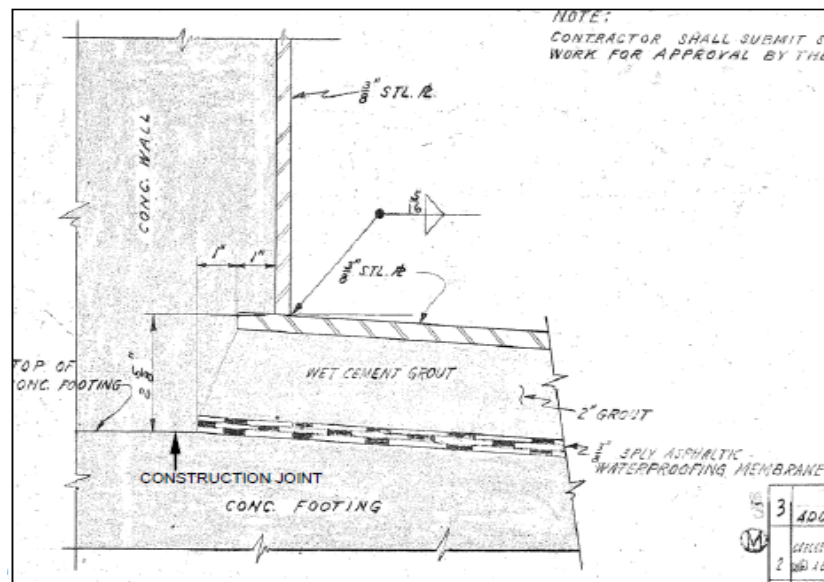
**Fig. 2. SX Farm Tank Bottom Liner to Sidewall Design Detail**

Tank design was identified as a contributing cause to liner failure primarily based on design features limiting thermal expansion of the bottom liner with addition of high heat waste. For A and SX Farms, the orthogonal transition between the tank bottom and tank sidewall was deemed less desirable compared to the earlier tank farm design of a rounded knuckle transition. Fig. 2 shows this orthogonal transition of the SX Farm tanks. A fillet weld was used to close the seam where the sidewall and tank bottom liners meet versus the butt welding of the knuckle transition of earlier tank designs. A review of the basic differences between fillet and butt welds indicates that the superior butt welds would be preferred for the tank farm waste tanks. Other design specifications changes for A and SX Farms were weld inspection techniques. Welds were inspected using the Vacuum Soap Test at 10 in. of mercury versus the superior full penetration X-Ray weld testing. These design changes applied to A and SX Farms were identified as features that could likely cause liner failure.

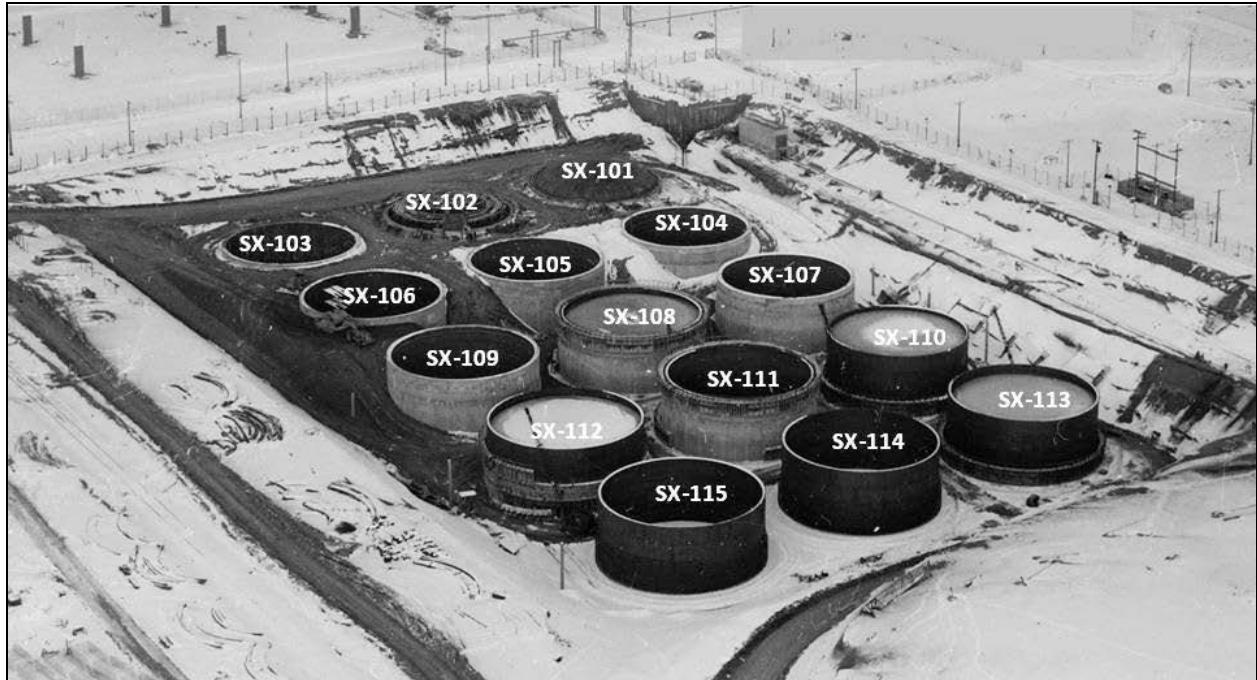
**Fig. 3. SX Farm Construction Photograph Taken January 20, 1954**

Temperatures during construction of the tank farms were examined to determine if the tank liner fabrication occurred at or below the metal ductile-to-brittle temperature transition. Any low temperatures experienced during construction at or less than the 18°F ductile-to-brittle transition temperature where impact loading (e.g. a dropped tool or piece of equipment from scaffolding) had the potential for creating micro-fissures may have triggered fissures in the steel liner. It was determined that the most severe temperatures occurred during construction of SX Farm [9]. A photograph of the SX Farm under construction (see Fig. 3), taken January 20, 1954 (high 11°F low -6°F), shows several of the tanks full of water either undergoing leak testing or for concrete wall pouring. During this cold period snow covered ice is seen in the water filled tanks. Other tank farms experienced less severe temperatures than those recorded during SX Farm construction.
