**241-AY-102 Leak Detection Pit Drain Line Visual Inspection – 15678**

Theodore Venetz \*, Kayle Boomer \*, Jason Engeman \*, Jason Gunter \*, John Garfield \*\*, Brandon Vazquez \*, Cameron Joslyn\*

\* Washington River Protection Solutions  
\*\* AEM Consulting, LLC

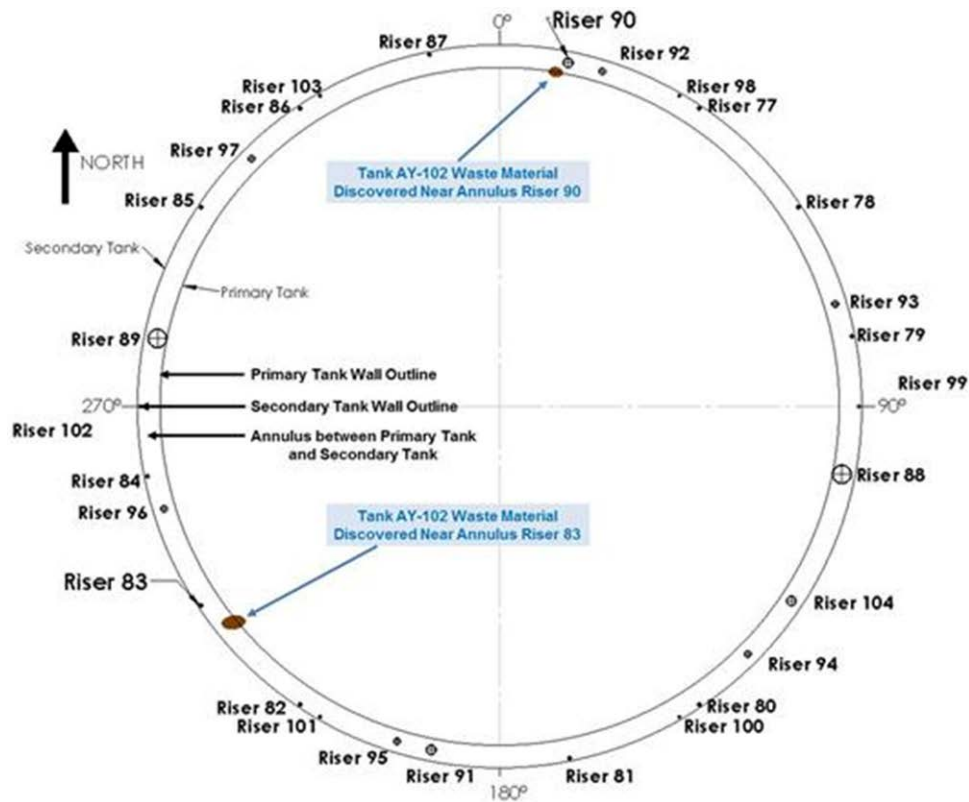
**FIGURE I: Leak Accumulation Sites First Discovered in August 2012**

During a routine visual inspection of the annular space in August 2012, an accumulation of material was discovered at two locations on the annulus floor of Tank AY-102 (Riser 83 and 90).

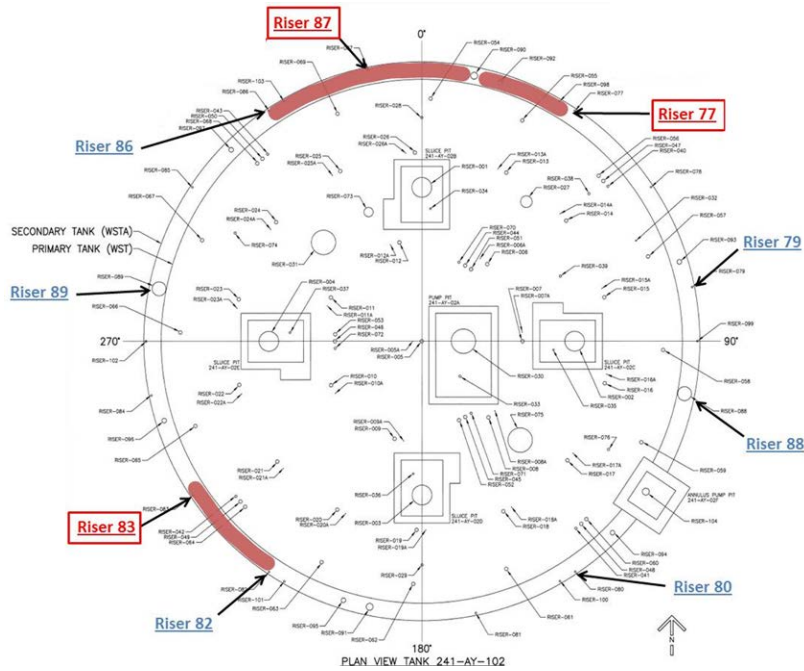
**FIGURE II: View of Waste Accumulation Sites on Annulus Floor as of September 10, 2014 in Tank 241-AY-102**

In October 2012, Washington River Protection Solutions LLC (WRPS) determined that waste had leaked into the annulus of AY-102.[2] WRPS conducted an extensive review of Tank AY-102 and increased both inspection and monitoring of the tank; however, the precise cause and location of the leak could not be determined. In March 2014, additional material was detected on the annulus floor underneath Riser 77 which is adjacent to Riser 90. Ongoing periodic inspections are being performed at the waste accumulation sites (Risiers 77, 83, and 87) and via six other risers to view >95% of the annulus floor to track for changes (see Figure II).

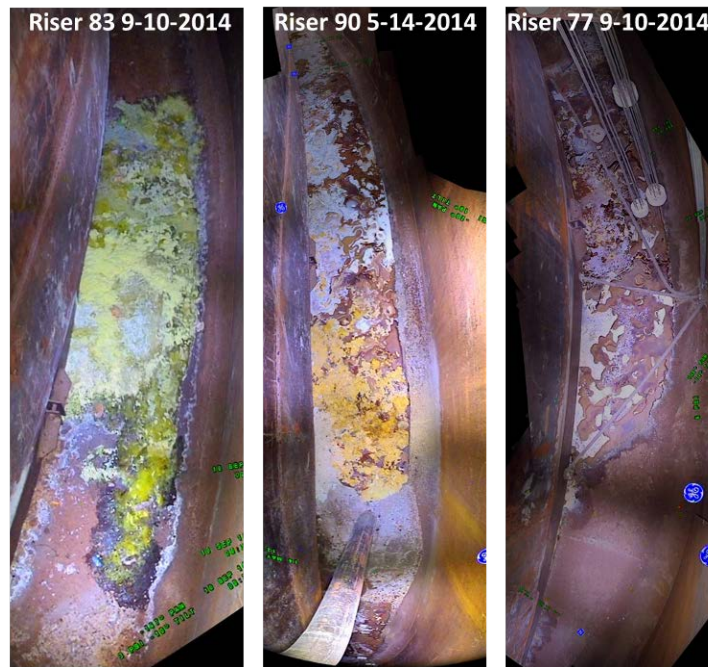
**Figure III: Leak Accumulation Sites to Date in Tank 241-AY-102.**

Since August 2012, these leak accumulation sites have continued to grow in volume with a total leak accumulation volume estimated at 30.6 gal (0.116 m<sup>3</sup>) as of 9/10/2014 (see Figure III).

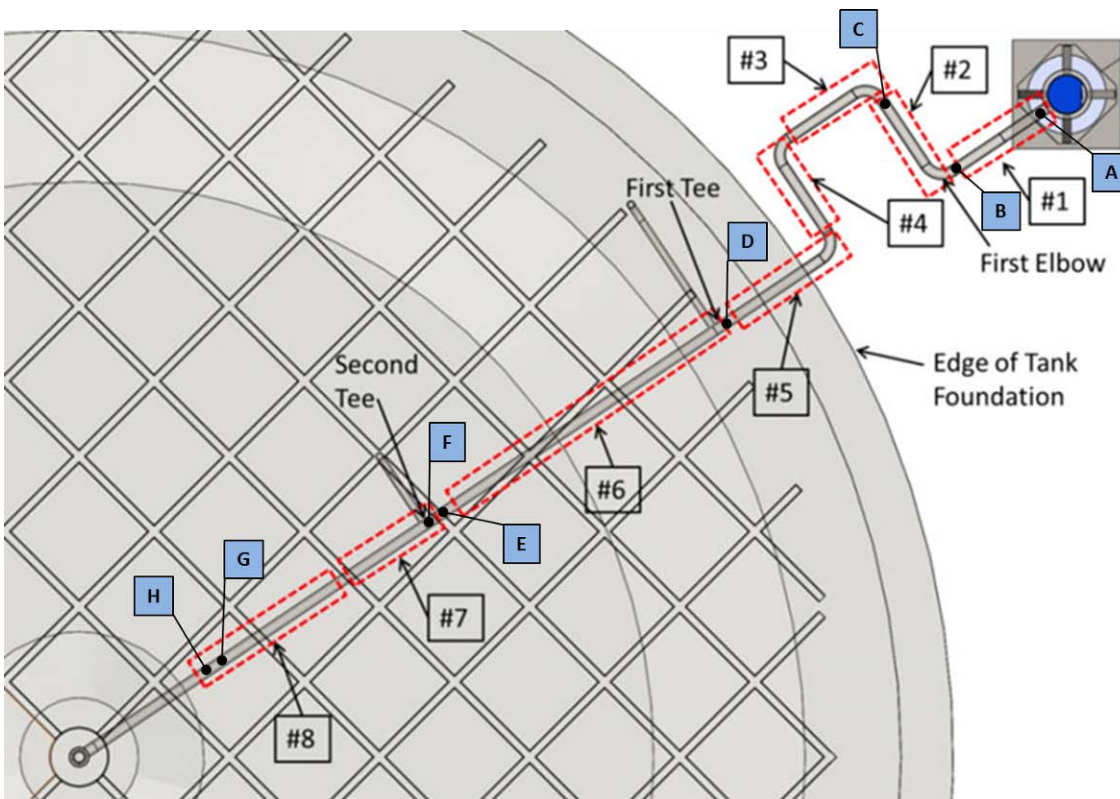
**FIGURE IX: Inspection Overview**

- **Section #1:** The entrance was partially wetted and had sediment and corrosion consistent with past inspections.
- **Sections #2, #3, and #4:** The pipe was wet with considerable sediment and rust in the bottom of the pipe into section 4, which is between the third and fourth elbows in the expansion loop. This

wetness is consistent with the level of water in the LDP prior to pump down six days before the inspection.

- **Sections #5 and #6:** Very dry and showed no evidence of dripping or drainage from the slots in the 101 mm (4 in) drain lines. These sections showed less debris and corrosion product in the bottom of the pipe.
- **Sections #7 and #8:** Past the second tee, were wet and had a similar volume of debris and corrosion products as found in the first four sections.
- The central sump was not observed, since the crawler could not traverse through the last few feet of the drain line due to the amount of debris present (see “G” of Figure X).

The 6 in (152 mm) drain line was wet from the center of the tank to the second tee connection (sections #8 and #7 in Figure IX) and from between the second and third elbows down to the LDP sump tank (sections #4, #3, #2, and #1 in Figure IX). The wet environment seen in sections #1 - #4 (see Figure IX and Figure X) is remnant to the liquid level prior to pumping down the LDP (six days before the inspection).

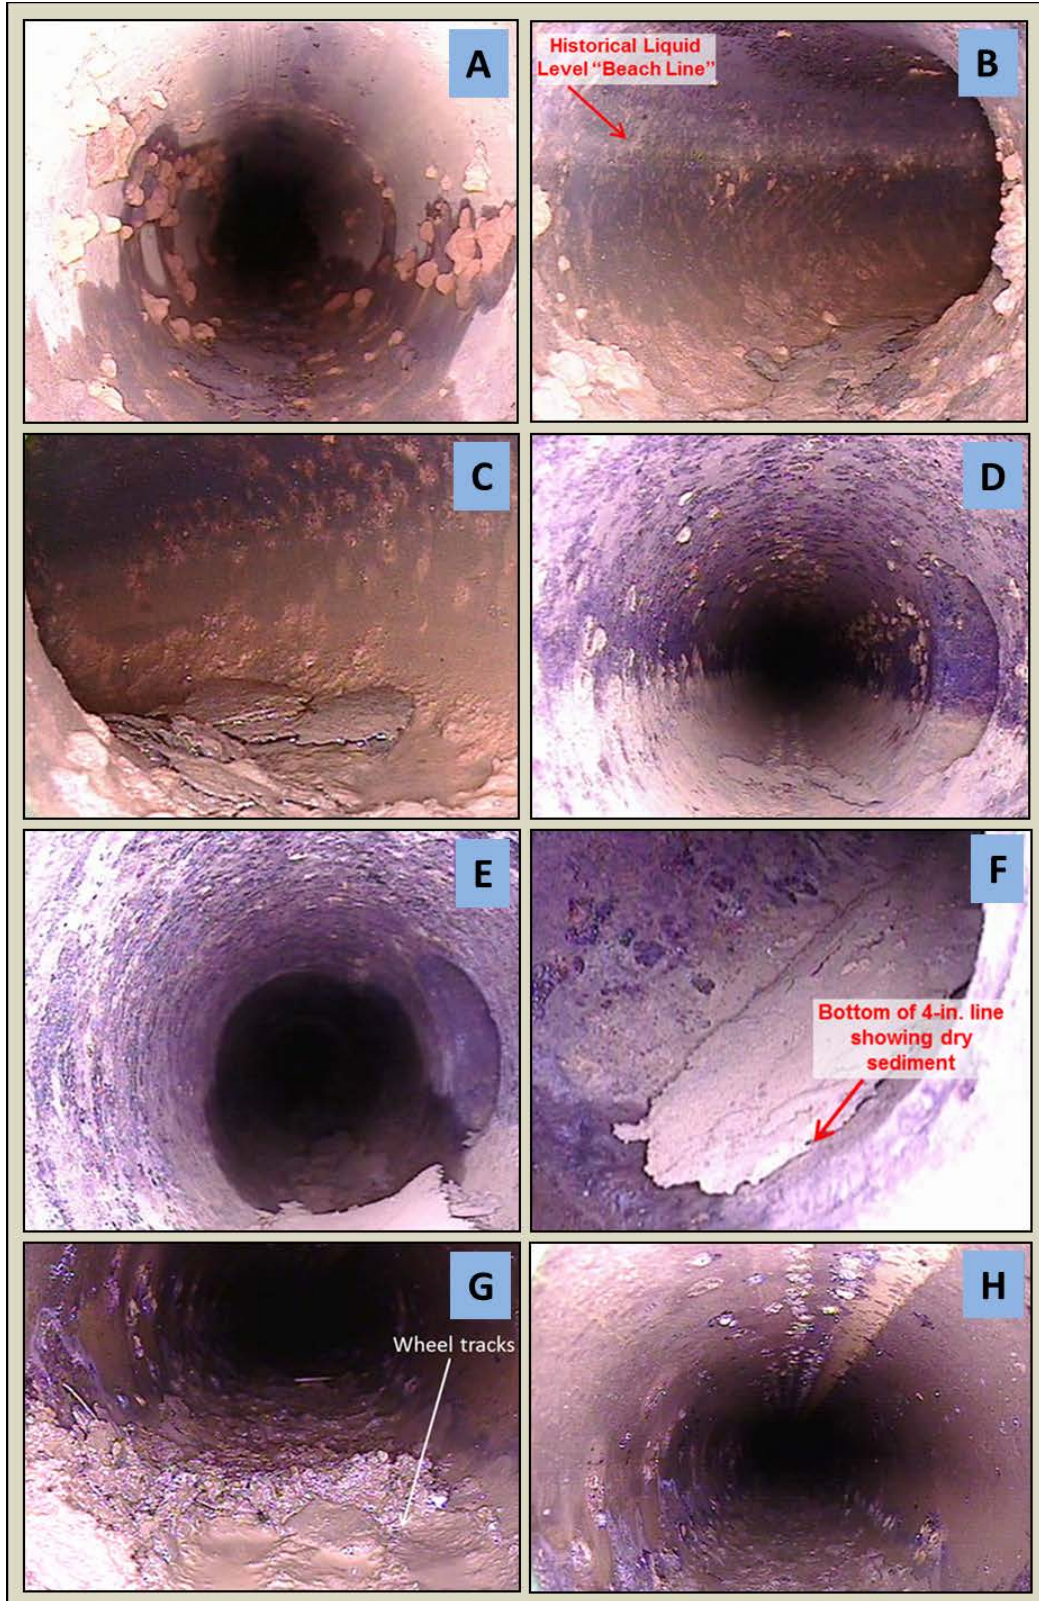
FIGURE X: Drain Line Visual Inspection Photographs

Prior to the inspection, it was assumed that the intrusion was liquid migrating through the expansion joint between the vertical concrete sidewall and the foundation pad (see Figure IX). The expectation was that the first tee (see “D” in Figure X) might show the presence of liquid because it drains from a point nearest this joint. Both the first and second tees were dry (see “D” and “F” in Figure X) and did not show the presence of any liquid. During the inspection, no other sources of water intrusion were observed.

Although the debris proved to be an impediment to the crawler and may cause a delay in the flow of waste to the LDP, it is insufficient to restrict the flow of a substantial amount of liquid to the LDP. If small leaks occur in the secondary liner, it is unlikely that the waste would reach the LDP sump in a timely fashion with or without the presence of the debris. This conclusion is based on the rate of flow of waste from the Tank AY-102 primary tank, in which waste has moved slowly over a year or more to cover a relatively small fraction of the liner floor.

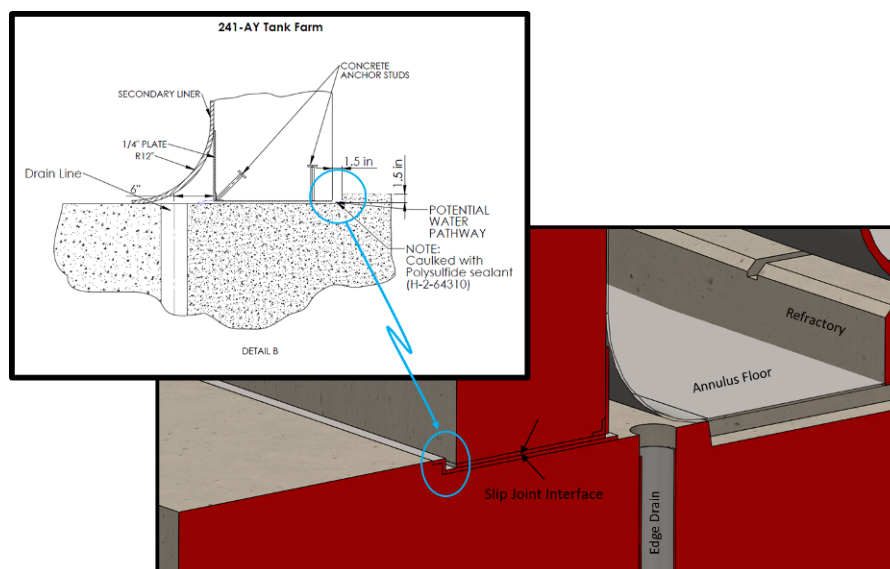
**FIGURE XI: Concrete Wall/Foundation Expansion Joint Interface**

Vacuum applied to the LDP system may be pulling moisture from the surrounding soil through the 6 in drain line into the sump and the 24 in (607 mm) riser. The pathway is likely at the polysulfide-sealed slide plate joint between the footing and the bottom of the concrete side wall. The soil in this location is warmed by contact with the tank wall. This relatively warm, moist air is drawn in 57 ft (17.4 m) below-grade and can condense in cooler parts of the LDP drain system if the temperature differential is sufficient.

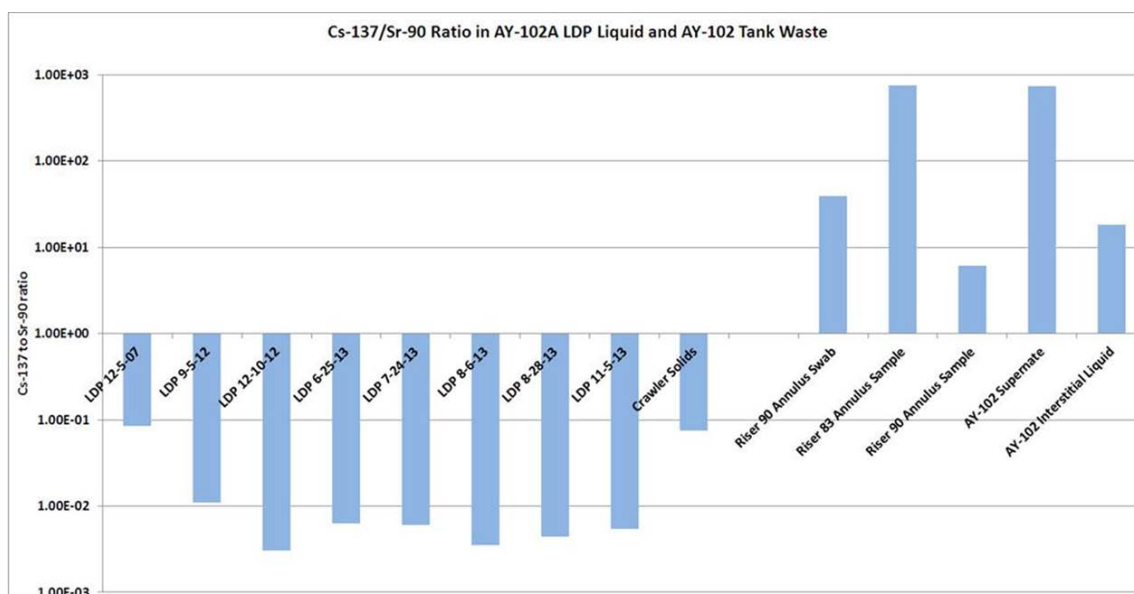
**Figure XII: Cs-137/Sr-90 ratio from Crawler Solids Compared to other AY-102 Samples**

The chemical characterization of the solids was primarily iron from rust in the debris with trace quantities of Cs-137 and Sr-90 (Table I).[6] The Cs-137 to Sr-90 ratio is similar to past LDP liquid samples and not similar to waste samples from the tank or the annulus (Figure XII). The overall concentration of Sr-90 is similar to annulus materials, but the more mobile component, Cs-137, is much lower than any of the tank or annulus materials.

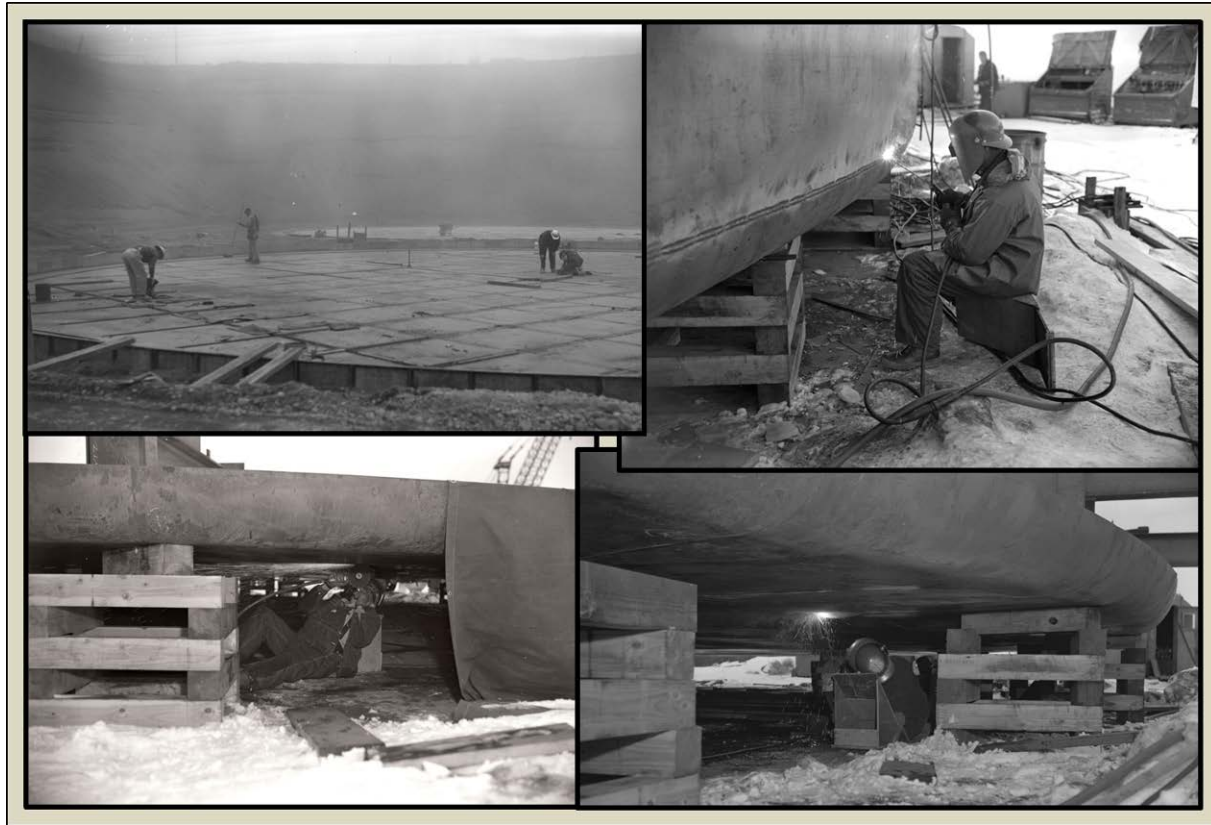
**FIGURE XIII: Debris Observed in Drain Line Piping Likely Attributed to Tank Construction Activities**

The drain line contained sufficient debris to hinder crawler movement. It was determined the debris is not Tank AY-102 waste. This quantity of material was unexpected. From a review of tank construction photographs, one potential debris source could be from construction activities (see Figure XIII). During much of the secondary tank liner bottom construction, the foundation slots and drain line piping facilitated collection of dust, concrete, wood, and welding material remnants which could have easily blown or fallen into the drain line.

Also, in some sections of the drain line, the debris appears to be corrosion products, but the drain line does not show signs of excessive degradation. None of the material seen had the appearance of tank waste (i.e., no greenish or yellowish deposits or dark fluids, dried salt deposits, or crystalline material).

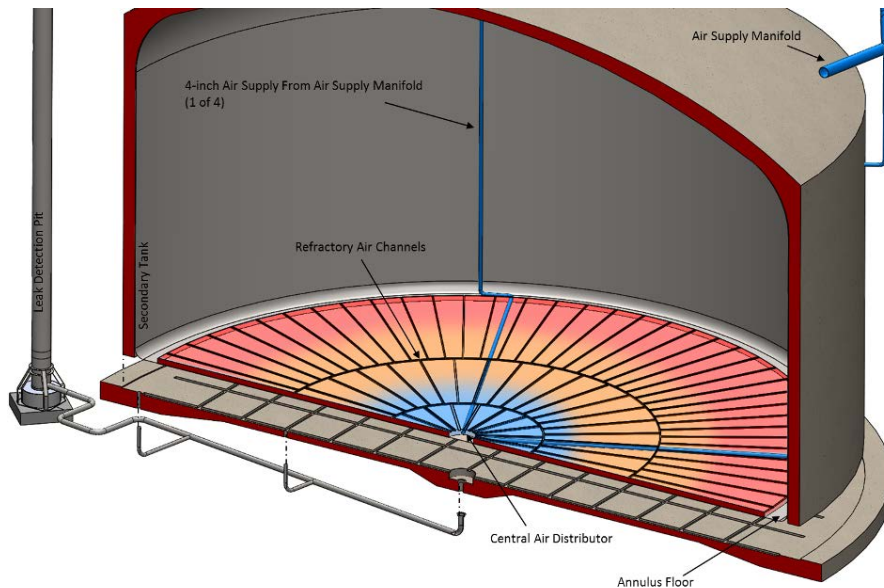
**FIGURE XIV: Tank Bottom Thermal Profile**

The annulus air is distributed radially through a central air distributor in the refractory layer, which leaves the refractory and concrete foundation cooler in the middle and warmer toward the outer radius (see Figure XIV), as indicated by embedded thermocouples. Thermal gradients as depicted in Figure XIV give a means for air flow to transport dissolved moisture (100% relative humidity air) which will condense in some portions of the system and subsequently evaporate in others depending on the local temperature driven by thermal gradients. Figure XV gives a theoretical thermal profile (cross section view) of the Tank AY-102 and surrounding soil which shows the air moisture transport mechanism is present within the system. Confirmation of these thermal gradients would require a second entry with the IHI robotic pipe crawler equipped with onboard temperature/pressure/humidity sensory devices.

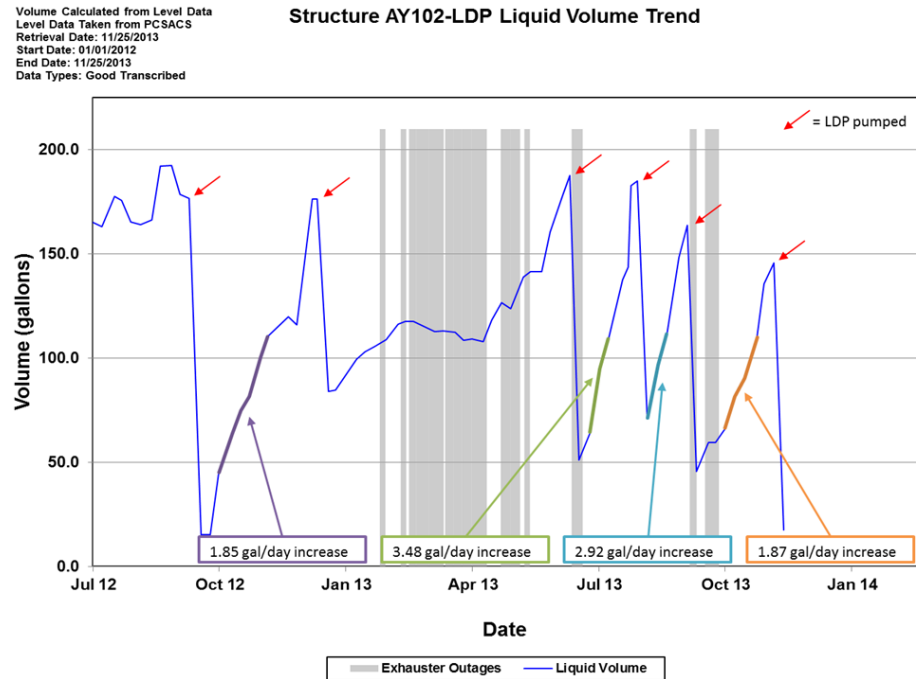
**FIGURE XVI: Tank AY-102 LDP Level Trend Showing In-leakage Correlation to Exhauster Outages**

The liquid level rise stops during the periods when the annulus exhaust is shut down and the vacuum is off (see Figure XVI). This correlation suggests that the vacuum drawing air into the drain system plays a role in the intrusion. The rate of intrusion does not appear to vary with seasonal temperature fluctuations.
