Overcoming Waste Removal Challenges at Savannah River Site: A Case Study of Tank 15 – 16198

Seth Campbell *, Toby Hess *, Scott Plummer *

* Savannah River Remediation, LLC

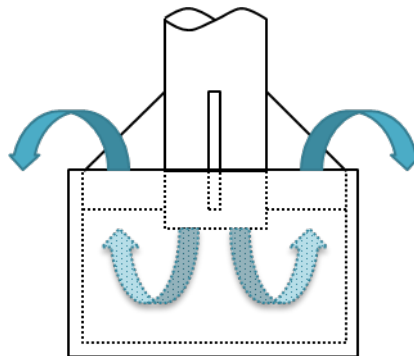
Figure 1. End of Liquid Addition Downcomer

The primary liquid source for rewetting the tank was the inhibited water system. Inhibited Water (IW) is well water with small concentrations of sodium hydroxide and sodium nitrite to prevent corrosion in carbon steel equipment and piping systems. The IW system is a pressurized system, so a downcomer was designed to convert the pressurized flow to gravity flow prior to impacting the solids. This was accomplished by attaching an open-topped container to the end of a downcomer (pipe inserted into the tank through a tank top riser), causing the liquid to fill the container and overflow. The overflowing liquid would then fall to the liquid surface only influenced by the force of gravity (see Figure 1). The height of the open container above the sludge was kept less than 0.46 m (18 in) for two reasons: 1) to limit the fall height to much less than assumed for the dropped object accident and 2) to maintain the impacted sludge surface area less than or equal to the area of the object assumed in the accident scenario.[5]

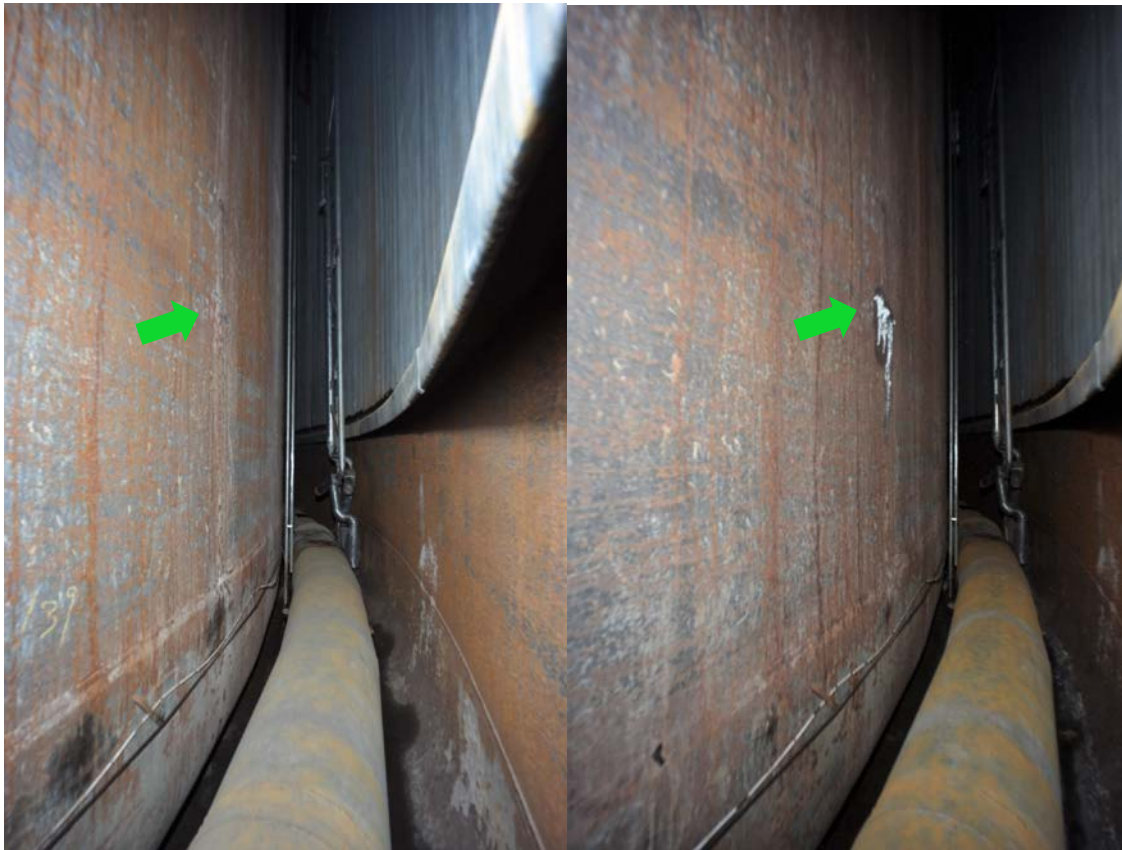
Upon completion of a readiness assessment, liquid additions commenced for rehydrating the sludge in Tank 15. The expected volume of liquid required to rewet the sludge was estimated to be between 326 m³ (86,000 gal) and 757 m³ (200,000 gal) with a best estimate of 568 m³ (150,000 gal). The wide estimate range was due to the sloped topography of the sludge and the unknown interstitial void space volume. The sludge was covered with liquid and the sludge was declared to be rewet after 697 m³ (184,000 gal) of liquid had been added to Tank 15.[10] Known leak sites reactivated near the end of the liquid additions; however, the leak rate was extremely small. Visual monitoring of the tank wall also identified four new leak sites as condensation wept through the flaws located above the liquid level.[11] Only one of the newly discovered leak sites is currently below the liquid level. As expected, however, continued use of annulus ventilation resulted in sealing a majority of the leak sites. Figure 2 shows a known leak site (a) before liquid additions, then (b) after a leak formed and plugged with salt. The leak rate has slowed to the point that the seepage evaporates before reaching the annulus pan for those sites that have not been completely sealed. The CTS was never deployed.

Figure 2. Known Leak Site Before and After Liquid Additions
