## **Freestanding Liquids in a Resin Disposal Container – How Unidentified Legacy Issues and Decisions Can Affect Current Radwaste Processing Activities-16605**

Mike Nolan

Energy Northwest Columbia Generating Station, PO Box 968, Richland, WA 99354

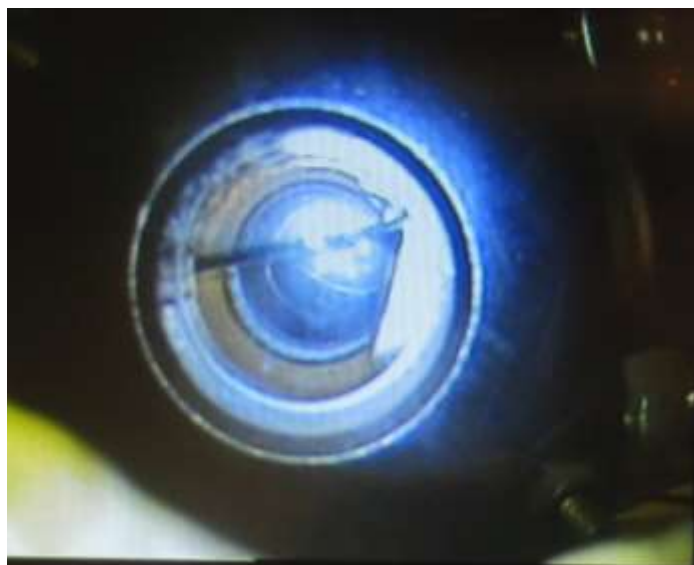
Fig. 1. Dewatering System Sight Glass

Leading up freestanding liquid issue, in 2010 the plant's main condenser was replaced. Subsequent to the replacement and plant operation, higher concentrations of iron were measured in the main condenser hotwell and condensate filter demineralizer resin waste disposal liners (CFD liners). This was identified by changes in color (brown, orange, red, black, depending on the oxidation state for the iron), as viewed in the dewatering system sight glass on the dewatering skid. Additionally, depending on particle sizes, the iron had a tendency to pass through dewatering filters and become visible in the sight glass.

When issues started to become more prevalent in late 2011 and early 2012, a radioactive waste and transportation specialist misdiagnosed discolored water in the resin drying system sight glass as a failed filter lateral (e.g., broken piping, failed filters, etc.) and not that iron was present. At that time, the plant dewatering system operator was directed to stop using the selected set of dewatering filter laterals, which were misdiagnosed as damaged. This decision had an adverse effect on resin drying time, as well as the ability to assure the processed container met the disposal facility's waste acceptance criteria.

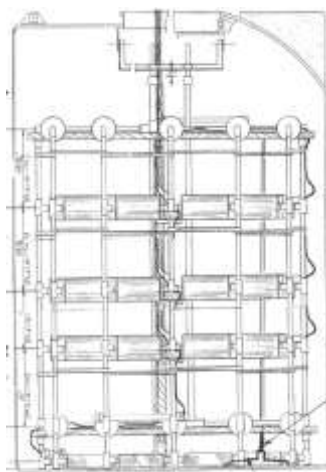
Fig. 2. Cut-Away of Resin Liner used for CFD Powder

On 05/29/14, another CR was written which once again misdiagnosed the presence of iron vs. a physical failure of the CFD liner internals. As a result of this CR, the disposal container supplier was asked to evaluate their material condition and make

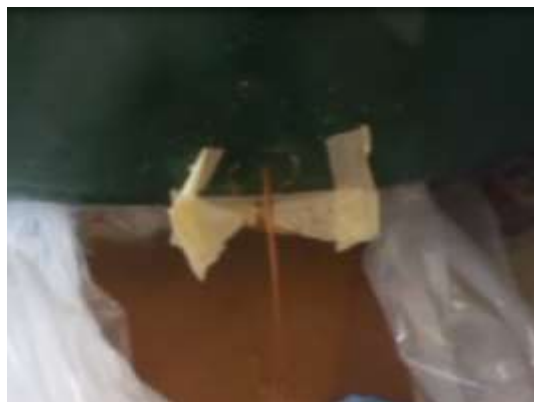
Fig. 3. Liner 14-033-L Freestanding Liquid Test

Upon receipt, the State Compliance Inspector selected one container, at random, for inspection. 14-032 was selected. A hole was drilled in the side of the container near the base and the presence of liquid was found.

As a consequence of the freestanding liquid exceeding waste acceptance criteria, the burial site use permit was suspended, pending an investigation.

Authorization was obtained from the disposal facility and state regulator to have all containers on the shipment returned along with the commitment to verify compliance prior to return for disposal

At a minimum, a dewatering verification filter would be driven to the bottom of each container and suction applied to verify no liquids were present prior to returning the containers to the disposal facility.

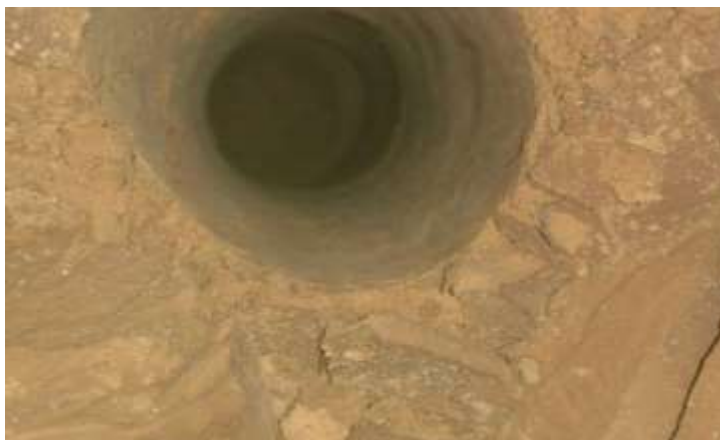
Fig. 4. Dewatered and Dried Condensate Filter Demineralizer Resin

In the figure, above, a pipe was pushed to the bottom of the liner through the Powdex resin and the dewatering filter was then placed in the hole to the bottom of liner 14-048-L (close-up). It was easy to see that no liquid was present in the bottom of the hole. Verification filter placed in bottom and pumped to verify no freestanding liquid is present.

As an added measure of insurance, a dewatering verification filter was added to the bottom of each disposal container. Upon completion of the resin drying process, a diaphragm pump was hooked up to the dewatering verification filter, directed to a container, and a suction taken for a minimum of five minutes. If no liquid was viewed in the container, the disposal container was deemed to be dry. If liquid was viewed, the container was required to sit for a minimum of one hour before the dewatering verification was again performed. This sequence was repeated until no liquid was observed, which assured the liner met burial site waste acceptance criteria. This dewatering verification was completed for all containers on Shipment 14-32, which included container 14-033-L. An example of the results is depicted below:

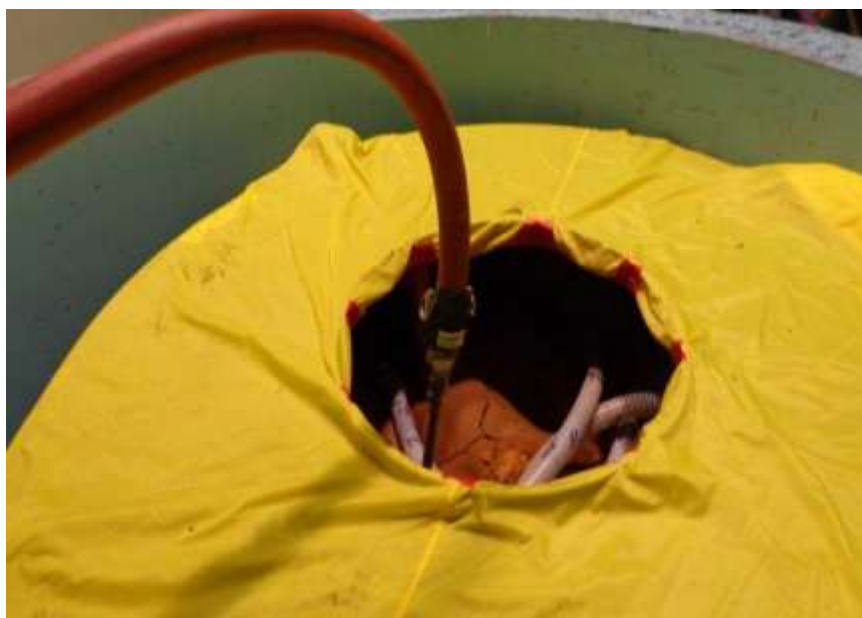
Fig. 5. Dewatering Verification Filter, inserted into a filled and dried CFD resin liner.

This liner was already processed (full). Note the cracking of the resin and the deep, orange rust color.
