Failure Evaluation of Savannah River Site High-Level Waste Evaporator 242-25H – Part II – 17353

Charles Keilers *, Bruce Wiersma **, John Schwenker *, Thomas Yamamoto *

* Savannah River Remediation, LLC

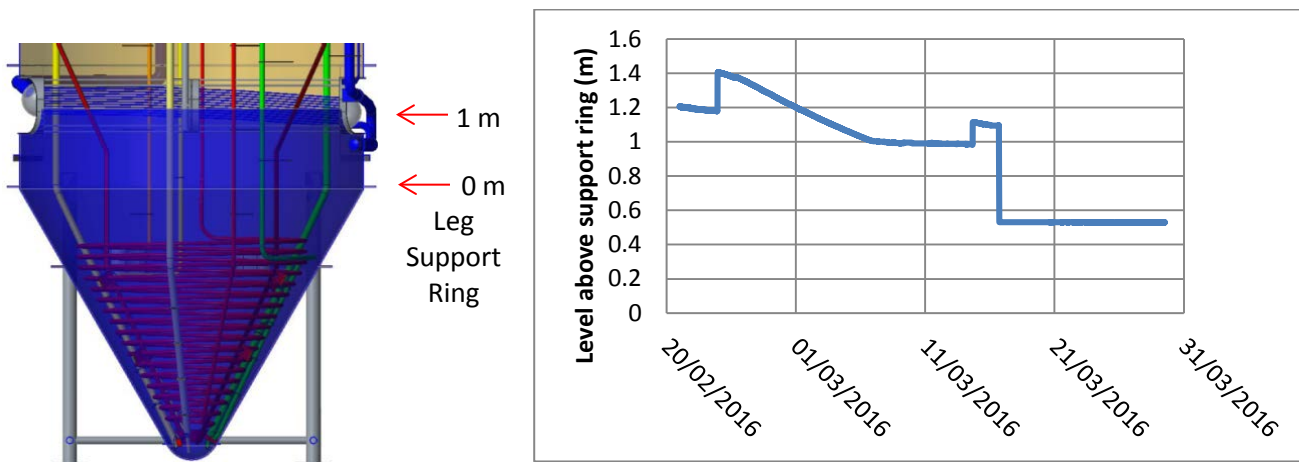
Fig.2. Leak rate data (evaporator figure is from [3]). Level dimensions are relative to the support ring where the legs are attached and where the shell transitions from a cone below to a cylinder above (i.e., 0 m).

In early March 2016, to help find the leak-site, the leak was permitted to flow unimpeded until level stabilized, which occurred at about mid-elevation of the tube-bundle, 1.0 m above the support ring for the leg attachments (Figure 2). Level was raised and allowed again to fall unimpeded, this time falling more slowly and stabilizing at 1.1 m above the support ring, still within the height of the tube-bundle. Level was then lowered below the tube-sheets but above the support ring; it remained steady for the next two weeks, supporting a scenario that the leak-site was within the tube-bundle elevation.

The leak-rate data during this period was analyzed and is consistent with a crack about 25 mm long by 0.5 mm wide at the tube bundle elevation.¹ An attempt to re-activate the leak in early May 2016 was unsuccessful, indicating that the leak has somehow sealed.

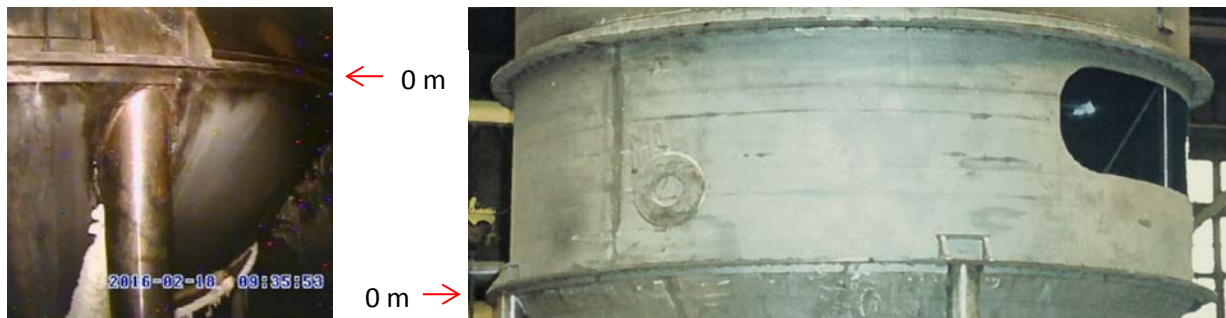
Fig.3. Figure on the left shows visible salt deposits, emanating from where the legs penetrate the vessel insulation. Salt deposits are not visible on or above the support ring (0 m level). Figure on right shows the leg support ring during fabrication before installing vessel interior components, shipping to the site, and installing insulation.

After the leak's discovery, remote inspections of the vessel exterior showed salt deposits where the leg supports penetrate the vessel's insulation and insulation sheathing (Figure 3). Salt was not observed on the upper cylindrical portion of the vessel, supporting that the leak-site is in the cone below the support ring and not at the tube bundle elevation.

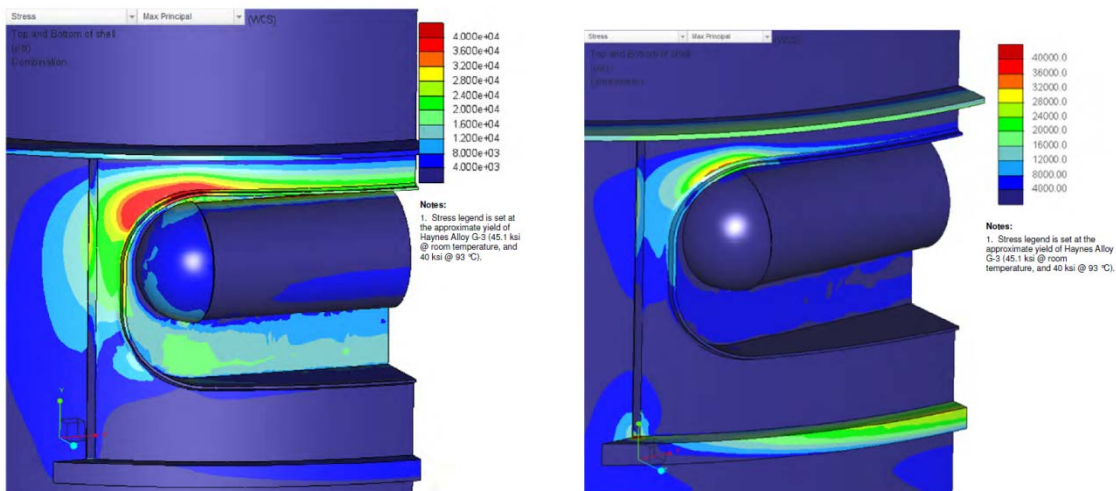
- The highest calculated stresses are at the interfaces of the shell, the tube-sheets, and the sleeves for both the steam and the condensate chests (Figures 4 and 5). In these locations, calculated stresses during descaling operations exceeded yield, driven by a 135°C temperature gradient between the steam and the shell over a short distance. The temperature gradient is lower (40°C) during normal operations, leading to calculated stresses of about half of yield.

- For these stresses, calculated fatigue life ranged from about 300 to 4,000 cycles for welds and 900 to 14,000 cycles for base metal. For comparison, the 25H Evaporator has experienced about 500 to 700 thermal cycles, assuming about 20 descaling operations and 10 to 20 normal thermal transients per year.

Fig 4. Maximum principal stresses for descaling and normal operations [3].

Given these results, thermally induced fatigue of the shell where it joins the tube-sheets is possibly but not conclusively the cause for the leak. Fatigue could be enhanced by environmental factors (e.g., mercury), an initial defect, or both. However, a fatigue failure at this location is contradicted by the lack of visible waste externally above the cone.

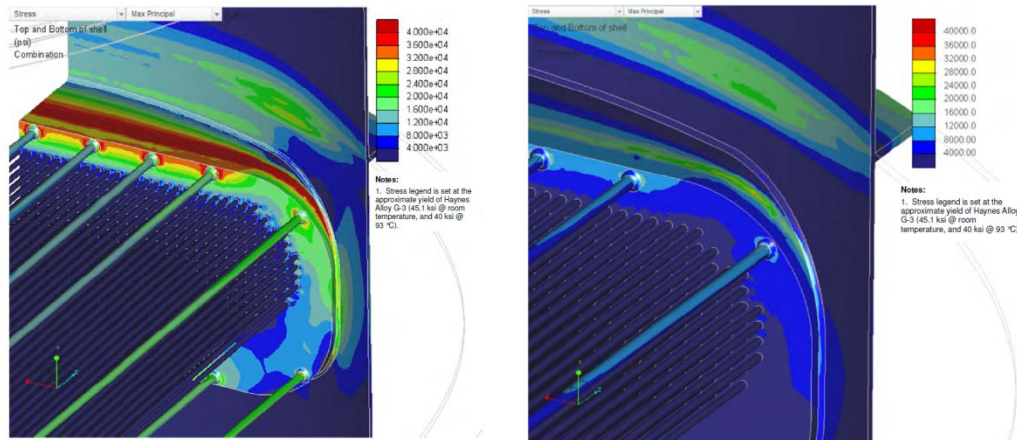
Fig 5. Maximum principal stresses for descaling and normal operations [3].

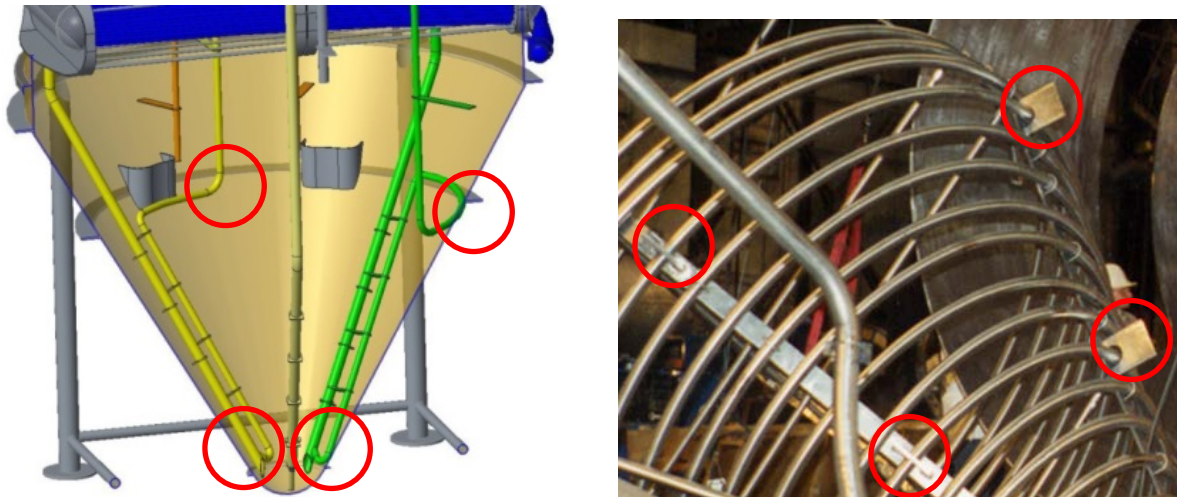
Fig. 6. Potential rubbing locations in the vessel cone: (1) possible steam line interferences [3]; (2) warming coil support plates.

For the 25H Evaporator, two possible sources of metal-to-metal contact and relative motion in the cone are shown in Figure 6:

- There are two steam lines that run to the bottom of the vessel. These create a vacuum in the lift lines, causing the motive force to remove concentrated waste from the vessel. Drawing dimensions indicate the potential for these steam lines to interfere with the vessel at four locations [3]. The steam lines would fit in the vessel, provided there is a small twist of the steam lines by a fraction of a degree. The resulting torsion could cause a high contact force between the steam lines and the vessel. Daily repetitive motions, perhaps caused by daily temperature swings or random building vibrations could cause relative motion.

- The warming coil frame has eight guide plates that may touch the vessel with a low contact force. The guides prevent excessive lateral motion in the event of an earthquake. The guide plates were not needed in earlier SRS evaporators because they used smaller warming coils. The warming coil has low natural frequencies and is susceptible to amplified motion, possibly caused by random vibrations or cross flows.

The parametric study found, for the warming coil guides, the required contact force to fail the vessel would be low, ranging from about 1 N at 10 Hz under abrasion to 4 N at 200 Hz under adhesion with good lubrication. It is possible that cross flow or other disturbances could cause the warming coil to vibrate in this frequency range. For the steam lines, assuming a high contact force and low contact area indicated that a repetitive motion every twenty minutes to thirty hours would be sufficient to wear through the vessel.

Overall, a wear failure in the cone seems possible and intuitively more likely than erosion; however, the sources of motion are speculative, making wear failure not conclusively the cause.
