Failure Evaluation of Savannah River Site High-Level Waste Evaporator 242-25H – Part I 17366

Author: T. Yamamoto
Savannah River Remediation LLC

A slow leak was discovered in the Savannah River Site (SRS) 242-25H Evaporator (25H) in February 2016. Part I discusses the physical investigation to determine the nature and location of the leak site. Part II separately discusses the analytical work to determine the most plausible failure modes.

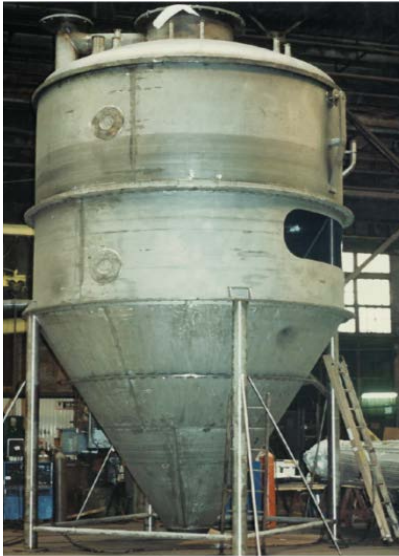
Fig. 3. Construction of 25H Evaporator Vessel

ring is seal welded on the bottom side and stitch welded on the top, Figure 3, separating the cone from the vertical section of the evaporator.

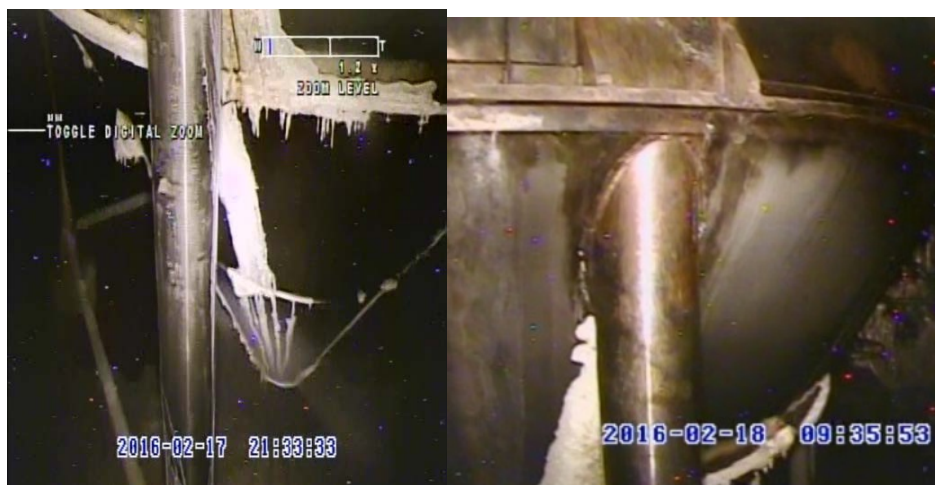
The examination of the exterior walls showed liquid and salt waste coming out of the north-west and north-east leg openings of the evaporator vessel. This location is just below the support ring (see Figure 4.) that segregates the cone from the vertical section of the evaporator. The exterior exam did not indicate any location where the lagging allowed a path to go around the stiffening band. The leak location contradicts where the indicated level stopped during the previous leak test.

Fig. 4. Figure on the left shows visible salt deposits on the lagging of the evaporator vessel. Figure on the right shows one of the location where the leak is coming out of the vessel lagging where the leg penetrates thru.

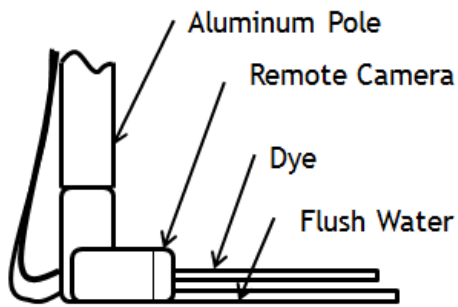
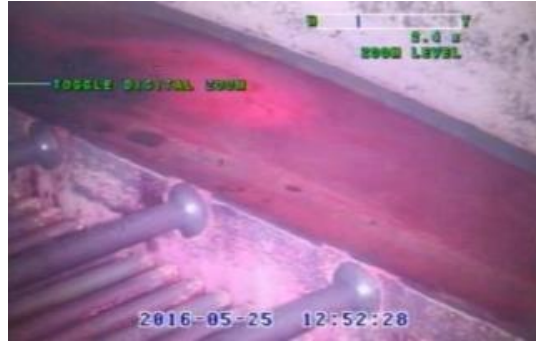
After the internal examination was completed, the team developed a water washable remote dye penetrant system. The unit was comprised of a water lance for flushing, and a dye lance for application attached on a remote camera with a pan and tilt function to direct the flow (See Figure 5.). The remote dye penetrant tool was lowered through the S6 port to examine the areas south of the tube bundle. A separate tool and camera were lowered through the Y3 and Y4 ports to examine the north side of the tube bundle with the camera utilizing the opposite port for inspection. The dye and water were sprayed with peristaltic pumps that would be turned on and off to initiate spraying. It was applied to the surface at an area of interest and allowed to sit for at least 20 minutes then reapplied as needed to keep the surface wet. After the 20 minute dwell time, the area of interest was flushed and the camera was focused on the area of interest looking for small deformations where the dye may weep out.

Fig. 5. Figure on the left is the dye penetrant application unit with a dye and flush lance attached to a remote camera. Figure on the right is the top of the steam tube bundle with dye penetrant on the surface before flushing.

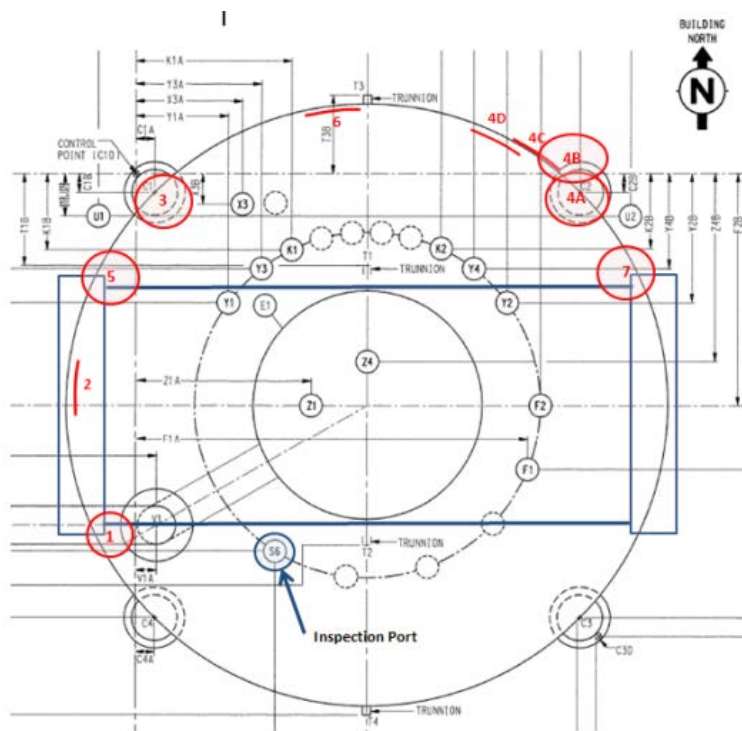
Fig. 6. Dye Penetrant Locations sprayed.

The majority of the north side of the evaporator from the middle of the evaporator down was sprayed with dye and washed. Additional enhanced visual inspections with dye penetrant were performed on the tube bundle looking where the tube sheet was welded to the vessel. There were no specific locations that indicated a leak from the enhanced visual inspection with the dye penetrant. Figure 6 shows all of the areas of interest where dye was applied and the chart gives a description of the individual locations.

1. Tube Bundle Inlet
2. Seam below the weld line where the body is welded to the cone
3. Northwest corner, Leg connection
4. Northeast corner
 - A. Leg connection
 - B. Rough patch above leg connection
 - C. Weld line near leg connection
 - D. Seam just below the weld line where the body is welded to the cone

5. Tube Bundle Inlet
6. Steam Lift Supports
7. Tube Bundle Outlet

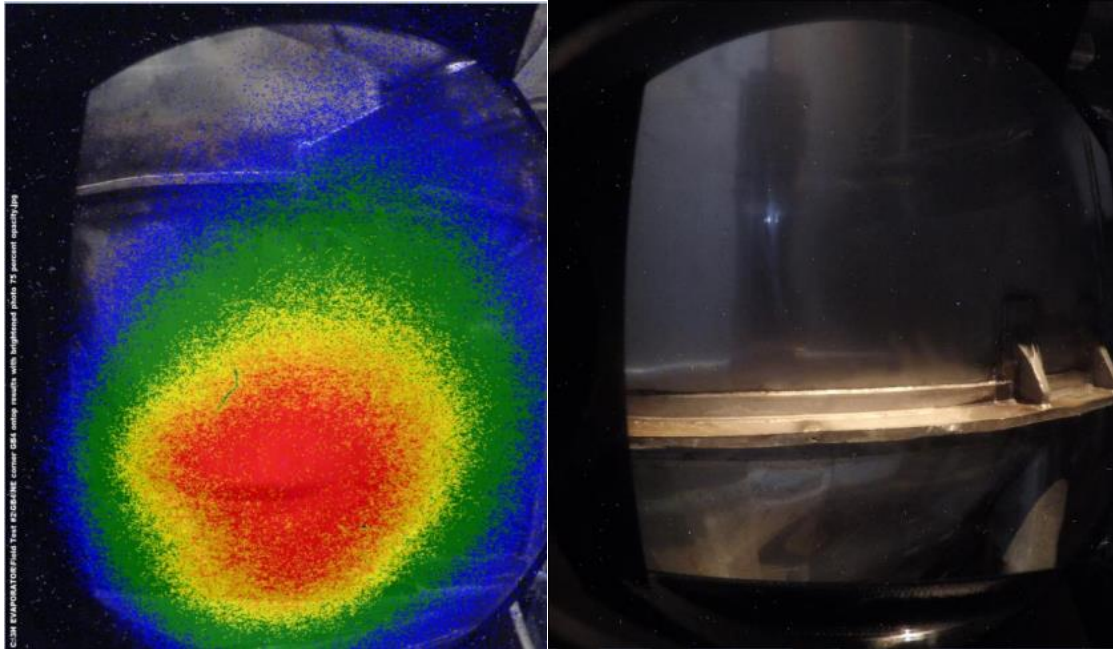
The results from the Grey QB indicated that there was a very intense concentration of radioactive material in the lower section of the evaporator pot, and background

radiation levels in the upper portion (See Fig. 8.). If a leak were to occur in the upper section of the evaporator near the tube bundle, one would anticipate an area with higher radiation levels that would indicate more intensely near the stiffening band that segregates the upper vertical section from the lower coned section. However, that was not observed in the image.

Fig. 8. Figure on the left shows the activity spot in the lower cone section of the evaporator. Figure on the right shows an adjusted image that is scaled to the hot spot on the left image, which resulted in intensity level of the image on the right to have a background value with no values reaching the colored portion of the image.

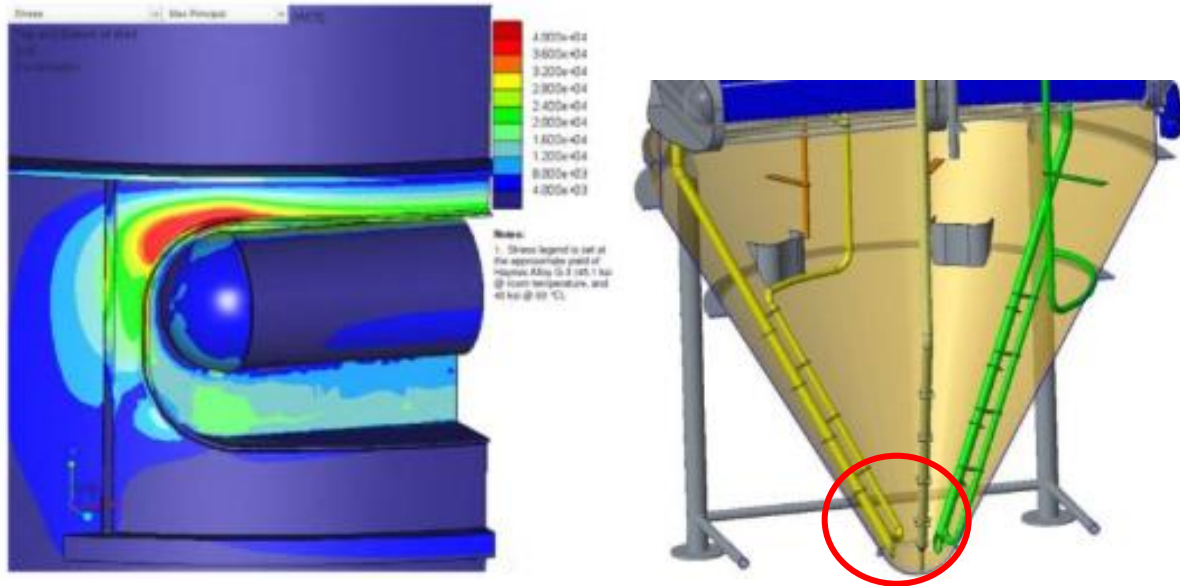
In parallel with the physical investigation, another team was tasked with analyzing the vessel to determine any potential locations where the leak could occur. A Finite Element Analysis (FEA) identified areas with large temperature gradients over small distances where the shell joins the tubesheets and the evaporator vessel (see Figure 9). The calculated stresses exceed yield during tube-bundle descaling operations. Additionally an investigation considered the lower section of the evaporator pot. The steam lift lines and the warming coil guide plates could rub against the vessel and wear a hole in the vessel from rubbing (see Figure 9) [3]. Part II will provide more detail of the analysis.

Fig. 9. Figure on the left indicates in red the high stress point where the tight radius of the tube sheet is welded to the evaporator vessel. Figure on the left shows where the lift has the opportunity, when thermally growing, to interfere with the body of the vessel and could cause wearing and eventually a leak. Developed by AECOM.

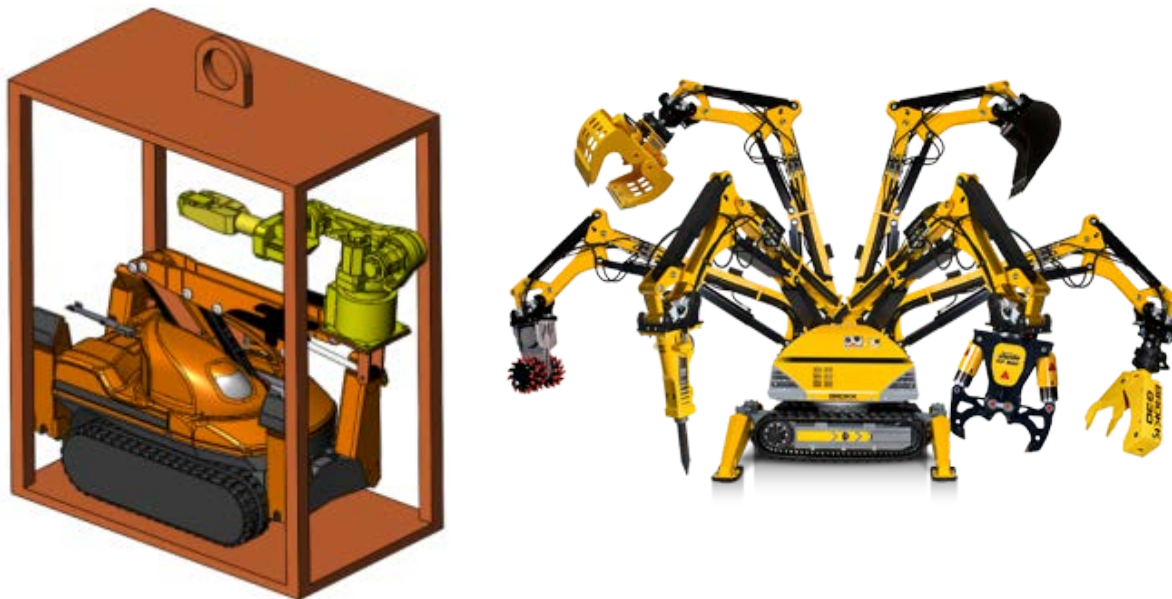
Fig. 10. Figure on the left shows a model of the BROKK 100 with the KUKA arm attached to the robot on the lifting mechanism that will lower and raise the unit out of the cell. Figure on the right shows a typical BROKK 100 with some of the other attachments that are readily available for the BROKK if needed.

Development of remote equipment to cut the lagging and remove the insulation from the lower section of the evaporator is in progress. A BROKK 100 (remote excavator) with a KUKA machine assembly robot attached to a platform on the end of the BROKK will be used (see Figure 10). The unit will be lowered into the cell via a crane platform with the BROKK positioning the arm close enough to the evaporator to remove the lagging and insulation. It is anticipated that the KUKA will be fitted with a plasma torch to cut pieces of the lagging. Once all or sections of the lagging are cut and removed from the cell. The robot will then be raised out of the cell and a separate end effector will be placed on the KUKA with a tool changer and multiple tools to remove the bulk of the insulation.
