## **Achieving Leak Tightness in New Savannah River Site Saltstone Disposal Units – 17454**

Charles Keilers, Savannah River Remediation, LLC

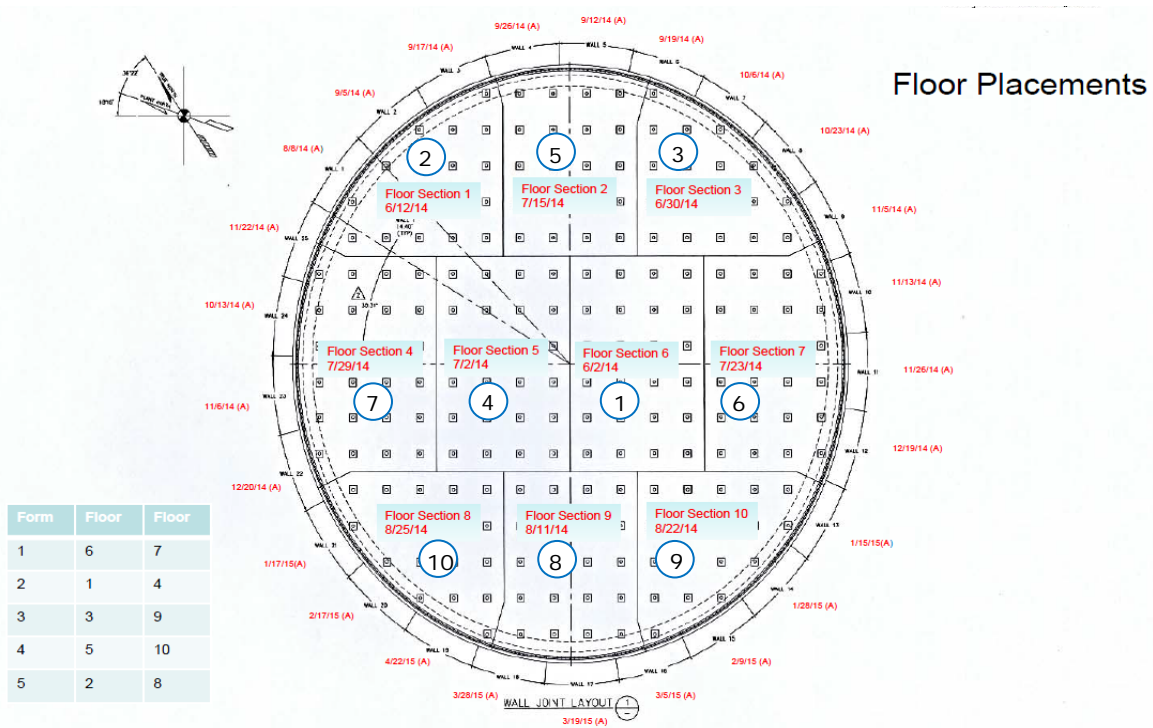
- Construction joints should be avoided or, at least, minimized for a water-tight structure. Because of its large size, SDU-6's base slab was placed in ten sections, as shown in Figure 4, with water-stops across the construction joints. The "checkerboard" installation sequence created conditions conducive to shrinkage cracking due to restrained edges at construction joints. The thicker wall footing may also have restrained concrete shrinkage, causing cracking near the wall.

Fig 4. SDU-6 floor sections, showing the “checkerboard” placement order that likely restrained shrinkage and enabled concrete shrinkage cracking.

The SDU-6 experiences identified improvements that can be made in design and construction of these large environmental engineering containment structures. The most likely cause of the base slab cracking is restrained drying shrinkage due to the checkerboard placement shown in Figure 4, possibly exacerbated by the concrete mix design. Even so, standard concrete design practices will lead to distributed tight cracks that still may not achieve the zero leakage criteria specified for SDU-6. The SDU-6 project baseline included an elastomer coating or liner to protect the concrete from the high-pH, high-sulfate Saltstone solutions. Because of a potential opportunity to eliminate the coating, it was not installed prior to the hydrostatic test. However, sufficient data relative to concrete chemical attack was not yet available to justify eliminating the coating. Following discovery of the leak during the hydrotest, an adhered elastomeric liner system was chosen, not only for chemical resistance, but also for higher assurance of bridging floor cracks and preventing leakage. In late 2016, the liner system was installed, and a second hydrostatic test demonstrated that SDU-6 meets the zero leakage criteria.

As shown in Figure 4, the base slab was cast in 10 placements with water-stops between each section at the construction joints. The base slab is 0.305 m (12 inches) thick and has steel reinforcement bars running in each direction near the top and bottom surfaces for crack control (i.e., #5 @ 6 inches, top, and #6 @ 12 inches bottom, each way; minimum reinforcement ratio of 0.6 percent). At the outer wall, the foundation slab thickness increases to 0.610 m (24 inches), primarily to provide space for the wall reinforcement system. For external surfaces, concrete crack control followed ACI 350 for normal environmental exposure [3]. Internally, reinforcing at the top surface of the base slab is designed for severe environmental exposure (e.g., sulfate solutions exceeding 10,000 ppm).

- Increase batch plant capacity, allowing placement of larger floor segments.
- Develop a concrete placement strategy and plan that addresses key attributes, including minimizing construction joints and restrained edges.
- Consider thermal protection to achieve gradual cooling during curing and minimize the potential for cracking.
- Better control moisture and curing practices to avoid rapid surface drying.
- Reevaluate the reinforcement detailing, considering anticipated construction loads, thermal and temperature loads, and construction sequence.
- Determine by test the actual shrinkage characteristics and the time-temperature and strength-gain characteristics of the mix design and reevaluate the mix design.

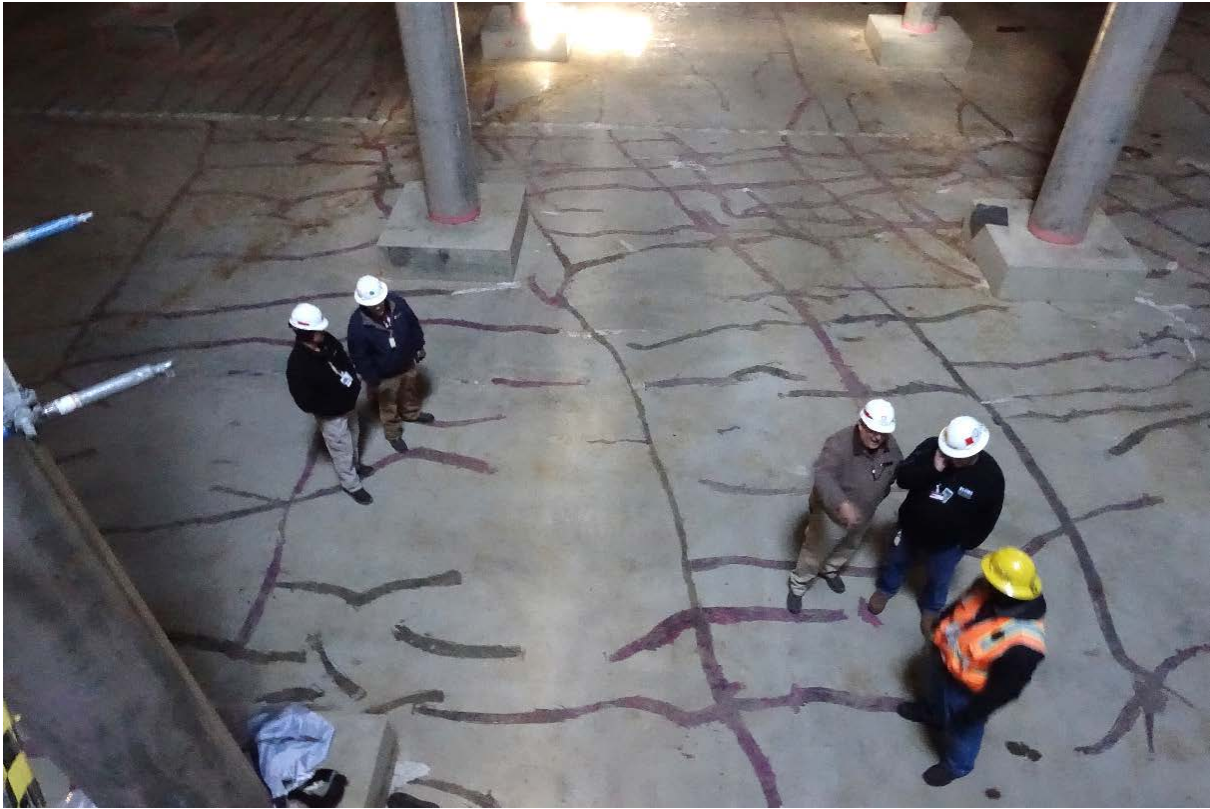
- The SDU-6 base slab has extensive tight visible cracks with widths of 0.07 to 0.5 mm (3 to 20 mils). Visible surface cracks were repaired with a flowable, gravity-fed epoxy, as shown in Figure 5. Early on, several cracks were ground down, and the cracking disappeared within 6 to 10 mm depth. However, concrete core samples taken in January 2016 in areas susceptible to shrinkage found cracks extending through the slab thickness [7].

Fig. 5. Slab cracking, highlighted in purple from the dye used in the 2015 hydrostatic test adhering to epoxy that was gravity-fed into cracks (photograph from [7]).

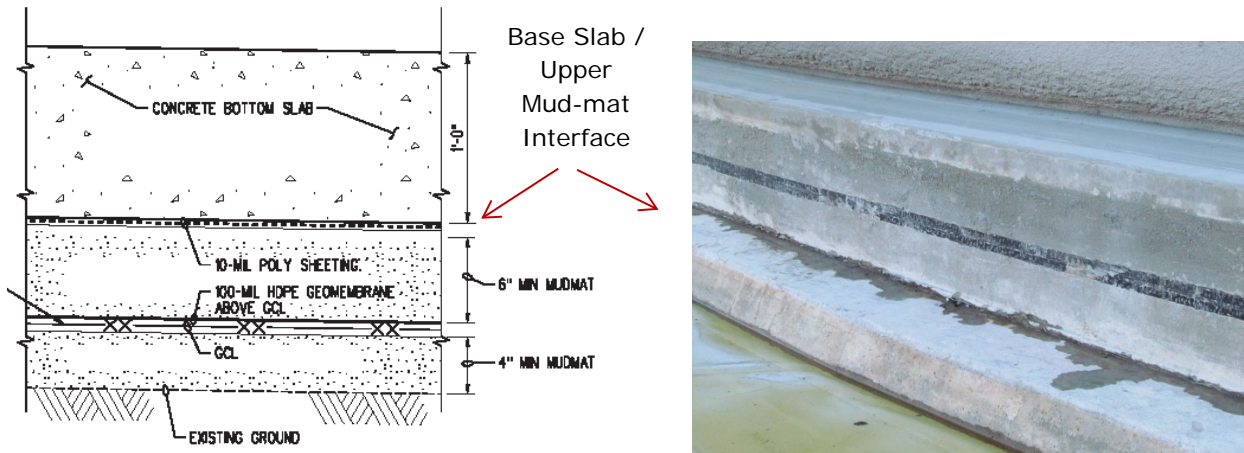
- SDU-6 is required to pass a hydrostatic test with a dye tracer and with zero apparent leakage. When tested in late 2015, without a liner or coating, water flow and dye were observed between the upper and lower basemats and the slabs. Estimated leak rate is less than 4 L/min (1 gpm) (Figure 6). There was no measurable change in water level over the three days of the test.

Fig. 6. Representative leakage between the SDU-6 base slab and upper mud mat during the 2015 hydrostatic test. There was no dampness on the walls and no measurable drop in level over 72 hours, but there was visible dye and flow at the basemat. Estimated leak rate was less than 4 liters per minute with tank at capacity.

Figure 6 shows the base slab and the upper and lower mud mats, which are separated by a polyethylene sheet and geomembrane, respectively.

In late 2015, SDU-6 was hydrostatically tested without a coating or liner. Measured drop in level over 72 hours was less than the 1.6 mm (1/16 inch) detection threshold and less than the 3.2 mm acceptance criteria in Reference [4]. The walls were dry. However, water flow and dye were observed at the base slab and mud mats at numerous locations (Figure 6). SDU 6 was suspected to be leaking through either cracks in the base slab or via pathways around the construction joint water-stops. Visible floor cracks had been repaired with flowable epoxy before testing. After leak testing, additional cracks were identified in the base slab; however, these appear most likely due to pre-existing but undiscovered cracks that became visible after wetting with water with dye.

Since there was no measurable change in level, the leak rate was estimated as a maximum of 4 L/min (1 gpm). An adhered elastomer liner system was selected and installed to chemically protect the concrete and achieve leak tightness.
