## **Comparison of Exhibited Wear in Tefzel®, Kynar®, and UHMWPE Valve Seats Exposed to Cyclic Operations with Abrasive Slurry - 17519**

Carl Enderlin\*, Harold E. Adkins Jr\*, Jason Engeman\*\*

\* Pacific Northwest National Laboratory

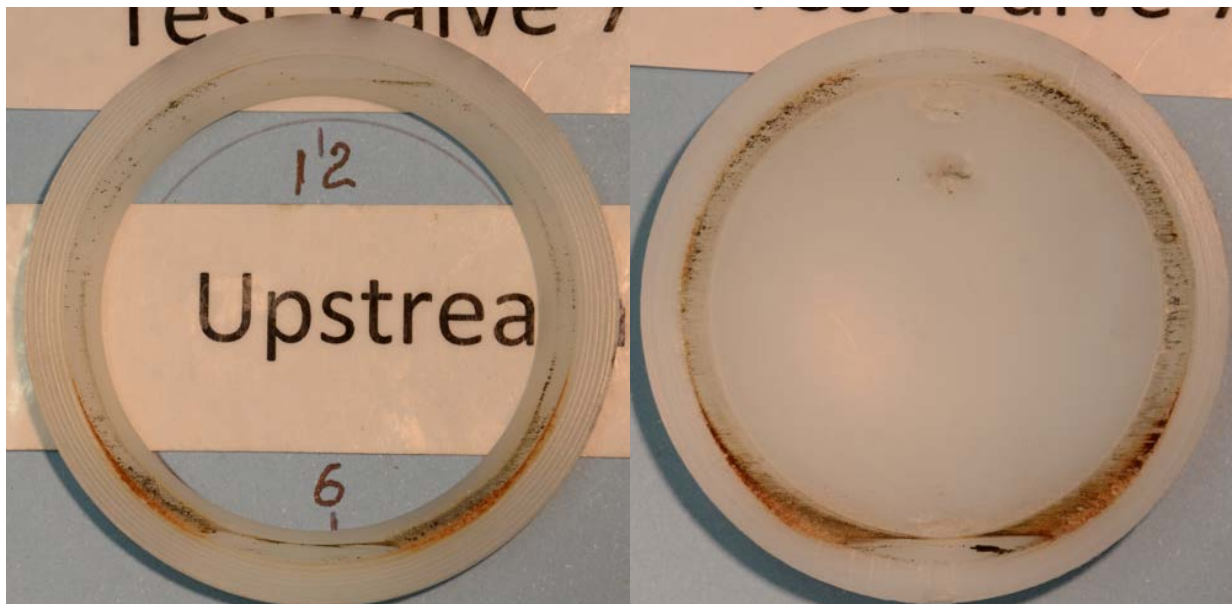
The UHMWPE seat faces (i.e., annular surface) exhibited visible and detectable scoring, but no evidence of material loss was observed; no removed or partially attached pieces of seat material were noted. Based on the observations, the scratches were possibly the result of plastic deformation of the seat face. The wear observed in the seats of the three-way, UHMWPE-seated valve was greater than

anything observed for the seats of the three, two-way, UHMWPE-seated valves. Refer to Figs. 4 and 5, respectively. The degree of wear observed in the UHMWPE seats was significantly less than that observed in the Kynar® and Tefzel® seats.

The blank, drain, and blind UHMWPE seats of the three-way Flow-Tek drain valve showed wear around the entire circumference based on the appearance of embedded material and apparent discoloration. In contrast, based on appearance, the upstream port seat of the three-way drain valve only exhibited wear around the lower third of the sealing surface (Fig. 4). The degree of roughness corresponded to the regions with the most embedded material and greatest amount of discoloration. The blank and blind ports had significantly smoother surfaces at the top and bottom of the seat faces that corresponded to regions with minimal embedded particulate. A similar surface existed at the bottom of the seats for the drain and upstream ports.

Based on appearance and texture, the lower portions of the TV7 seats experienced greater wear than the upper regions, with the upstream seat experiencing the least amount of detectable wear. The surface condition of the center region of the blind seat appeared unchanged.

**Fig. 4.** Left: UHMWPE seat from upstream port of three-way, Flow-Tek, 2-inch drain valve (TV7) after being rinsed. Right: UHMWPE blind seat for three-way, Flow-Tek, 2-inch drain valve (TV7) after being rinsed. (Note: Blemish in upper portion of center region is a hole made to extract blind seat from valve flange stem.)

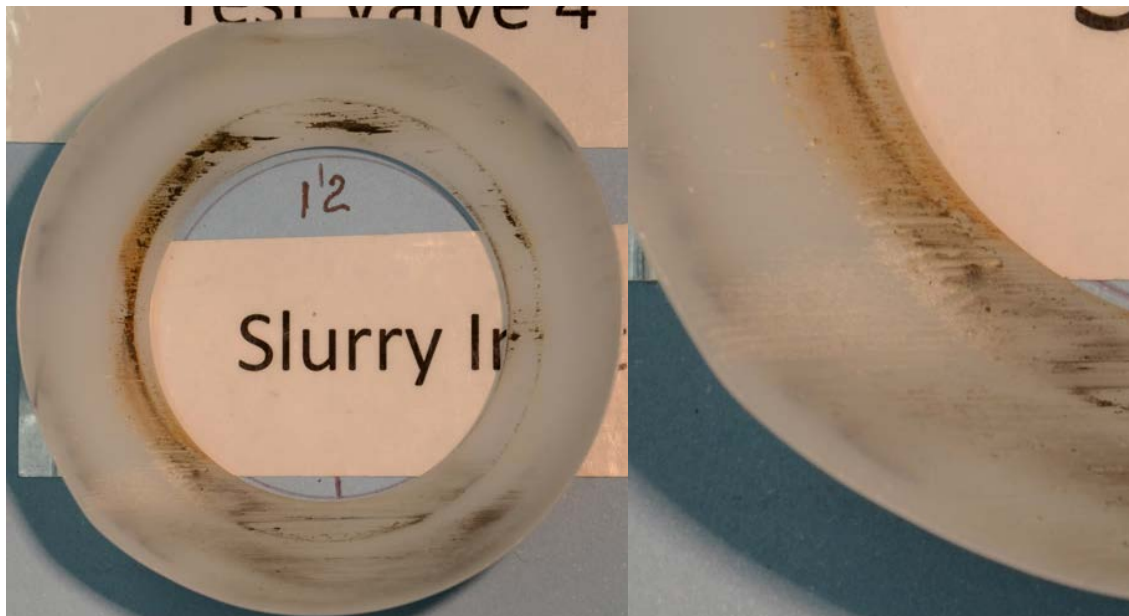
For the two-way Flow-Tek valves with UHMWPE seats, wear was predominantly greater on the lower half of the seats due to the influence of gravity. However, based on surface texture, the wear was not symmetrical around the circumference of the seats or between opposite sides. The lowest portion of the seats had a very smooth region that contained minimal embedded particulate (lighter dimple area seen in Figs. 4 and 5.). The seat faces of the two-way valves each had one side

that felt smoother than the other. The rougher side of each seat corresponded to the side over which the ball penetration passed during valve rotation, exposing that side of the seat to less contact with the ball's outer surface.

**Fig. 5.** Upstream UHMWPE cavity filler/seat from two-way Flow-Tek Slurry valve (TV4) after being rinsed. Seat (i.e., sealing surface) consists of annular inner region of component. Image on right is of lower left section of seat.

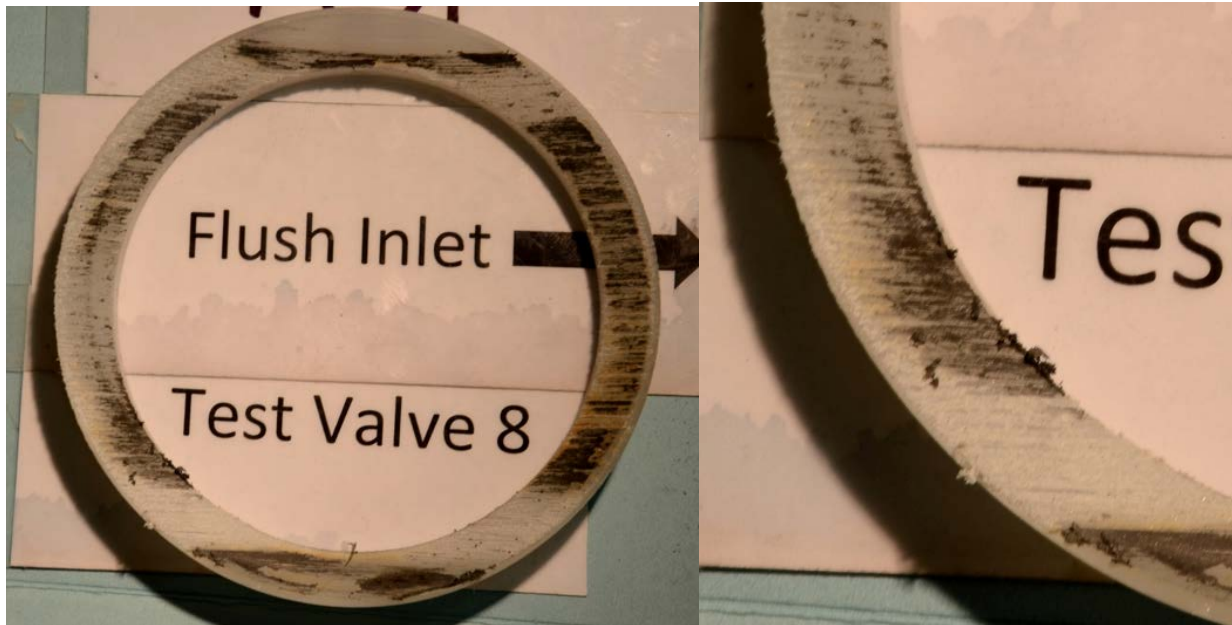
The seats of the Kynar®-seated, three-way valves contained significant scratches/grooves in the direction of the ball rotation, and small deposits of the Kynar® flakes were observed within the valve internals. The scratches also contained small flakes of Kynar® material, giving the appearance that the scratches had been slowly formed by continual removal of small pieces of material. Refer to Fig. 6. The rough appearance of the wear marks and the small flakes of material gave the impression that material removal occurs via localized chipping away of the seat material as in a brittle fashion, as opposed to a ripping away of longer threads of material.

The scoring of the seats generated relatively deep scratches that created a very rough surface. Wear on seat faces appeared symmetrical and similar at each valve port, with symmetrical wear marks from ball rotation on each side of the seat faces. No evidence of the relief groove remained in the face of the seats.

The top and bottom regions of the seats were worn smoother than the sides of the seats. The black marks on the faces of the seats are embedded particulate. While

the Kynar® seats experienced the embedding of particles, based on relative comparison of surface texture, the roughness resulting from scoring was greater than that resulting from particle embedment. The interior, central region (i.e., the region corresponding to valve/ball port) of the blind flange had no visual or tactile indications of wear. Refer to Fig. 7.

**Fig. 6.** Flush-port Kynar® seat from PBM, 3-inch slurry valve (TV8) after being rinsed. Image on right is of lower left section of seat.

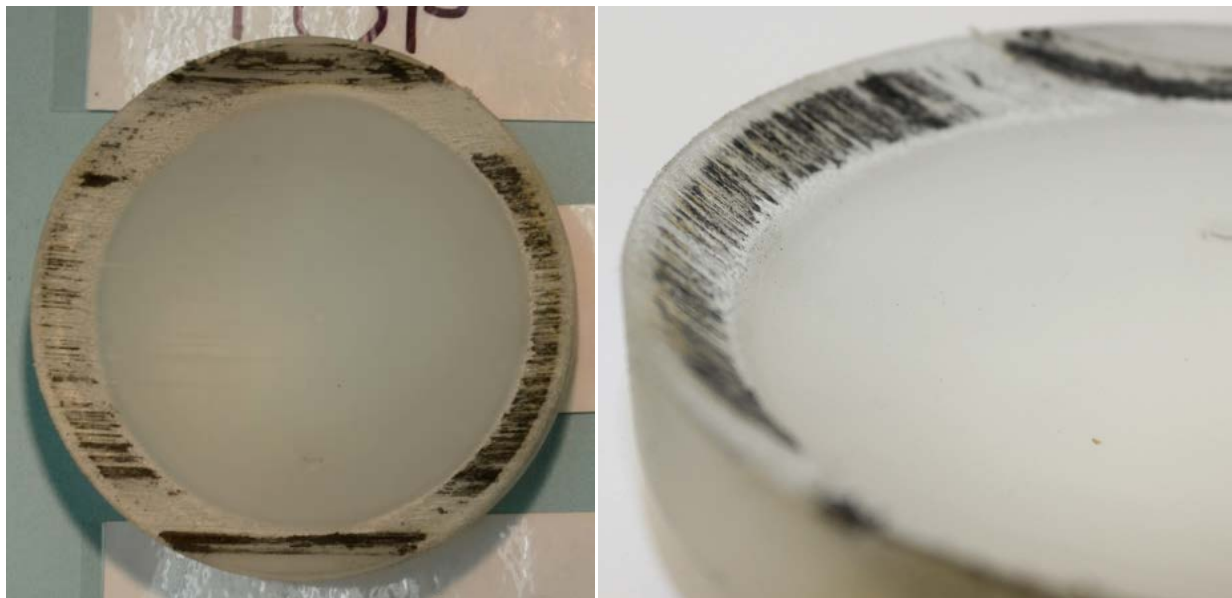
**Fig. 7.** Kynar® blind seat for three-way, PBM, 3-inch slurry valve (TV8) after being rinsed. Image on right is a close-up of left side of the blind seat.

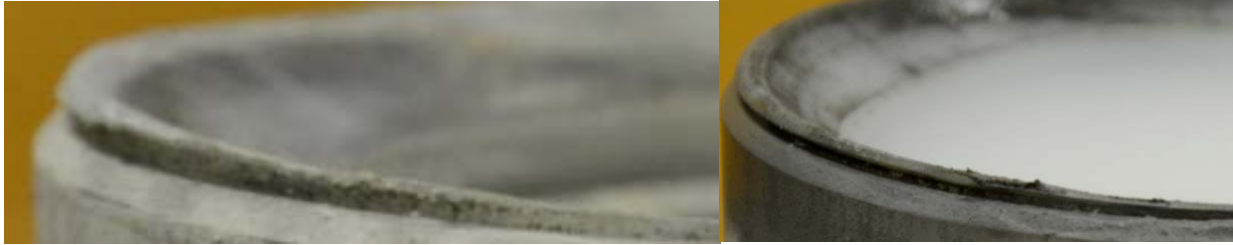
The seats from the Tefzel®-seated, three-way valves displayed a plastic material creep/deformation in which the outside lip of the seats was extruded beyond the edge of the retaining channel for the seat. Examples of the observed deformation are presented in Fig. 8. The side of the seats displaying the greatest amount of deformation corresponded to the direction of valve rotation (i.e., side in constant contact with exterior of ball).

There was no evidence of material loss from the seats, just a reshaping of the seats, which eliminated the relief groove in the face of the seat to form a continuous surface. It is unclear whether its absence was the result of deformation or having been worn away.

**Fig. 8.** Left: Tefzel® seat of three-way, PBM, 3-inch slurry valve (TV1) still in retaining channel of flush port flange stem. Right: Tefzel® blind seat still in retaining channel of flange stem from three-way, PBM, 3-inch drain valve (TV3). Note: Original installation of both pictured seats had the top of each seat flush with the top of the retaining channel.

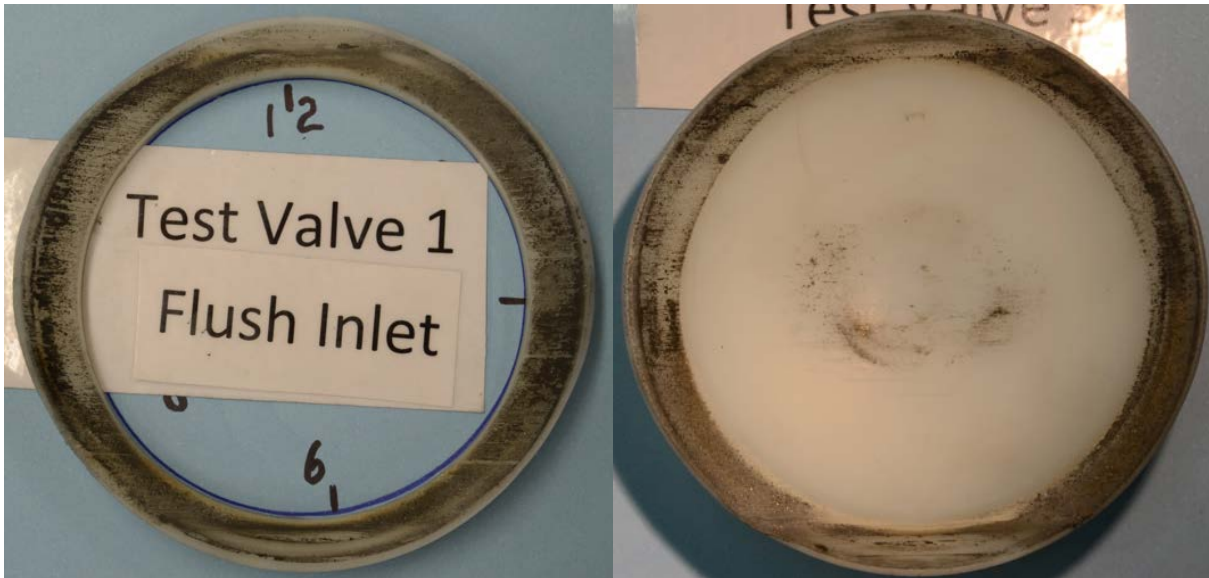
The Tefzel® seats for the three-way valves experienced the greatest degree of particle embedment. The embedding of the particles was what increased the roughness of portions of the Tefzel® seat faces as opposed to the scoring observed in the Kynar® and UHMWPE seats.

For the three-way slurry valve (TV1), embedded particulate was observed over the entire face of the seats except for small cleared areas at the top and bottom of the seats. The small cleared areas were the smoothest surfaces. The surface texture around the circumference of the seats was not uniform or symmetric. The face of the thin lip of seat material protruding from the flange-stem retaining channel at the outer edge of the seats was smooth. The amount of black embedded material observed corresponded to the degree of surface roughness/wear.

The center of the blind seat for slurry valve (TV1) contained some indication of scoring and particle embedment into the surface, which was not observed for any of the blind seats of the other seat materials tested. The deformation and appearance of the seats for the three-way drain valve (TV3) were similar to that observed for the slurry valve (TV1).

**Fig. 9.** Right: Tefzel® seat from flush port of three-way, PBM, 3-inch slurry valve (TV1) after being rinsed. Left: Tefzel® blind seat from three-way, PBM, 3-inch drain valve (TV3) after being rinsed.
