RESOLVING THE TECHNICAL UNCERTAINTIES IN THE DECOMMISSIONING OF AN ACCIDENT DAMAGED REACTOR – WINDSCALE PILE 1

M.T. Cross, W. C. Mullineaux, J. C. Jennings, W. A. Ingamells, M. L. Ferris United Kingdom Atomic Energy Authority Windscale, Seascale, Cumbria, CA20 1PF, United Kingdom

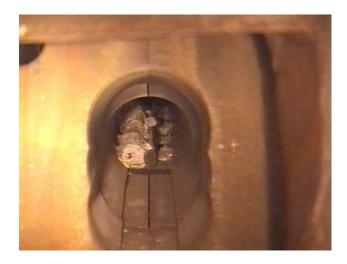
- Damaged fuel, the accumulation of dusts and larger debris has been observed in the discharge exits to the horizontal fuel channels by CCTV survey (Figures 3, 4). It is postulated that the levitation of graphite dust during a seismic disturbance could constitute an explosion hazard if ignited by a pyrophoric material, with potential pressurisation of the reactor containment and release of activity.

Fig. 4. Fire damaged fuel element displaced from its graphite boat

From recent CCTV surveys of the pile discharge face, dusts and loose debris are known to be close to the exit of several fuel and isotope channels of the FAZ (Figures 3, 4), and are also lodged on the Burst Slug Scanning Gear (BSSGs). In a seismic event some of this material is assumed to fall to the water duct floor. Fuel oxide dusts of a respirable size range (<10micron) entrained by the ventilation air flow, and discharged via the vent stack would be the principal hazard.
