## INVESTIGATION OF A SALT-CONCRETE SEAL IN THE ASSE SALT MINE

F. Gläß, R. Mauke, G. Eilers, J. Preuss  
Federal Office for Radiation Protection (BfS)  
Willy-Brandt-Staße 5, D-38226 Salzgitter, Germany

H. Schmidt, C. Lerch, N. Müller-Hoeppe  
Deutsche Gesellschaft zum Bau und Betrieb von Endlagern für Abfallstoffe (DBE)  
Eschenstraße 55, D-31224 Peine, Germany

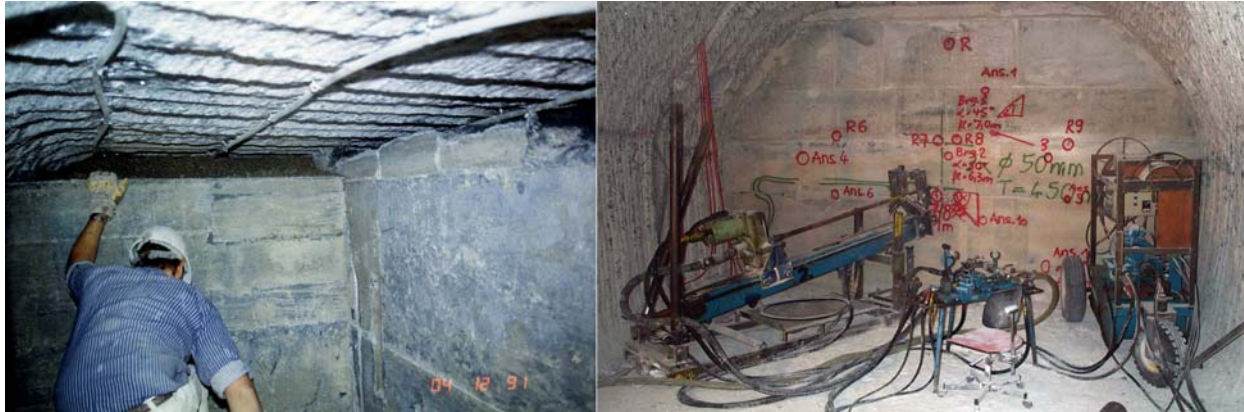
concrete consists of 380 kg of cement, 169 l = 198 kg of NaCl-saturated brine and 1496 kg of crushed salt. The seal was erected in two phases. 4 concreting sections were built during the first phase and 3 sections were built during the second phase. A gap of about 10 cm was left in the roof and was later on filled with salt-concrete by hand, i.e. the gap was stuffed. Finally, the contact zone of the former gap area and the rock salt was injected with cementitious grout (Fig. 1).

**Fig. 1. Construction phase of the salt-concrete Asse seal showing salt-concrete segments, the partly filled gap and the injection pipes (left) and start of the investigation program (right).**

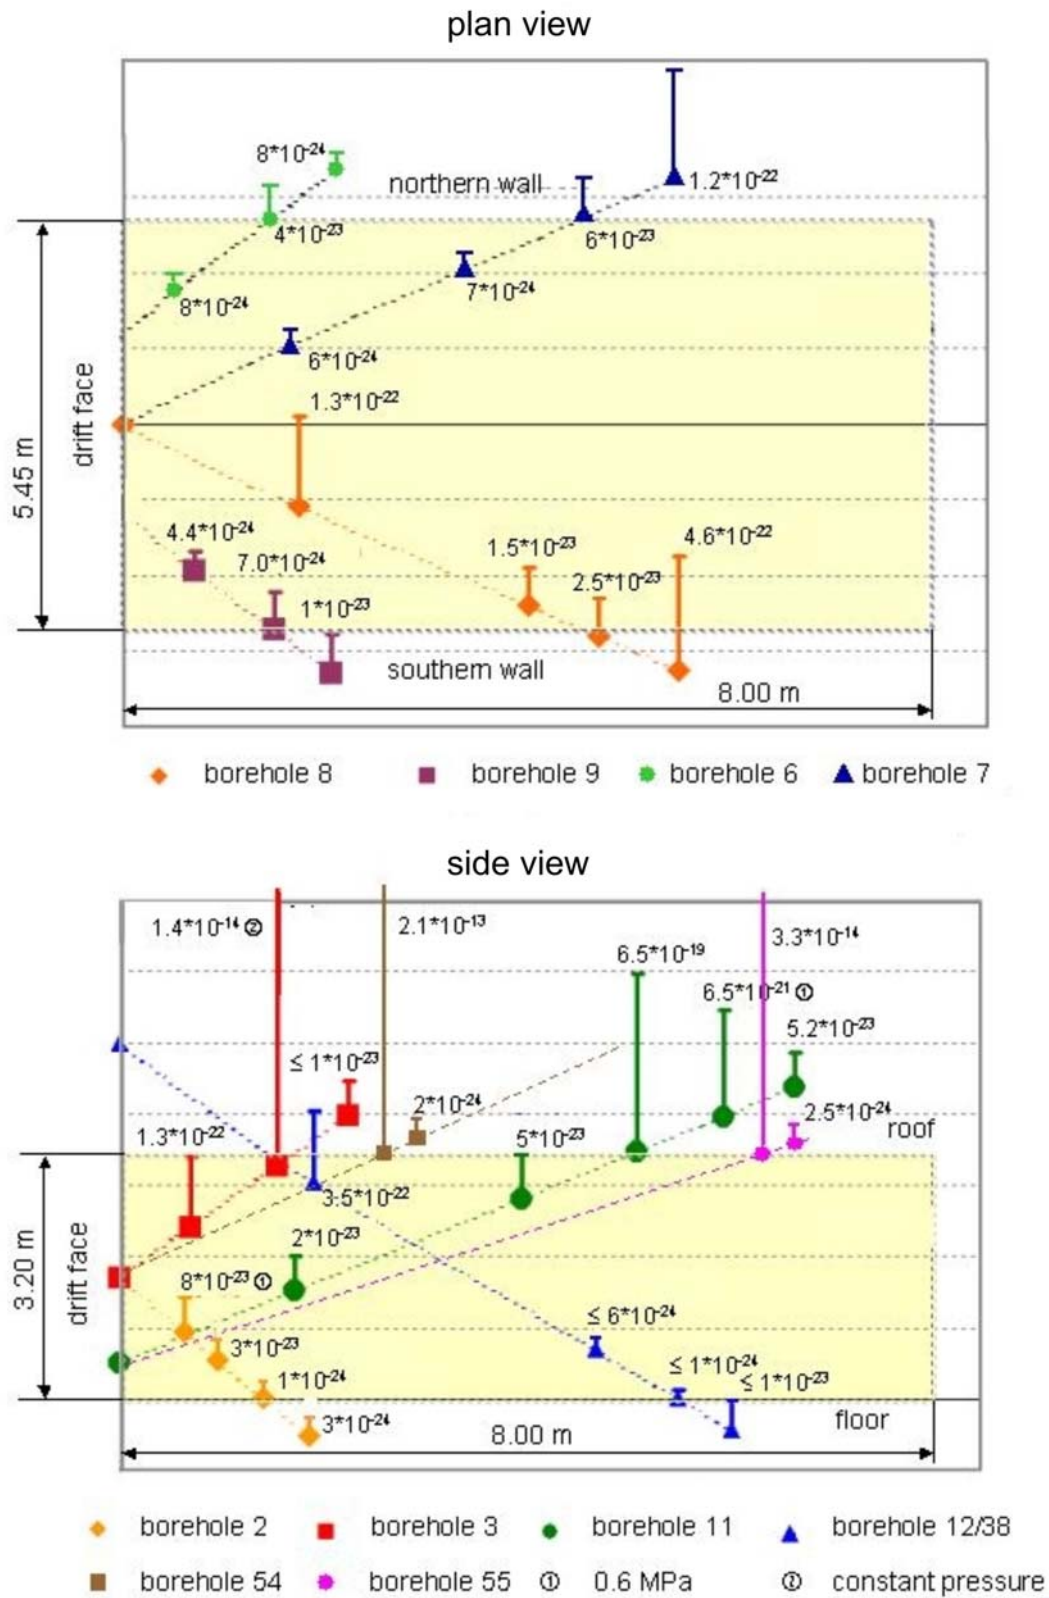
Pulse-tests were employed for most of the permeability measurements with gas being used at pressures of 0.6 and 1.2 MPa and an observation phase of two to four days. Additionally, constant-pressure-tests were performed in the roof. Relevant results of the tests establishing the permeability to gas are given in Fig. 2. Fig. 2 shows that in the contact zone to the walls and the floor the permeability is low, i. e.  $k < 10^{-22} \text{ m}^2$ . In the unfavorably constructed roof a wide range of permeabilities between  $2.1 \cdot 10^{-13} \text{ m}^2$  and  $6.5 \cdot 10^{-19} \text{ m}^2$  was determined. Consequently, the interference tests did not show any pressure response in the boreholes nearby at the wall and the floor. Evidently no zone of higher permeability exists in this area of the seal. In the roof, however, pressure responses were measured.

Fig. 2. Permeability to gas [m<sup>2</sup>] mainly resulting from pulse-tests performed at 1.2 MPa.

The contact zone to the walls and the floor showed a permeability to gas in the range between  $6 \cdot 10^{-23} \text{ m}^2$  and  $1.0 \cdot 10^{-24} \text{ m}^2$  and a permeability to brine in the range between  $8.0 \cdot 10^{-21} \text{ m}^2$  to  $1.4 \cdot 10^{-21} \text{ m}^2$ . These results indicate a good adhesion of the salt-concrete body to the rock salt contour. In the contact zone to the roof a permeability to gas in the range between  $2.1 \cdot 10^{-13} \text{ m}^2$  to  $6.5 \cdot 10^{-19} \text{ m}^2$  was measured. The high permeability in this area arises from the insufficient quality of the salt-concrete which fills the 10 cm gap at the roof (Fig. 1). This conclusion is drawn from measurements that were performed in the former EDZ with a minimum distance of about 1.5 cm to the contact zone (borehole no. 54, 55) by fixing a packer in the former gap area with its inner border in line with the contact zone. These measurements proved that the high permeability was not caused by the contact zone itself but by defects and large pores of the salt-concrete in the gap area.

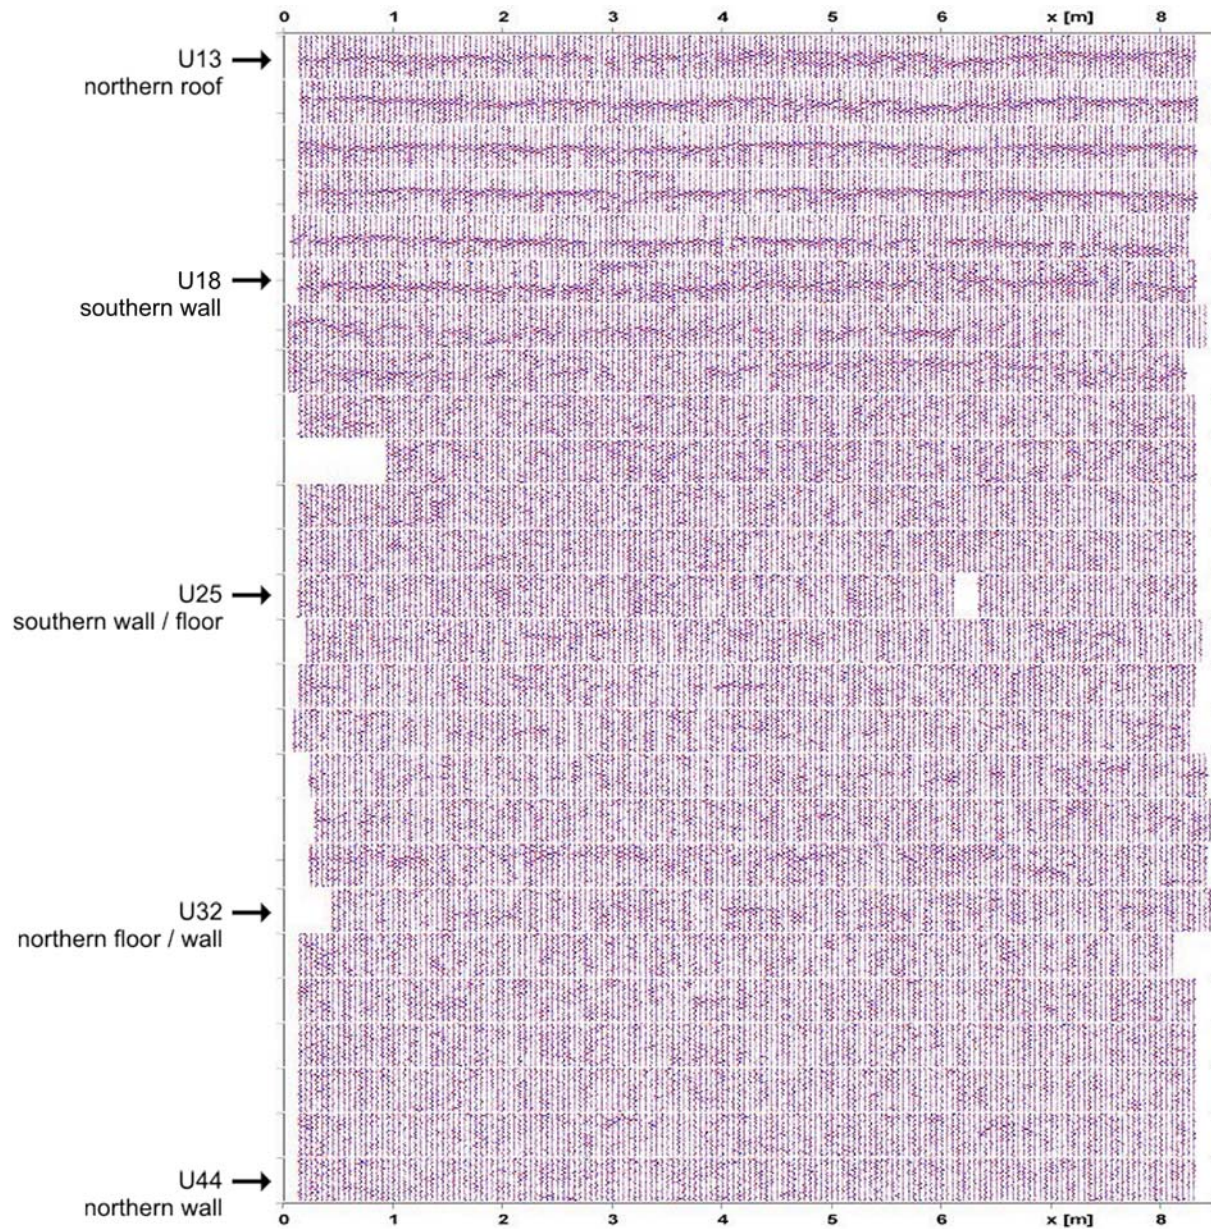
For ultrasonic measurements the reflection method [14] was mainly employed, using 26 boreholes. The reflection measurements covered the whole salt-concrete seal contour. The measuring equipment consisted of 1 emission unit and 4 receiving units, which were positioned at equal distances of 140 mm. The length of each measurement profile was 8 m with a distance of measuring positions of 200 mm. At each measuring position 7 signals were emitted on frequencies of 28 kHz, 40 kHz, 56 kHz, 80 kHz, 112 kHz, 160 kHz and 224 kHz. The results are given in Fig. 3. Corresponding to the results of the permeability and hydraulic fracturing measurements, significant reflections were received from the roof. The zone of extensive reflections is estimated to be about 10 cm wide. At the walls, however, no reflections occur at the contact zone showing a very good adhesion of the salt-concrete and rock salt contour as well as comparable properties (density and p-wave velocity) of salt concrete and rock salt. Single reflections from the floor showed small, locally spread and weakly marked heterogeneities. The evolution of the results for the entire contact zone is given in Fig. 3. The fact that a measuring frequency of 224 kHz could be used underlines again the integrity of the structure except for the roof. Otherwise, the high frequent signals would have been back-scattered without showing any result at all.

**Fig. 3. Evolution of the reflection measurement results of the salt-concrete seal focussing the contact zone [14].**

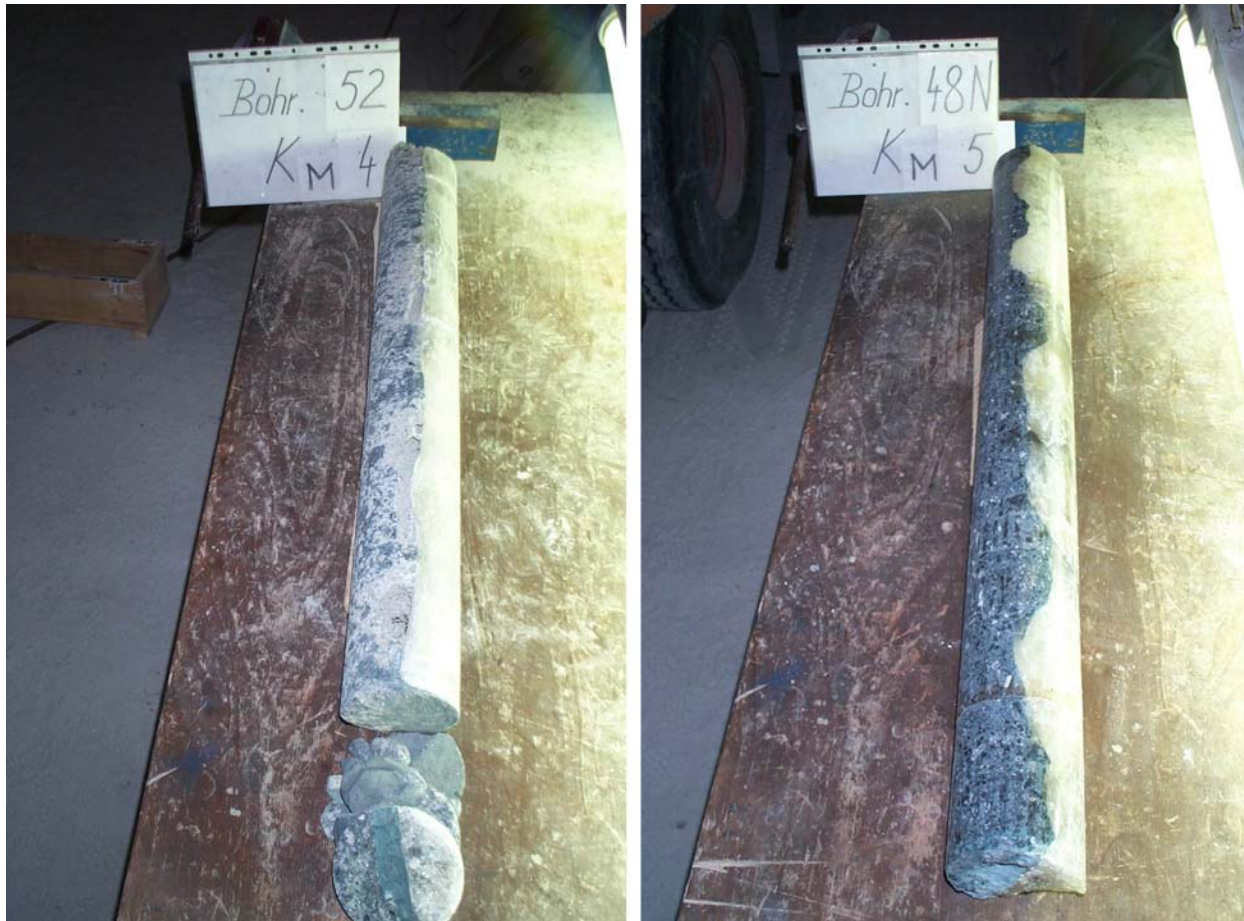
In the context of the laboratory tests 8 boreholes were drilled parallel to the contact zone to gain core samples containing the contact zone. In Fig. 4 two core samples are shown as an example. One core sample includes the contact zone to the wall, the other one the contact zone to the roof. The contact zone to the wall shows a very good adhesion of the rock salt and the salt-concrete body. The contact zone to the roof is of significantly worse quality. These results again comply

with the results of the permeability tests, the hydraulic fracturing tests as well as the ultrasonic measurements.

**Fig. 4. Core sample no. 52 from the roof (left) and core sample no. 48 from the wall (right).**

positions showing smaller principal stresses in the floor and roof the permeability is determined to  $k < 6.5 \cdot 10^{-19} \text{ m}^2$ . The results of the hydraulic fracturing investigations clearly indicate that the higher permeability measured in the roof is not a result of missing rock pressure but of bad quality of the hand filled gap, which has not significantly improved by grouting. The results of the permeability tests are confirmed by the results of the ultrasonic measurements showing mainly that the former gap area is a weak zone with defects and large pores, which is underlined again by visual inspection of core samples. The permeability in the contact zone of the roof is bounded by  $k = 6.5 \cdot 10^{-19} \text{ m}^2$ , which is the minimum permeability measured. Thus, good quality can be attained in the roof, too. Nevertheless, the lesson had to be learnt that the construction must be modified to guarantee an excellent quality of the contact zone to the roof.
