LIQUID LOW-LEVEL WASTE SOLIDIFICATION OPERATING EXPERIENCE AND LESSONS LEARNED

S. A. Coleman, CEM, PMP
Brookhaven National Laboratory

D. S. Hodge, CHMM
Argonne National Laboratory

WM'05 Conference, February 27 – March 3, 2005, Tucson, AZ

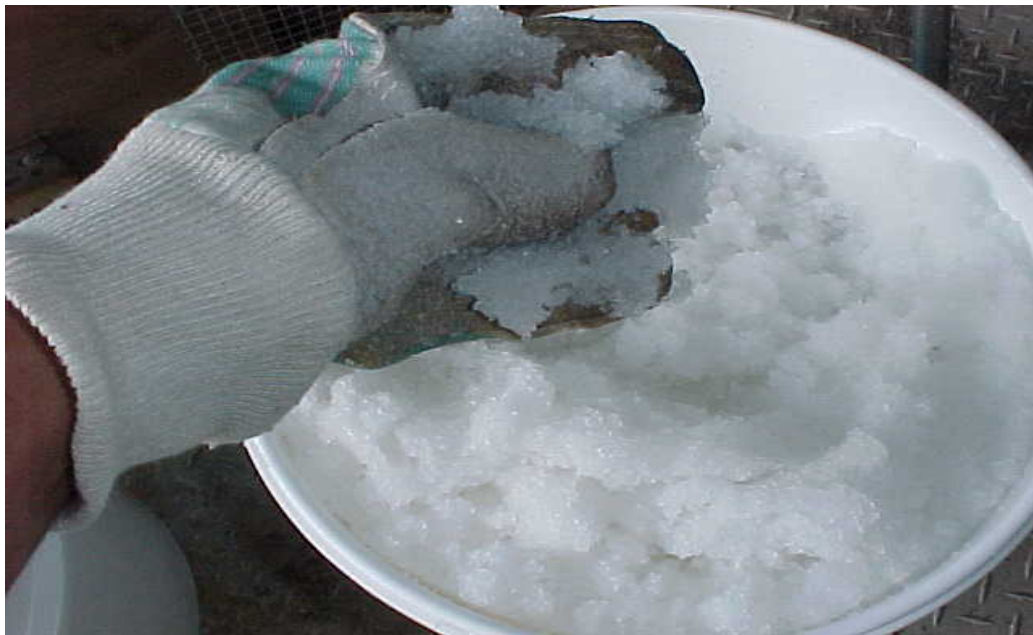
Fig. 1. Five-gallon Bucket Pilot Study

- **0.4** pounds per gallon of solidification/stabilization material meets the Hanford WAC and provides more than adequate safety margin for solidification of LLLRW.
- Non-mixed and mixed processes provided similar results. Both five-gallon samples were completely free of liquids

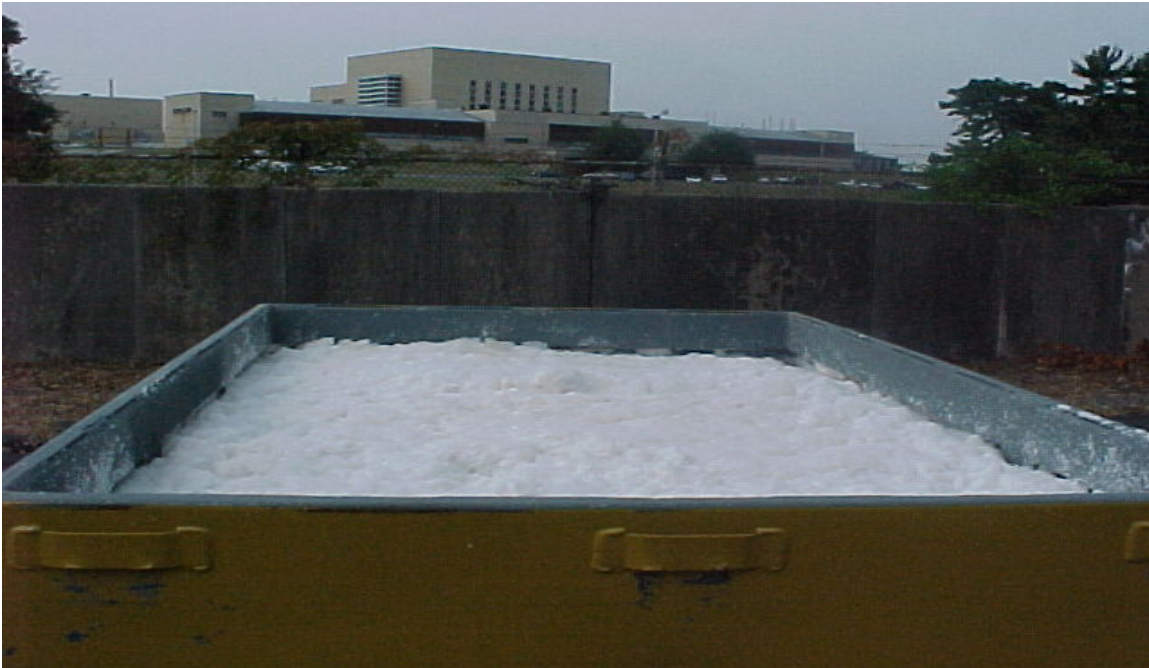
Fig. 2. Solidified LLLRW after Shake Test

B-25 container (see Figure 1), which would be subjected to a transportation shake test (driven across the site for an hour to simulate road conditions) and subsequent test at an analytical laboratory to verify no free liquids and compliance with Hanford's WAC.
