Reactor Vessel Head Disposal Campaign for Nuclear Management Company

H.L. Hoelscher, J.W. Closs
Nuclear Management Company, LLC
700 First Street; Hudson, WI 54016
USA

S.A. Johnson
Duratek, Inc.
140 Stoneridge Drive; Columbia, SC 29210
USA

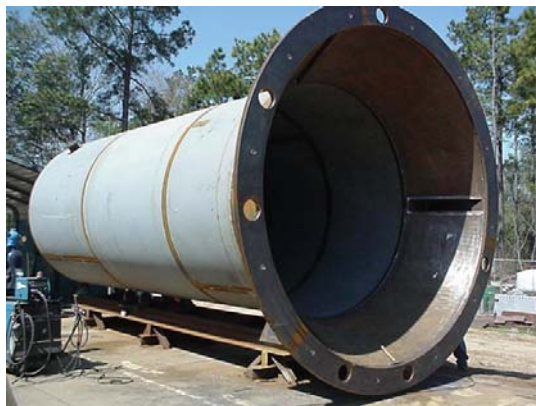
To contain the radioactive material, the packaging system utilized an upper (see Fig. 1) and lower closure that sandwiched the flange of the head. Once installed, the closures were never removed. This ensured containment of the radioactive material and minimized radiation exposure by not having to remove the packaging closures for reuse on subsequent shipments. The closures were fabricated from 2.5 cm thick (1 inch) steel plate. In addition to providing shielding, the 2.5 cm plate (1 inch) provided the necessary strength for safely handling the package while minimizing the cost of the discarded packaging material.

Fig. 1. Disposal package upper closure assembly.

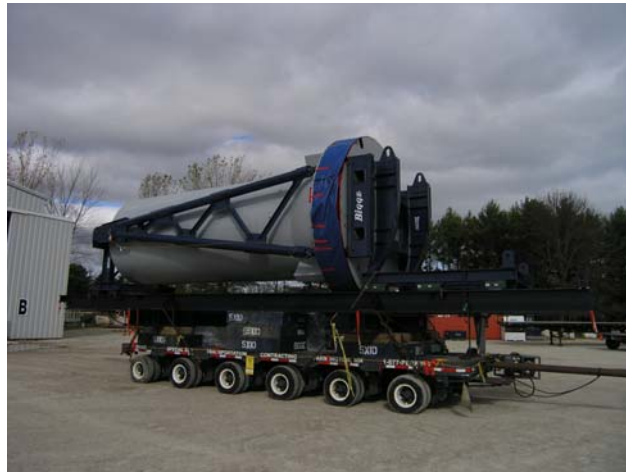
The packaged head was then transported to the location where it was to be installed onto the conveyance used for transport to a disposal site in Utah (see Fig. 2). It was during the transport from the equipment hatch to the staging area that water leaked from the joint between the LCP and the head mating surface. Subsequent investigation revealed that the leak started as the head was exiting the equipment hatch. The majority of the water was spilled in the vicinity of the hatch and the remainder was spilled on the platform trailer. Other than at the hatch, no contamination was found along the head's travel route to the staging area.

Fig. 2. Old reactor head ready for disposal.

As a result of the leak, the old head was placed in one of the buildings previously used for storing the Kewaunee replacement steam generators. Once in the building, several steps were taken to recover from the leak. These included:

- Drilling vent and drain holes into the LCP to verify all free water was removed from the bowl of the head,
- Decontaminating the head in the leak affected areas,
- Resealing the joint between the LCP and the head mating surface, and
- Repair of the failed closure stud.
