Inspection and Assessment Of The H-Canyon Ventilation System At The Savannah River Site - 15385

Bob J. Gilliam*, Jay Ray*, and Bill Giddings** * U.S. Department of Energy, Savannah River Site, Aiken, South Carolina, USA ** Savannah River National Laboratory, Aiken, South Carolina, USA

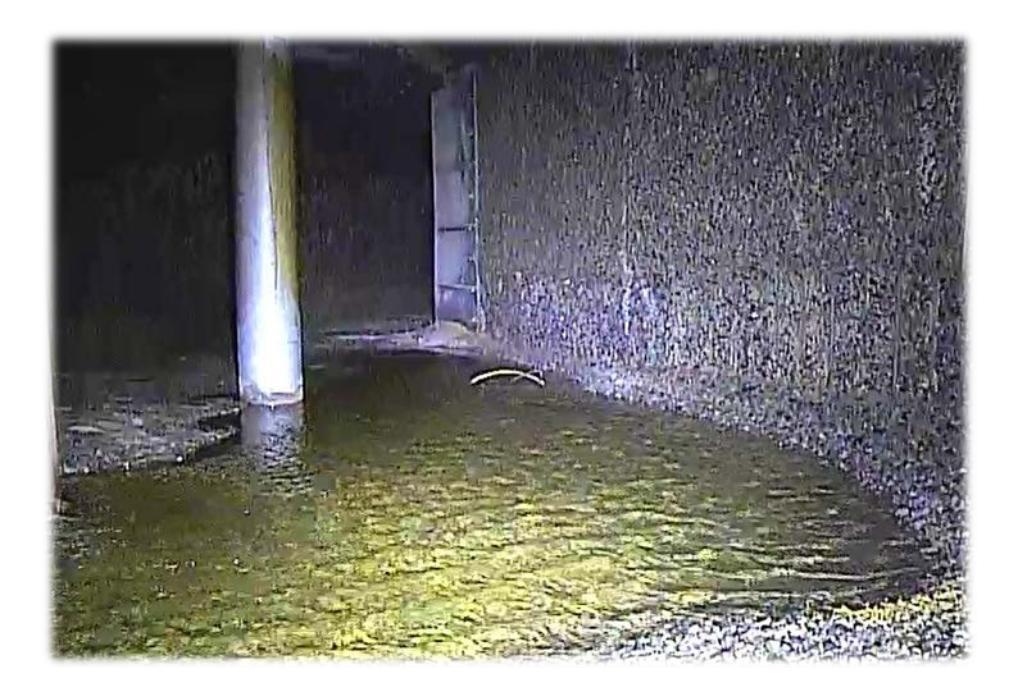
Water was pumped from a low point in the tunnel near the deployment location and the crawler was lowered into the tunnel. Cameras for viewing the cable reel feed were installed in the temporary hut prior to performing the inspection. There were about 20 centimeters of water remaining in the low point, through which the crawler traveled easily.

Fig. 16. Tunnel Conditions, After Pumping

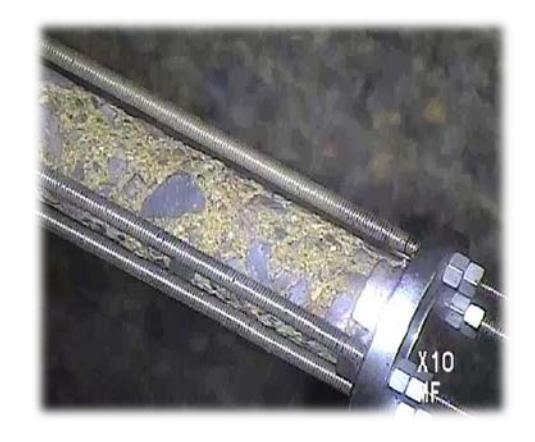
Fig. 17. Concrete Corrosion Coupon Inspection

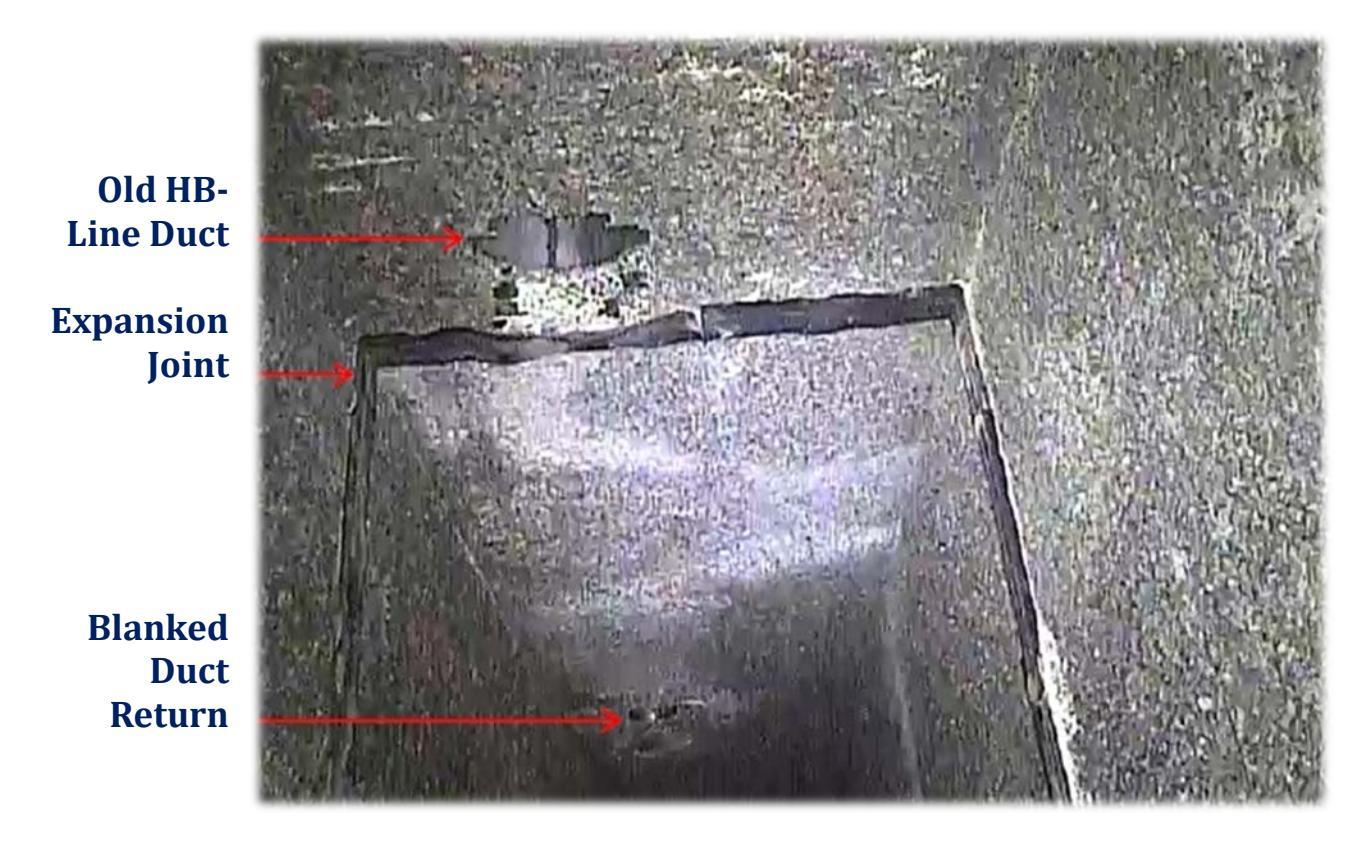
Fig. 18. Duct and Expansion Joint

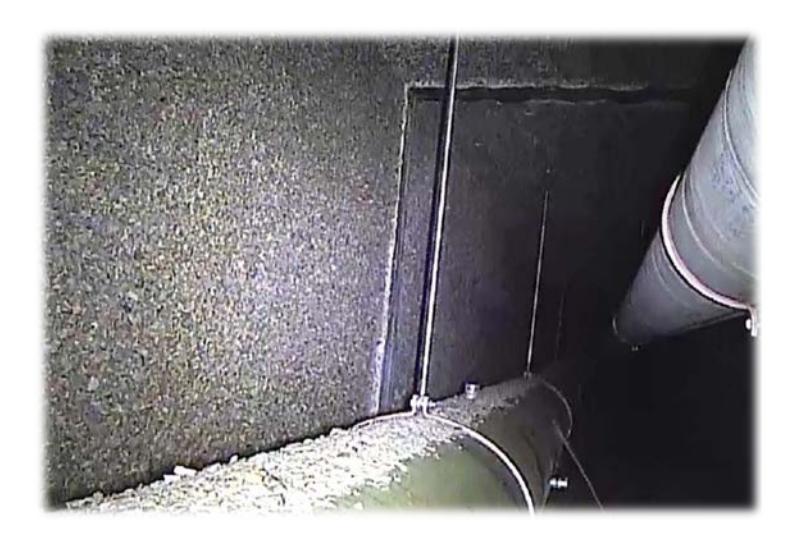
Fig. 19. Other Expansion Joints and Falling Debris on Duct-Work

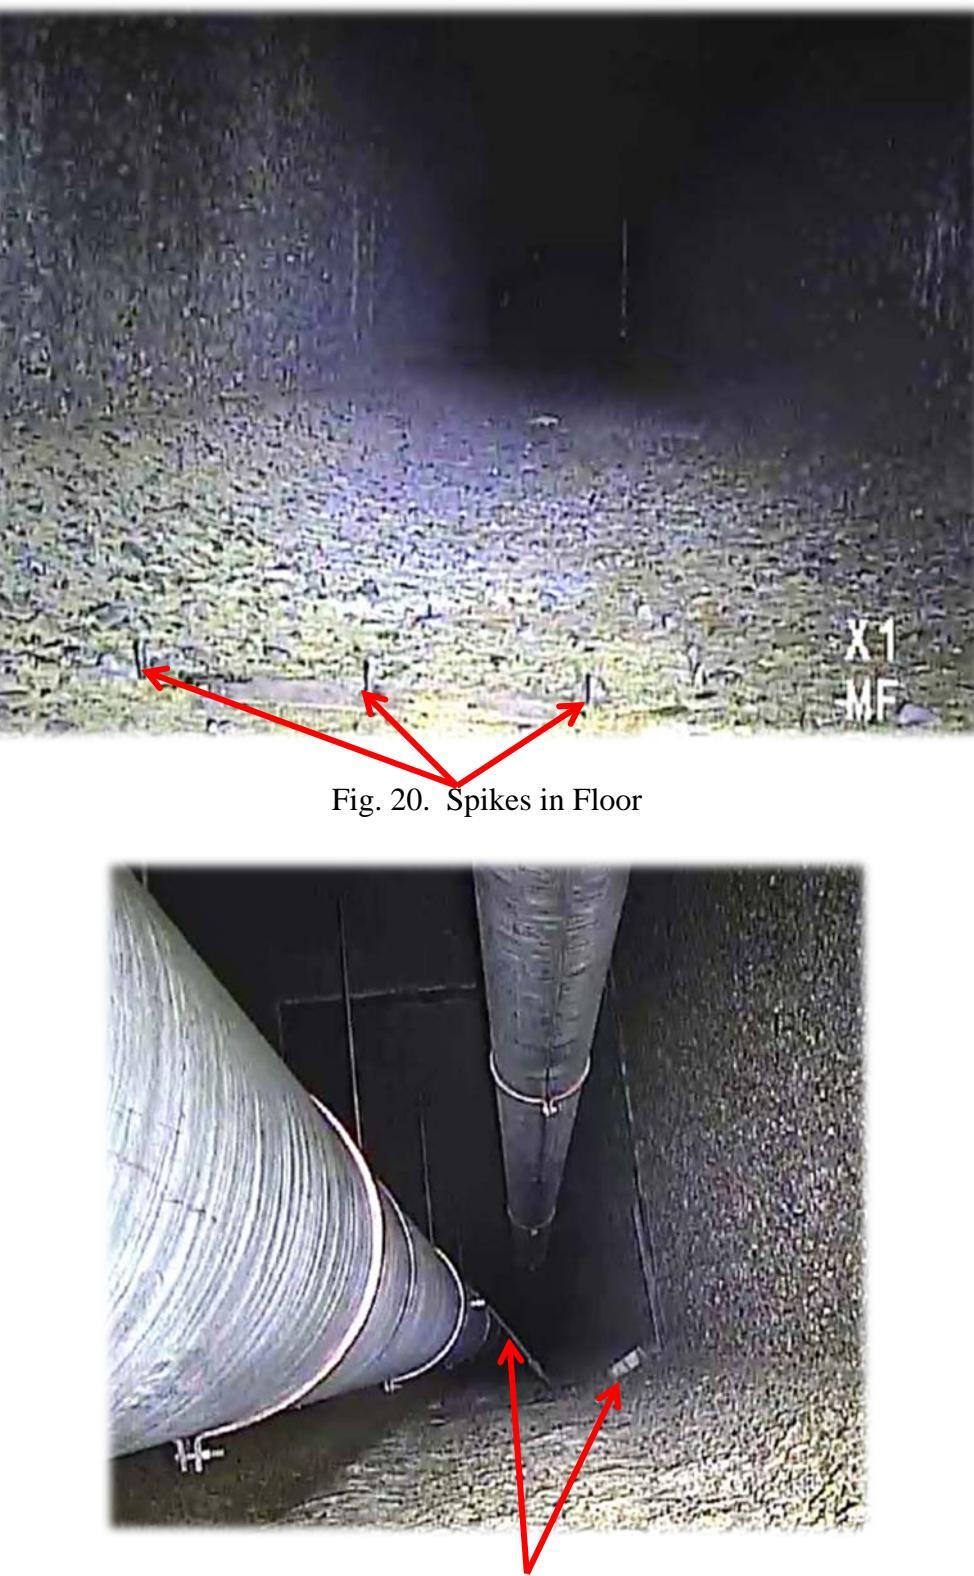
Several unexpected hazards from construction debris, including a bar with spikes, wires, plywood and metal panels were traversed during the inspection.

Fig. 21. Tunnel Debris

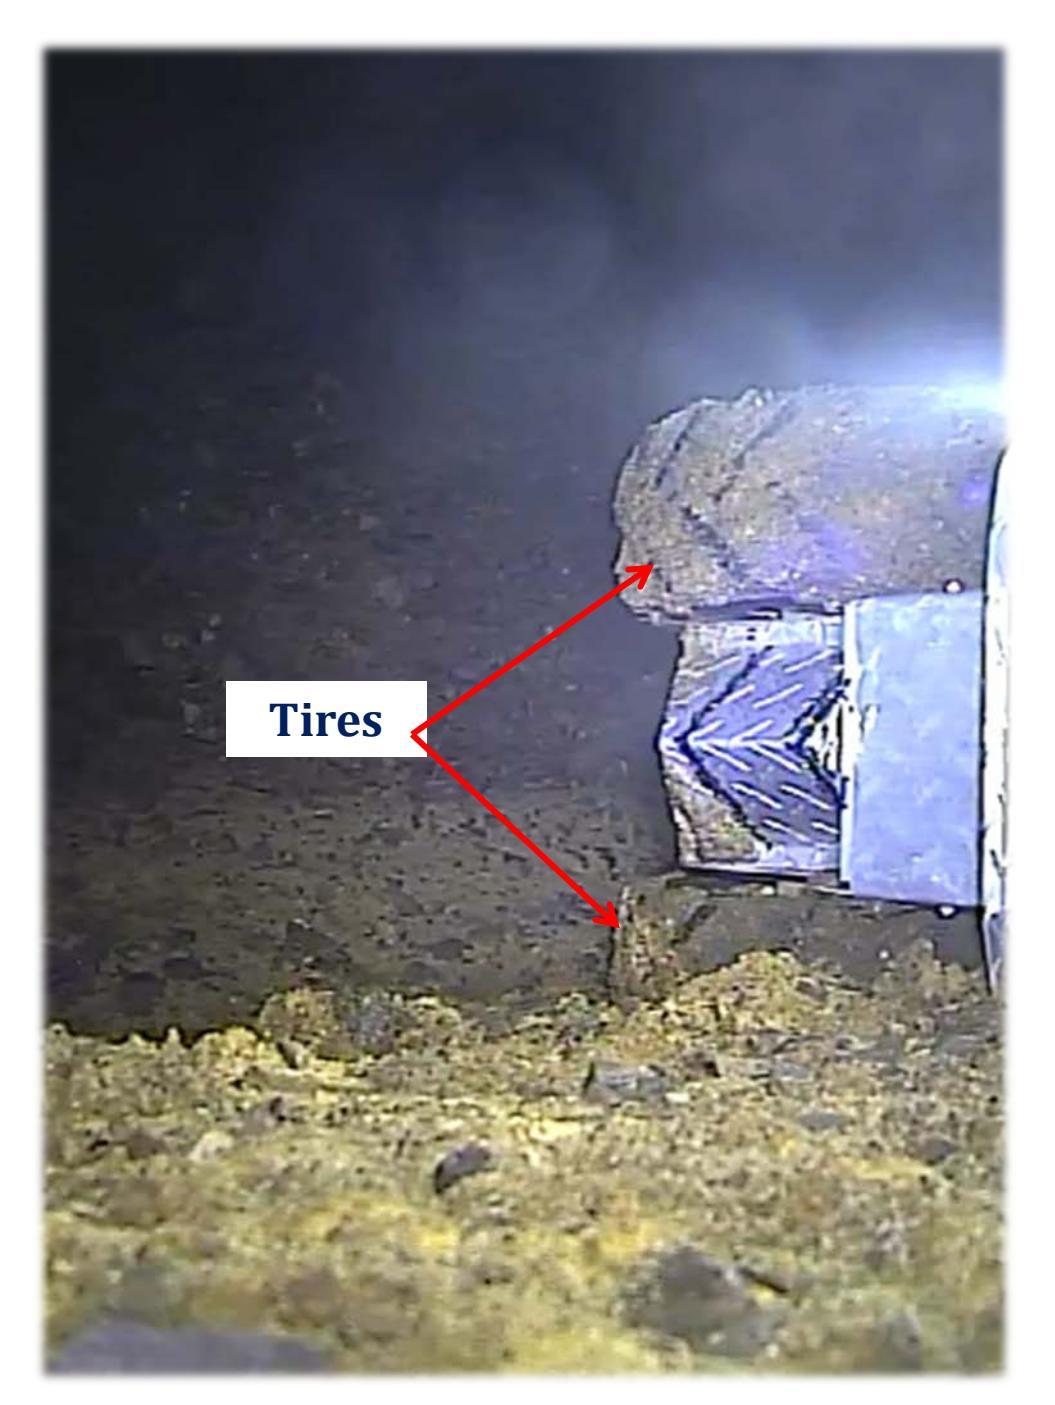
Following an inspection of the south wall, which required extending the scissor lift and slide to view above and behind the 91.44 centimeter-diameter ventilation duct; debris lodged in the

camera extension device. While trying to recover from the disabled extension, the crawler unexpectedly tipped on its side, abruptly ending the inspection.

Fig. 22. Toppled Crawler

Planning for the recovery and re-use of this vehicle is ongoing for future missions.
