HYDROGEN ABSORPTION AND CREVICE CORROSION BEHAVIOR OF Ti GRADE 12  
DURING EXPOSURE TO IRRADIATED BRINE AT 150°C

R. E. Westerman  
M. R. Telander

Pacific Northwest Laboratory<sup>(a)</sup>  
Richland, Washington 99352

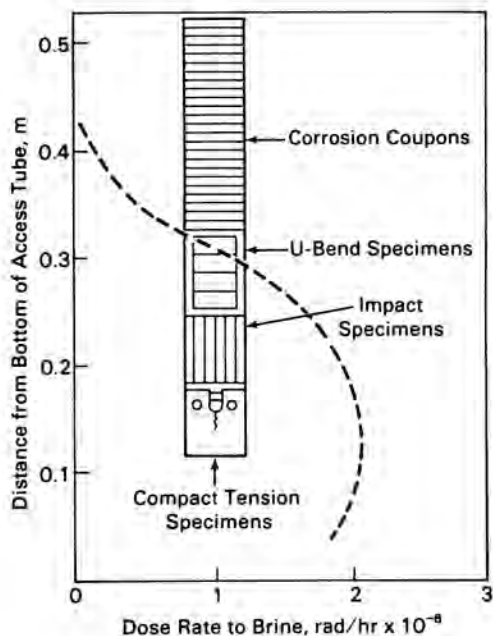
Fig. 1. Variation of Intensity of Gamma Irradiation over Specimen Array

Two tests were performed. The first test utilized an environment of Brine A (Table I) at a temperature of 150°C, and, to provide an irradiation overtest, a maximum gamma (<sup>60</sup>Co) irradiation intensity of  $2 \times 10^6$  rad/hr was imposed on the system. The test contained specimens of both Ti Grade 12 and Ti Grade 2 materials in the form of plain corrosion-coupon specimens, U-bend specimens, Charpy impact specimens, and bolt-loaded compact-tension fracture toughness specimens pre-cracked and stressed to 22 MPa  $\sqrt{m}$ . The specimens were contained in an electrically heated Zr-2.5 Nb autoclave held in an access tube in an irradiation facility. The anoxic brine flowed through the autoclave on a once-through basis at a flow rate of 35 mL/hr. The system pressure was maintained at  $\sim 3$  MPa. Because of the length of the specimen rack relative to the length of the <sup>60</sup>Co sources, irradiation intensity was not uniform over all the specimens in test (see Fig. 1). The test duration was three months.

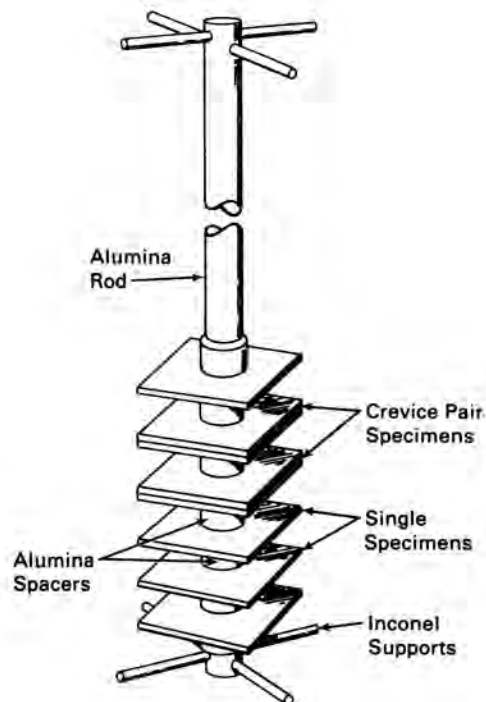
Fig. 2. Method of Mounting Specimens in Autoclave (Test 2)

The test was run in a static (unrefreshed) mode, with changes of brine at each specimen inspection. Only plain coupons of Ti Grade 12 material, 36-mm square, in both the as-received and SiC-grit-blasted conditions, were exposed in this test. Also, a number of specimens were allowed to contact each other closely as "crevice pair" specimens during the 10 1/2 months duration of their exposure (Fig. 2). The maximum exposure attained in this test was 18 months. As in Test 1, the autoclave was made of a Zr-2.5 Nb alloy, with the radiation being derived from  $^{60}\text{Co}$ . The system pressure was maintained at  $\sim 3$  MPa.

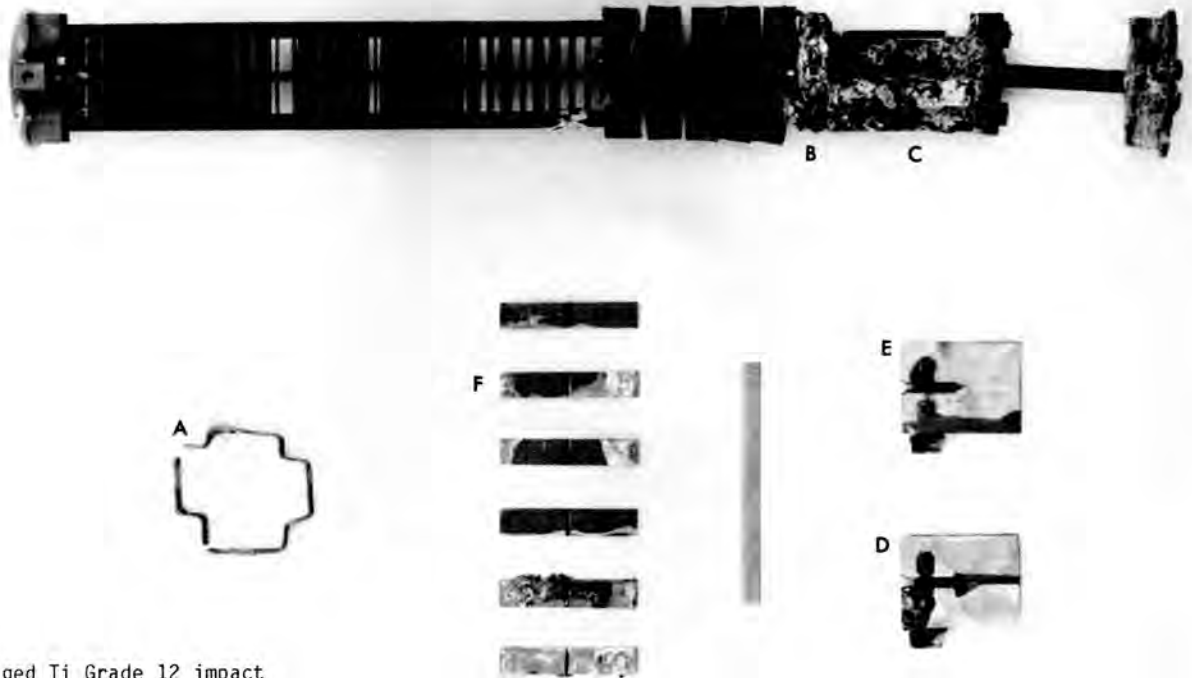
- A - Damaged Ti Grade 12 impact specimen retainment band
- B - Attack on Ti Grade 2 rack
- C - Attack on Ti Grade 2 impact specimens
- D - Attack on Ti Grade 2 specimen
- E - Attack on Ti Grade 12 specimen
- F - Undamaged Ti Grade 12 specimen

Fig. 3. Appearance of Specimens After Three-Month Test Exposure. Discoloration or presence of deposits does not necessarily indicate attack, as specimens were not cleaned prior to photograph. Rule is 96 mm long.

Within approximately two months of test initiation, bubbles of hydrogen gas were being discharged from the exit tubing along with the effluent brine. When the autoclave was opened for specimen examination, certain test specimens had been greatly damaged (Fig. 3), with much particulate  $\text{TiH}_2$  and  $\text{TiO}_2$  in evidence. The primary damage occurred to the Ti Grade 2 Charpy impact specimens and the associated Ti Grade 2 rack structure, though damage was evident elsewhere, including the corners of the Ti Grade 2 and Ti Grade 12 fracture toughness specimens (no crack elongation was observed in these specimens) and the Ti Grade 12 band used to restrain the Charpy specimens. The U-bend specimens showed no signs of incipient failure. Hydrogen analyses on representative Ti Grade 12 specimens, done in quadruplicate, showed an average increase of 23 ppm by weight; and the impact specimen restraining band, which had failed during the test,

The severe attack could have been initiated in either a crevice area (e.g., between Charpy specimens) or on a sharp machined corner of a specimen or rack component. Once started, hydriding and oxidizing reactions proceeded rapidly, with the attack spreading from specimen to specimen as the normally protective oxide film became breached and unable to re-passivate.

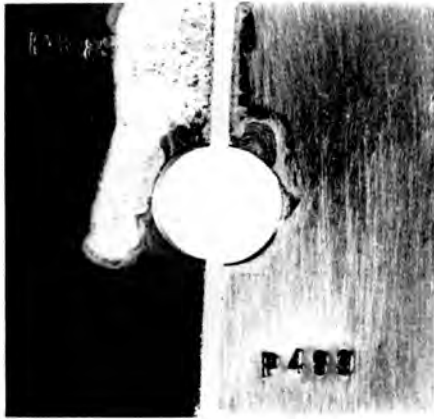
Fig. 4. Specimen Showing Crevice Corrosion Attack After Six Months Exposure. Half of specimen (on right) has been abraded to reveal attack near hole. Specimen was originally 36-mm square, with a 9.6-mm-diameter hole.

The specimens were first examined after 6 months. (No crevice pairs had yet been put in test.) At that time, it was noted that two of the twenty-one specimens in the test were forming thick layers of tenacious corrosion product, identified by x-ray-diffraction as  $\text{TiO}_2$ , on their surfaces. This oxide was apparently emanating from the crevice regions associated with the alumina spacers. The two specimens were cut in half, and the oxide was abraded from one half of each specimen with 180-grit emery paper. Classic crevice corrosion was found underneath the oxide on both specimens, with the maximum depth of attack being approximately 0.1 mm. One of the specimens is shown in Fig. 4.

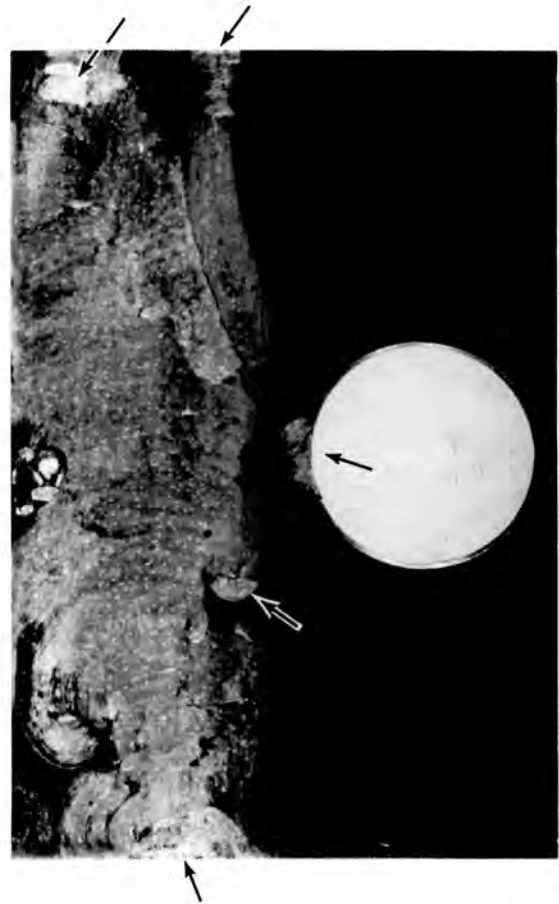
Fig. 6. Sites of Crevice-Corrosion Attack Under Corrosion Product ( $TiO_2$ ) Layer. Areas of severe attack are noted.

shown in Fig. 5. A specimen (R226X) exhibiting what appeared to be the most advanced corrosion was cleaned by light abrasion with emery paper. The sites of crevice corrosion attack under the  $TiO_2$  layer are shown in Fig. 6. The attack had proceeded to an average depth of  $\sim 0.07$  mm in several places on the specimen.

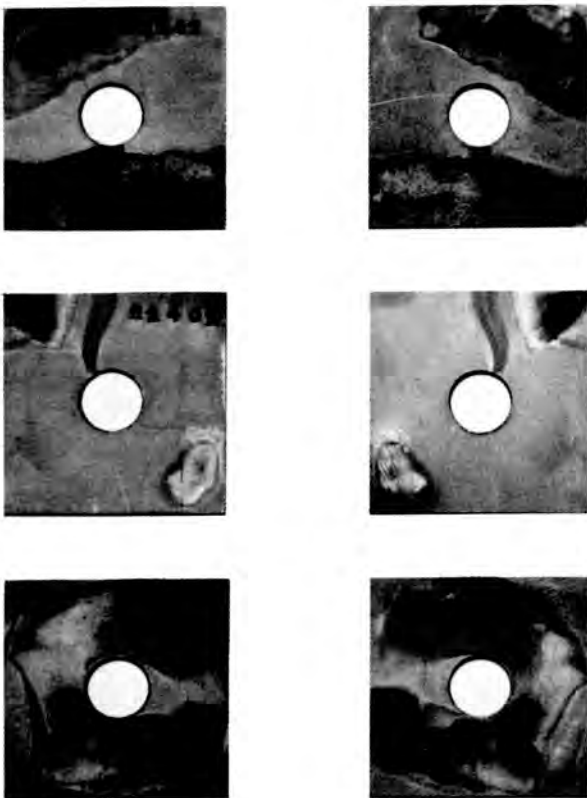
Fig. 5. Separated "Crevice-Pair" Specimens of As-Received Material, After 10-1/2 Months Exposure. Specimens are 36-mm square. Previously contacting surfaces are shown.

At the conclusion of the test (a maximum exposure of 18 months for some specimens) all of the specimens were removed for analysis. All of the crevice-pair specimens (six pairs, both as-received and grit-blasted) showed some degree of corrosion where they contacted each other. These specimens had a total exposure of 10 1/2 months. Typical crevice pairs are

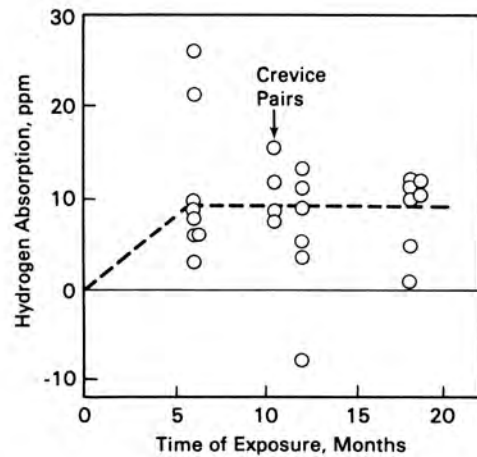
Fig. 7. Hydrogen Absorption Results, As-Received Specimens

Specimens from this test were analyzed for hydrogen content. The results of these analyses are shown in Figures 7 and 8.<sup>(a)</sup> The hydrogen absorption rates found in this study were remarkably low, much lower, for example, than those reported by Schutz and Hall (8) or the previously described results obtained from Test 1. The hydrogen absorption appeared to stop after six months; and the crevice pairs (which were sampled away from areas of advanced corrosion) showed no enhanced hydrogen absorption. The reason for the low hydrogen pickup may be related to the oxygen fugacity in the irradiated system caused by brine radiolysis. That is, a relatively oxidic environment might be expected to be more resistant to hydrogen absorption

(a) If it is assumed that the as-received Ti Grade 12 sheet stock is of constant hydrogen concentration (estimated at 25.1 ppm) throughout, then the 95% confidence interval associated with each data point in Figures 7 and 8 is 5.5 ppm. Each data point in Figures 7 and 8 represents the average of duplicate hydrogen-analysis results obtained from one test specimen.

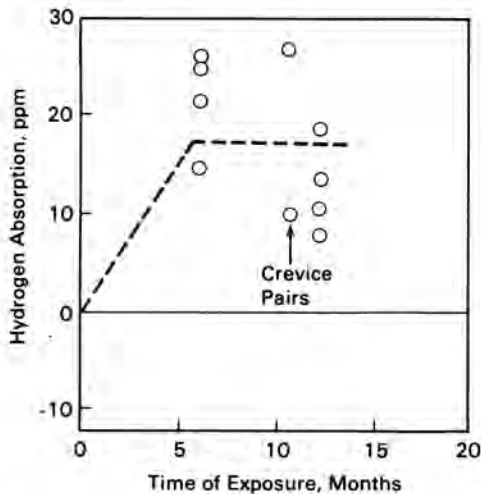
Fig. 8. Hydrogen Absorption Results, Grit-Blasted Specimens
