THE INFLUENCE OF COPPER ON ZIRCALOY SPENT FUEL CLADDING DEGRADATION
 UNDER A POTENTIAL TUFF REPOSITORY CONDITION

H. D. Smith
 Westinghouse Hanford Company
 P. O. Box 1970
 Richland, WA 99352

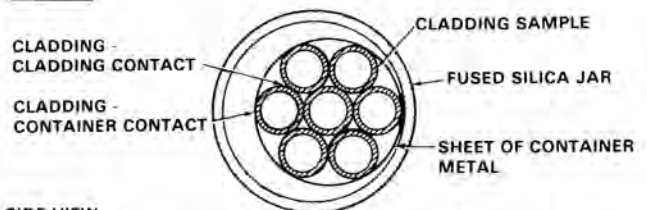
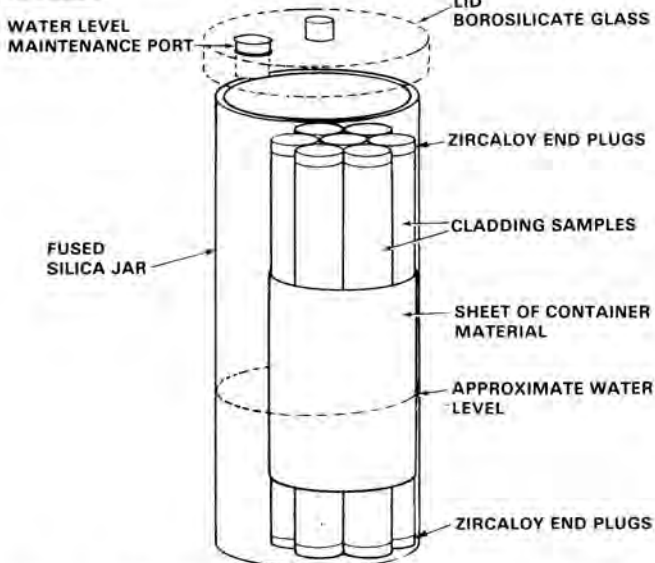
Fig. 1. Schematic of Corrosion Cell Used for the 2-Month and 5-Month Experiments. Copper foil wrap with copperwire tie holds bundle together. Zircaloy plugs are press fit to mechanically seal each cladding section.

In this experiment a 0.1 M copper nitrate solution held at 90°C was used to accelerate the localized corrosion phenomenon of concern. This high nitrate concentration exceeds that which would be expected to occur in the repository, but was considered a useful starting place. The copper container incorporating spent fuel was modeled using a small bundle of Materials Characterization Center's Approved Testing Material ATM 101(7) spent fuel rod sections (4 1/2" long) tied together by a 10-mil-thick, two-inch-wide copper foil wrap, certified 99.999 wt % pure. Three rod sections in each seven-section bundle were polished on one side to remove the oxide film, increasing the ability of the Zircaloy spent fuel cladding to react with the environment. Two such bundles were assembled, one for a two-month experiment, and one for a five-month experiment. (See Fig. 1.) Each bundle was immersed half-way up on the copper foil wrap in 0.1 M $\text{Cu}(\text{NO}_3)_2$ solution in a jar, and the temperature was maintained at $90^\circ\text{C} \pm 2^\circ\text{C}$ by placing the jars in an oil bath. The jars are made of fused silica and the lids are fabricated from Pyrex* glass parts.

Each bundle contained approximately 400 g of spent fuel, which resulted in a gamma radiation dose rate of about 1000 R/hr near the surface of the

bundle. This radiation field caused the fused silica jars to turn black, and it also caused the atmosphere in the jars above the nitrate solution to have a higher conductivity than is normally observed for humid air at 90°C; i.e., the resistance measured between two wires separated by 1.03 cm was $\sim 5 \text{ M}\Omega$ versus $>20 \text{ M}\Omega$ in air outside the jar. Fluid specimens were removed from each jar through the port in the lid at regular intervals during the experiment. During the course of the 2- and 5-month experiments, the solution pH remained at ~ 4.5 , while the concentration $[\text{Cu}(\text{NO}_3)_2]$ dropped to approximately one-half the original level, and the Zr content of the solution remained below the detectability limit of 25 ppb. The zirconium determination was made via inductively-coupled plasma optical emission spectroscopic analysis as soon as possible after a solution sample had been removed from the experiment (i.e., within 15 minutes). The fluid removed was replaced using a stock solution, volume for volume. Occasionally some evaporative loss was observed, apparently due to incomplete sealing of the port in the lid. This loss was made up with deionized water, volume for volume.

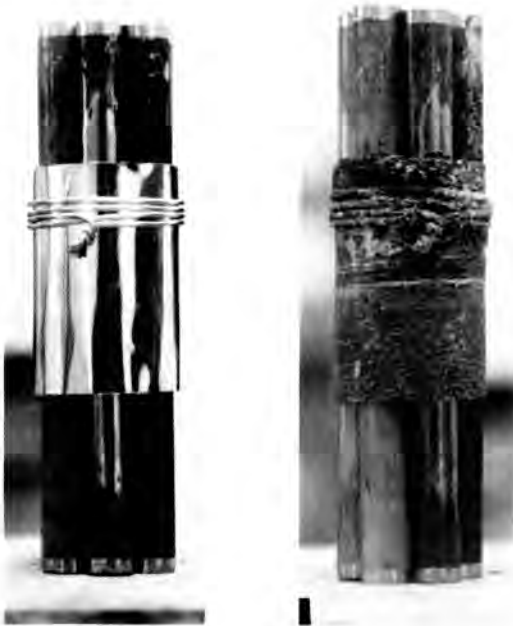
Fig. 2. Before and after Photographs of the Cladding Bundle Used in the 2-Month Experiment. Discontinuity in texture of deposits about half way up on the copper wrap indicates the water level during the experiment. Note that the polished cladding is still shiny after two months.

Each bundle became encrusted with a green compound that was identified by x-ray diffraction analysis (XRD) as $\text{Cu}_2(\text{OH})_3\text{NO}_3$ (copper hydroxide nitrate, also known as basic cupric nitrate and Gerhardite) during the experiment. The bulk of the deposit was above the water line and on the copper wrap as shown in Fig. 2, which presents before and after photographs of the 2-month experiment. The copper wrap was partially oxidized to Cu_2O (XRD) and was less flexible than the original copper. The bundle from the 5-month experiment appeared essentially the same as that from the 2-month, but the oxidation of the copper wrap had clearly gone further. When the copper wrap was removed, the cladding sections appeared unaffected, except that they had some of the same encrustation by the green copper compound. The polished areas also appeared unaffected except for a small amount of the copper compound that was mentioned above. More significantly, the polished metal was still bright and did not show any change of color that would suggest the development of a corrosion scale.

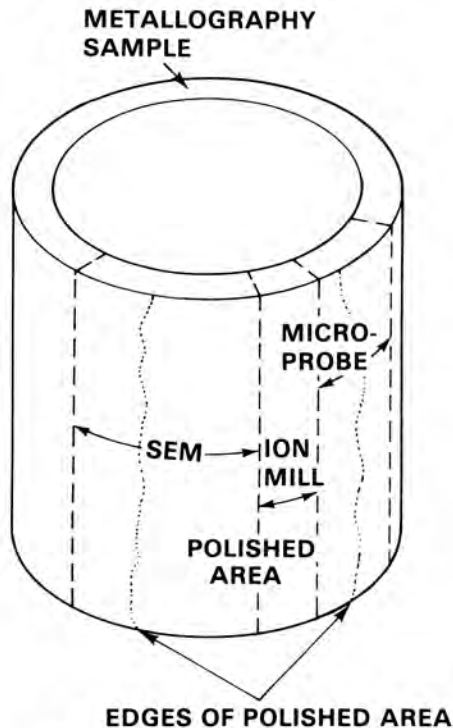
Fig. 3. Sectioning Diagram for Each Ring Specimen (see Fig. 2). Ring segments were evaluated via SEM, Auger/ion milling, electron microprobe, and metallography.

Ring samples were taken from the upper, middle and lower part of the cladding sections that had a polished strip on one side, for instrumental evaluation. Each ring was first defueled and then divided into several sections for different modes of instrumental analysis, as indicated in Fig. 3.

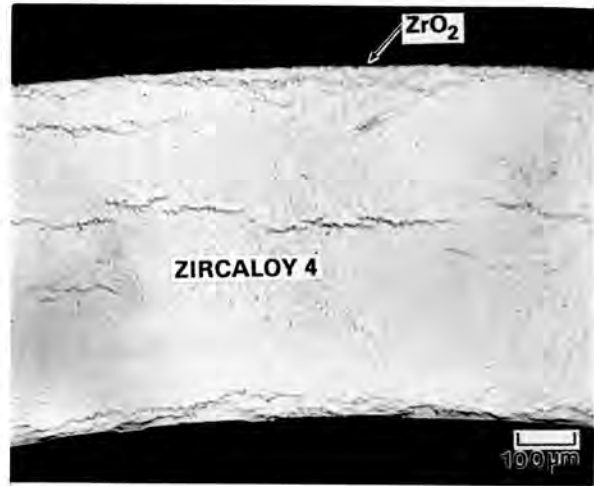
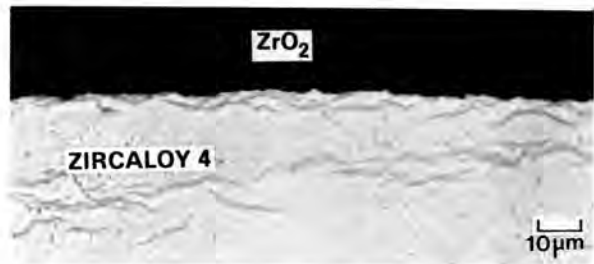
Fig. 4. Example of Thick Films on H. B. Robinson Spent Fuel Cladding From the 5-Month Experiment.

Metallography was used to survey the part of the circumference of the cladding section that was still covered with the original oxide. A polished section was produced which allowed the oxide film and the oxide-metal interface to be viewed in cross section. The section was then surveyed for unusual structures (as compared to archive material) that might indicate localized corrosion, and deposits of compounds or metal that might indicate an interaction between the copper and the spent fuel cladding. Nothing unusual was observed. A typical section is shown in Fig. 4.

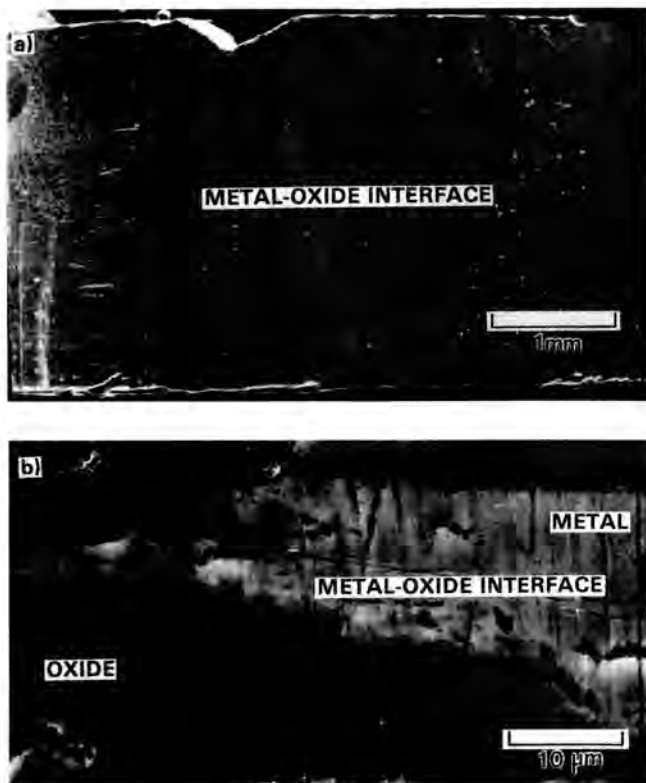
Fig. 5. Scanning Electron Micrographs of Cladding Samples With Thin Oxide From the 2-Month Experiment: a) Total specimen with well defined boundary between polished (right) and unpolished (left) areas, b) High magnification SEM micrograph of boundary showing oxide (dark) and metal (light) areas. Notice that the oxide-metal interface shows no topographical expression.

Figure 5 shows SEM micrographs of a specimen of an oxide film from the 2-month experiment which is also representative of what was seen after 5 months. There are many surface features on the cladding that are the result of the cladding manufacture and subsequent incorporation into a fuel assembly; these are visible

on the unpolished areas of the SEM specimen as scratches and grooves. The oxide surfaces of similar oxide specimens which were observed to have suffered abrasion during polishing procedures, have spalled in areas, giving a pitted appearance. The polished areas (on the right--lighter surface) display a variety of polishing and handling artifacts, i.e., scratches, grooves, etc. At a magnification of 1000-2000X an even greater array of scratches, grooves, crevices and pits are observed (see Fig. 5).

In spite of the topographic background outlined above, there are features that can be examined in detail for signs of active corrosion processes. At the boundary between the polished and unpolished areas, the oxide/metal interface is the very irregular boundary between the dark, thinned oxide (ZrO_2) and the metal substrate. The high magnification SEM micrographs show that wherever this boundary is clearly visible, there is no hint of oxide metal separation, etching, or pitting in either the 2- or 5-month experiment.

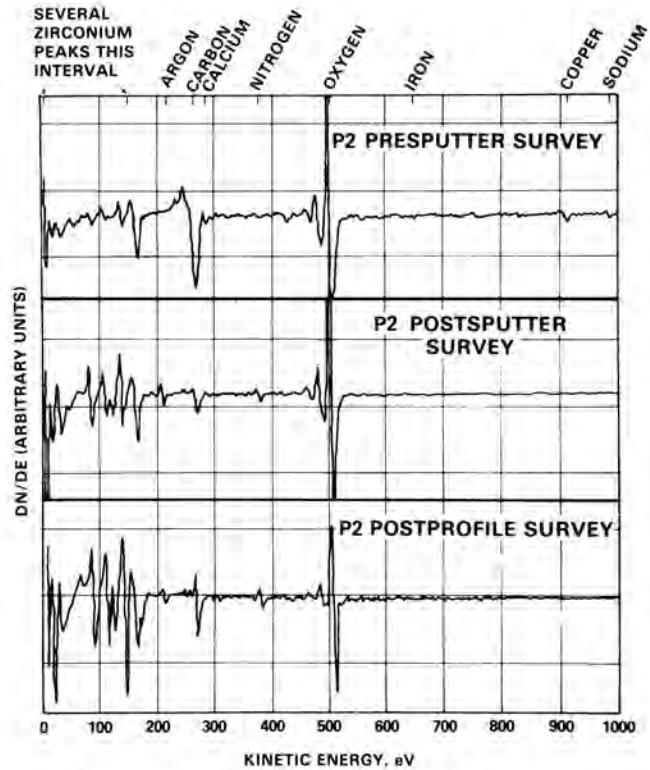
Fig. 6. Auger Electron Spectrum For Specimen P2 From the 2-Month Experiment. Copper, sodium, and calcium seem to be present on the undisturbed surface and are quickly removed by sputtering, i.e., the surface after 30 seconds of sputtering (Post-sputter surface) doesn't show these elements. All 12 specimens from 2- and 5-month experiments exhibited very similar spectrums.

Figure 6 shows the derivative (dN/dE) of the Auger electron flux as a function of energy, taken prior to milling (pre-sputter survey), after 30 seconds of milling (post-sputter survey), and after the depth profile was produced (post-profile survey). The data acquisition time was 5 minutes for each spectrum. Each peak is characteristic of a particular energy of Auger electrons emitted from the surface.⁽¹²⁾ The energies of the Auger electrons for elements observed on these specimens are indicated at the top of the figure. Elements such as sodium, calcium, oxygen (partly) and carbon (partly) are probably present as surface contamination. Carbon, nitrogen, oxygen, iron and zirconium are known to be present in the Zircaloy, and may be segregated into discrete phases or incorporated into the oxide film. Argon is apparently implanted in the surface during the ion milling procedure.

Copper is the element in question with respect to its possible influence on the corrosion rate of Zircaloy. There is no evidence that copper is present in any of the samples as anything other than one of several contaminants on the specimen surface along with sodium, calcium, etc. Thirty seconds of milling decreases the copper signal to below detectability (~1%) in every case.
