## **RCRA CLOSURE OF MATERIALS DISPOSAL AREA P, LOS ALAMOS NEW MEXICO**

Criswell, C. William  
Roy F. Weston Inc., Albuquerque, New Mexico

Material Disposal Area P (MDA-P) is undergoing clean closure under the Resource Conservation and Recovery Act (RCRA) as regulated by the New Mexico Environmental Department. The MDA-P is located on the north-facing slope of Canyon de Valle, an ephemeral drainage in Technical Area 16 of the Laboratory. It was operated from 1950 to 1984 and received materials from the burning of high explosives (HE), HE-contaminated equipment and material, barium nitrate, construction debris from the D&D of Manhattan-era buildings, as well as empty drums and miscellaneous containers, trash and vehicles. The burning operations were conducted at facilities adjacent to, and south of MDA-P. Disposal was conducted by pushing materials over the edge of the engineered slope, resulting in lateral accretion of the landfill and partial encroachment into the stream course. The closure will be conducted in two phases. Phase I, in progress, will be the complete removal of all landfill materials, decontamination of debris, treatment of contaminated soils, and offsite recycle

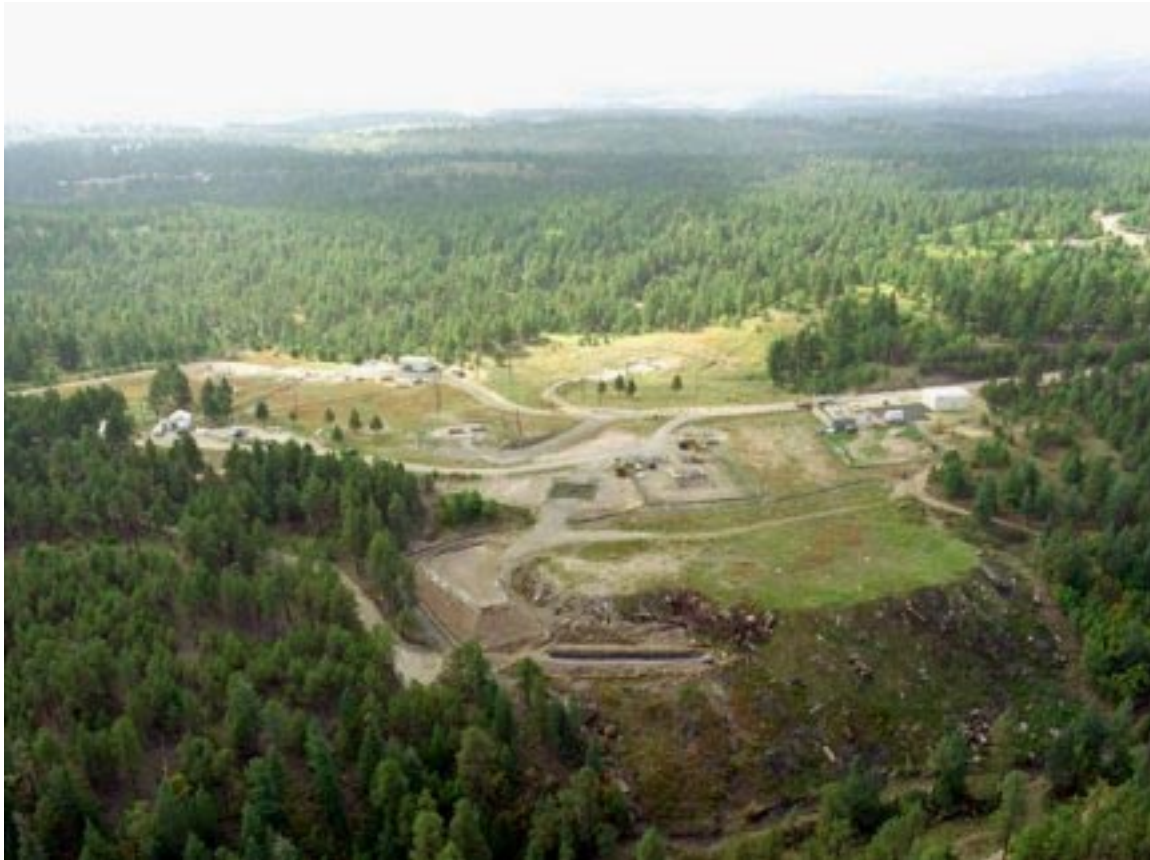
Figure 1.

Figure 1, is a photograph of MDA-P from the north. The site is located at the explosives burning grounds at Technical Area 16, also known as S-Site at Los Alamos National Laboratory.

The landfill comprises a debris wedge that extends from the flat lying surface to the bottom of the canyon. The relief on Canyon de Valle, in the foreground, is approximately 100 feet. The landfill extends down the north facing slope of the canyon into the active stream below. The smaller east lobe of the landfill primarily received wastes from the open burning of high explosives (HE) and HE-contaminated debris at the TA-16 Burning Grounds in the background. The major contaminants expected are barium and HE compounds. The lined, trench below the east lobe was constructed, along with 2 other trenches to contain any surface runoff from the landfill during removal and closure. The larger, west lobe of the landfill primarily received construction debris, including concrete sumps, pipes, and asbestos-containing materials.

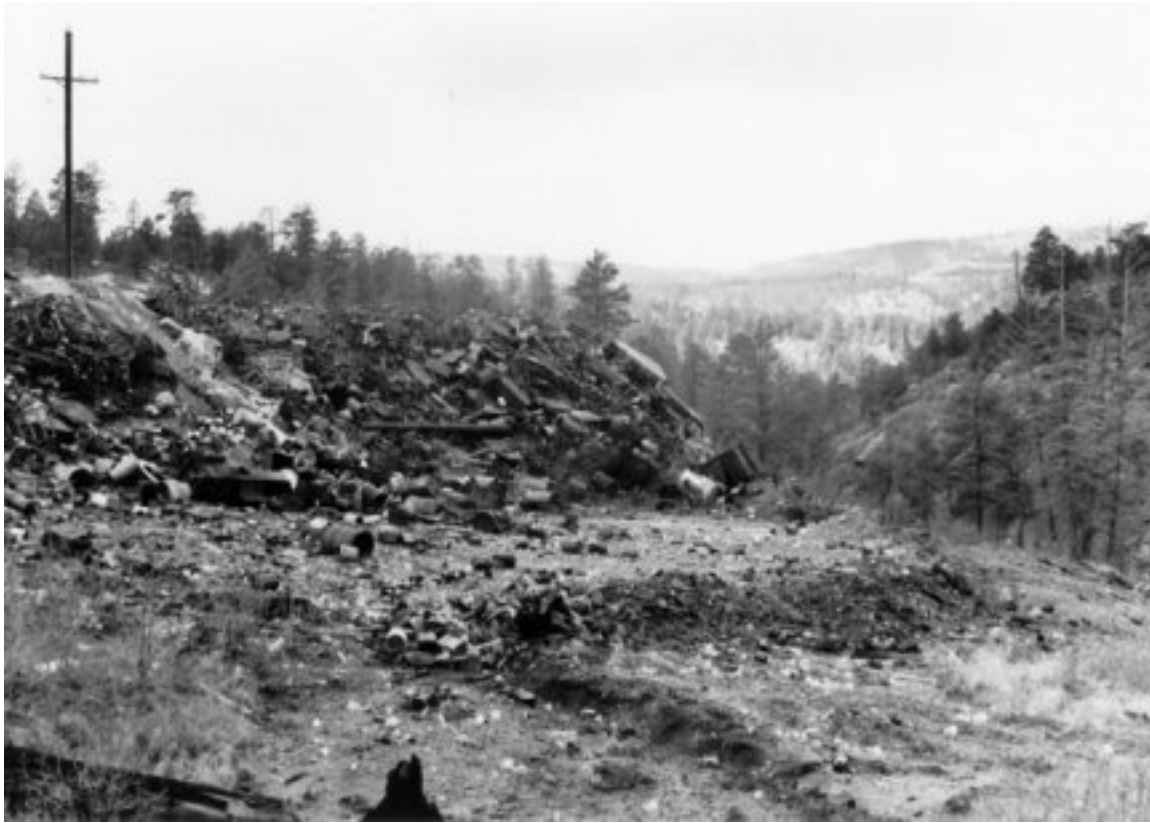
Figure 2.

Figures 2 and 3, are historic and recent photographs of the upper east side of MDA-P.

The black and white historic photograph was taken in 1965, the recent photograph in 1996.

The historic photograph yields some information, along with employee interviews and scant documentation of types of waste materials in the landfill. A low ridge of rocks in the foreground was useful in determining the sequential advance of the landfill over time. Most of the materials in the landfill were supposed to have been burned or flashed before disposal. Incomplete burns and partial detonations apparently resulted in some HE materials being buried with other ash and debris.

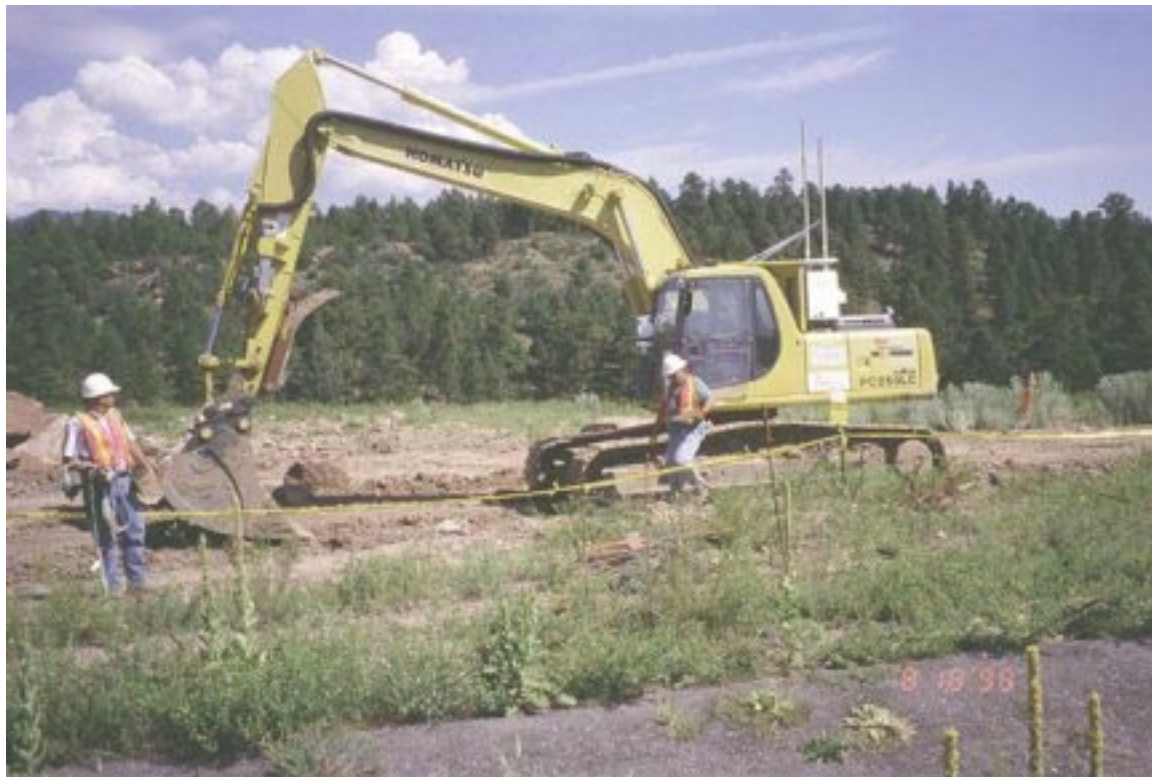
Figure 6.

Figure 6, is a photograph of the track-mounted excavator, modified to operate by remote, computer control. The remotely-operated excavator has 4 video cameras, and a set of computer and radio equipment.

The 2 antennas are for video and hydraulic control channels. The operator sits in a control booth approximately 300-400 feet away from the active excavation. The MDA-P landfill is designated a "Heterogeneous Area" therefore soils and debris must be initially excavated and handled remotely. Soil and debris is then inspected by high-explosives experts with military explosive ordnance disposal (EOD) training.

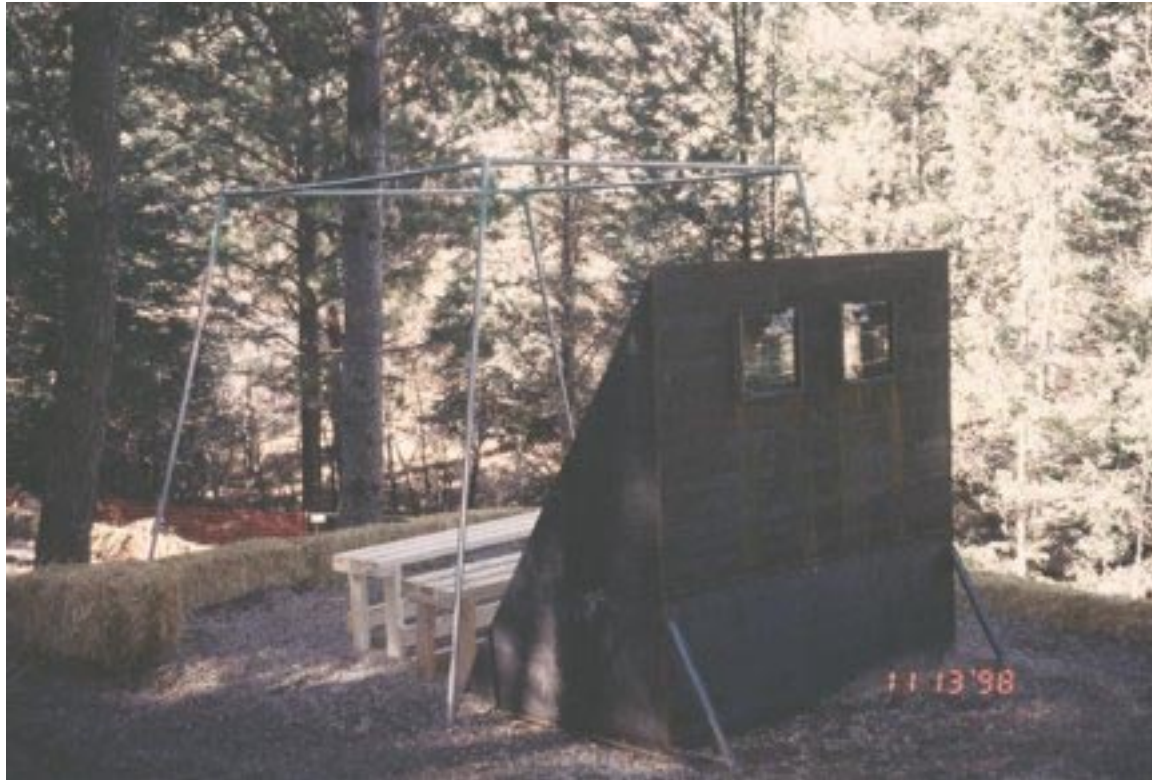
Figure 7.

Figure 7, is a photograph of the portable blast barricade.

All excavation operations are monitored from a safe distance by EOD personnel from this, or a similar barricade. Radio communications between the robot operator and spotters are essential for efficient operation. Once the spotters have inspected the materials, they can be removed by conventional heavy equipment fitted with Lexan™ blast shields. If the explosive loading limits are exceeded, operations must cease until the materials are removed from the area.

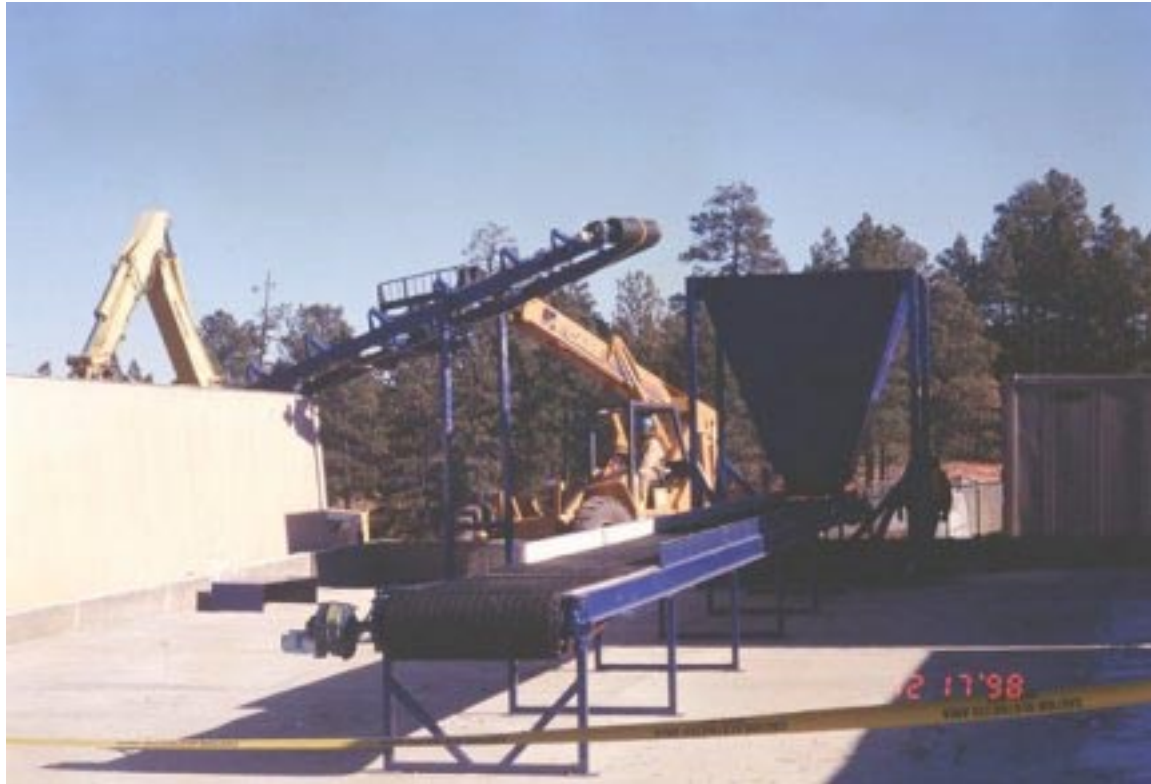
Figure 8.

Figure 8, is a photograph of the soil sorting conveyor equipment.

Soils with suspect HE materials must pass inspection by the team of EOD technicians. All pieces of HE capable of detonation must be removed from the soil and rendered safe for handling. The HE is passed to normal channels for storage and destruction. The soils are field screened for barium, HE, and other stains or contaminants, and staged for treatment and sampling, as appropriate.

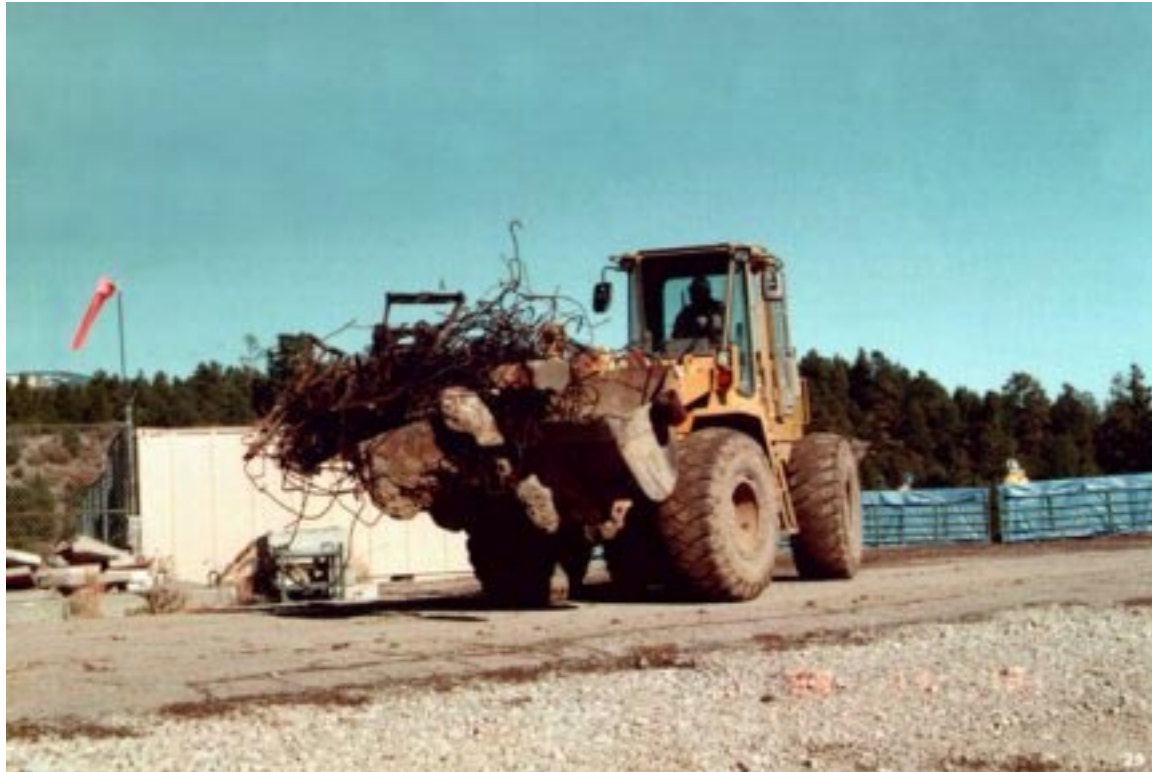
Figure 9.

Figure 9, is a photograph of typical debris tangle from the west lobe of the landfill.

This photograph was taken the first day of excavation. After inspection, all large debris is subjected to hot-water washing. Debris is then staged for sampling and recycling, if possible. Decontamination water is staged in 20,000 gallon tanks and sampled in batches

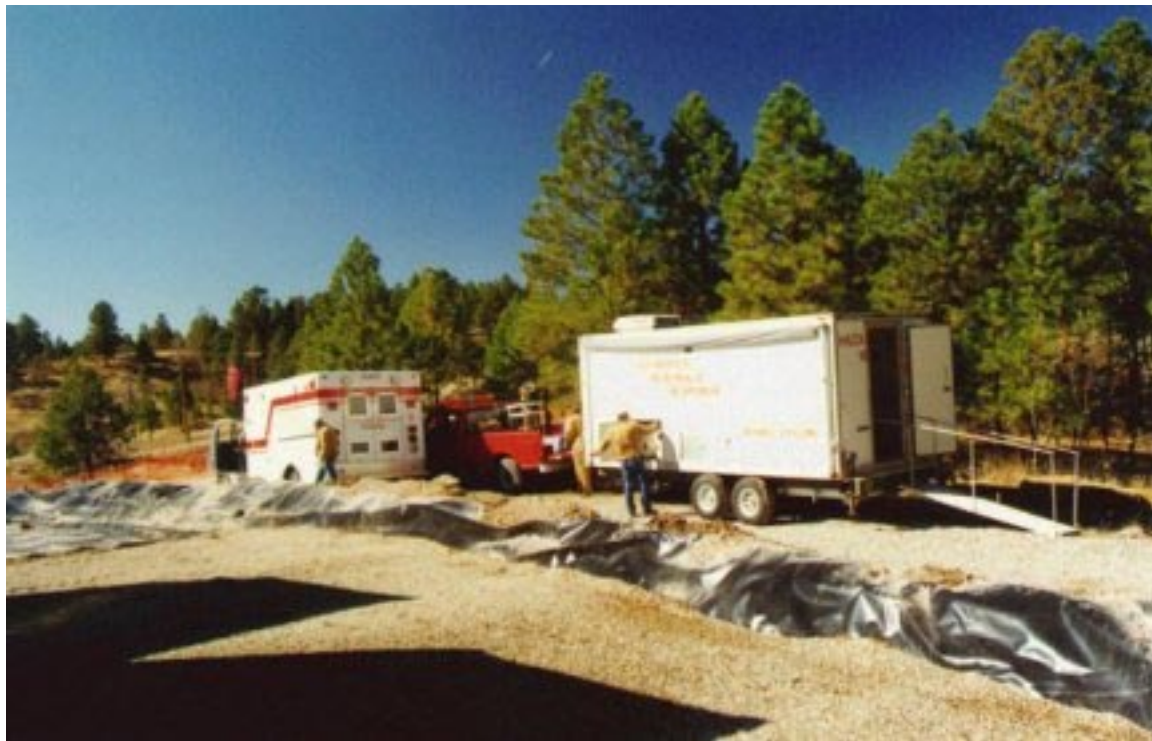
Figure 10a.

Figures 10a and 10b are photographs of the LANL hazmat team preparing to remotely open several sealed containers. A surface clearance of the landfill before excavation started resulted in the recovery of several dozen small containers of unknown content.

The containers were staged in a prepared area east of other operations. These containers are managed through routine LANL waste management personnel. The hazmat team provides initial inspection and access to facilitate characterization sampling and disposal.

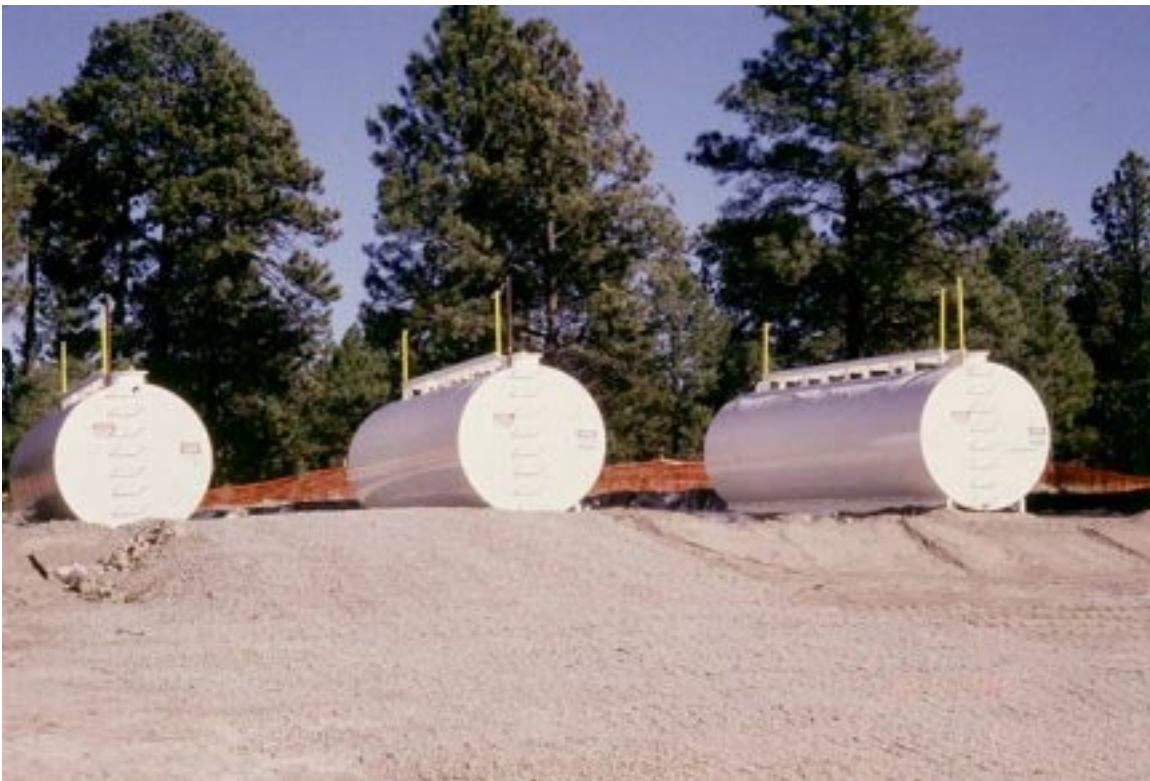
Figure 11.

Figure 11, is a photograph of the storm water storage tanks.

Each of the 3 runoff trenches is pumped to a storage tank where the water is sampled and analyzed before it can be used for dust control or other re-application. A common contaminant has been asbestos, so the water is filtered and then re-applied. The filters comprise part of the asbestos waste stream.
