**FINAL RESULTS FROM THE IN SITU VITRIFICATION TREATMENT AT  
MARALINGA**

Leo Thompson, Patrick Ombrellaro  
Geosafe Australia Pty. Ltd.  
Adelaide, Australia

Dr. Nicholas Megalos, David Osborne  
AMEC Engineering Pty. Ltd.  
Adelaide, Australia

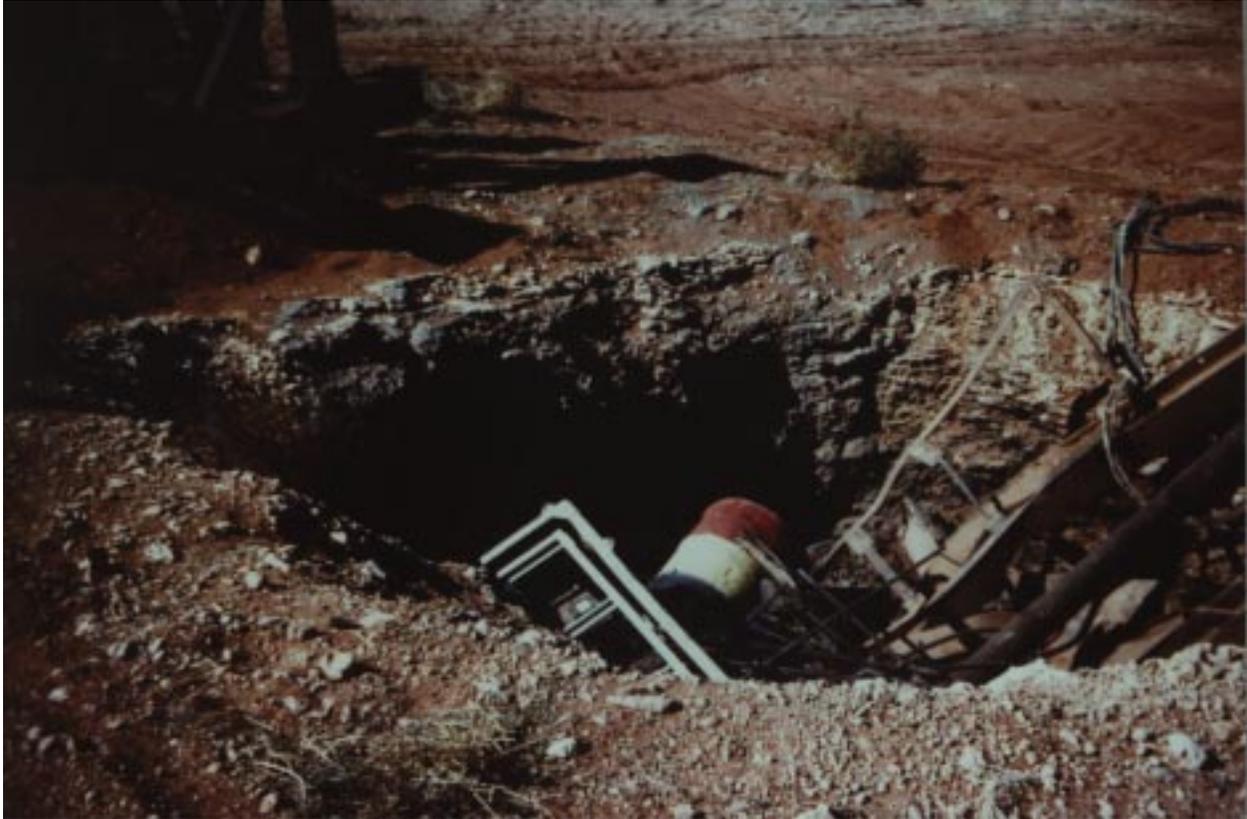
Contaminated wastes generated from the Vixen B trials were buried in a series of pits. The contaminated wastes included heavy steel debris, lead bricks, baryte bricks, concrete pads, electrical cable, instrumentation and contaminated soil. Each of the pits contained heavy structural steel including up to 10 large steel plates, each 50 mm thick, and structural beams associated with the test device. The total of the pits were expected to contain on the order of 2 kg of plutonium. The pits were subsequently covered with reinforced concrete caps. Figure 1 shows a photograph of one of the open pits in the early 1960's.

Figure 1. Photograph of an open pit in the early 1960's.

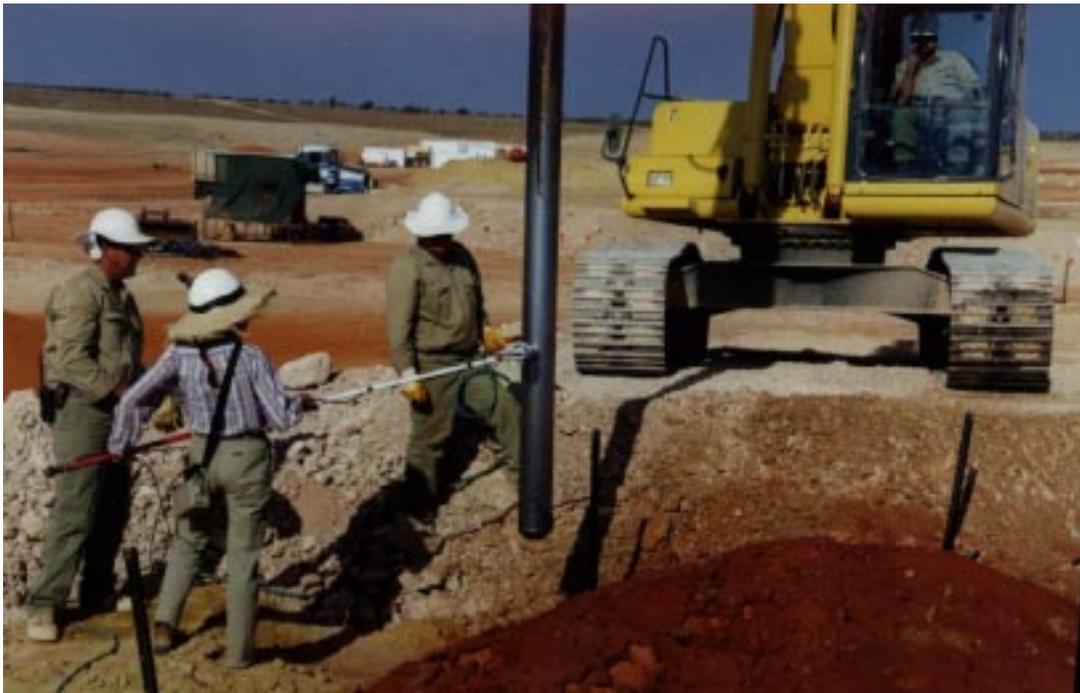
Pit probing involved the use of a heavy steel rod affixed to a hydraulic rock hammer mounted on a tracked excavator. The rod was driven vertically down into each pit over a grid pattern in an effort to collapse and fill voids. This technique was also used to try to locate the lateral boundaries of the pits and later in an attempt to determine the pit depths. A photograph of pit probing activities is provided as Figure 2.

Figure 2. Health Physics check of probe surface during probing of Taranaki Pit 3. Due to the nature of the contamination in the pits and the presence of clean cover soil above the pits, the retracted probe did not normally have significant surface contamination.

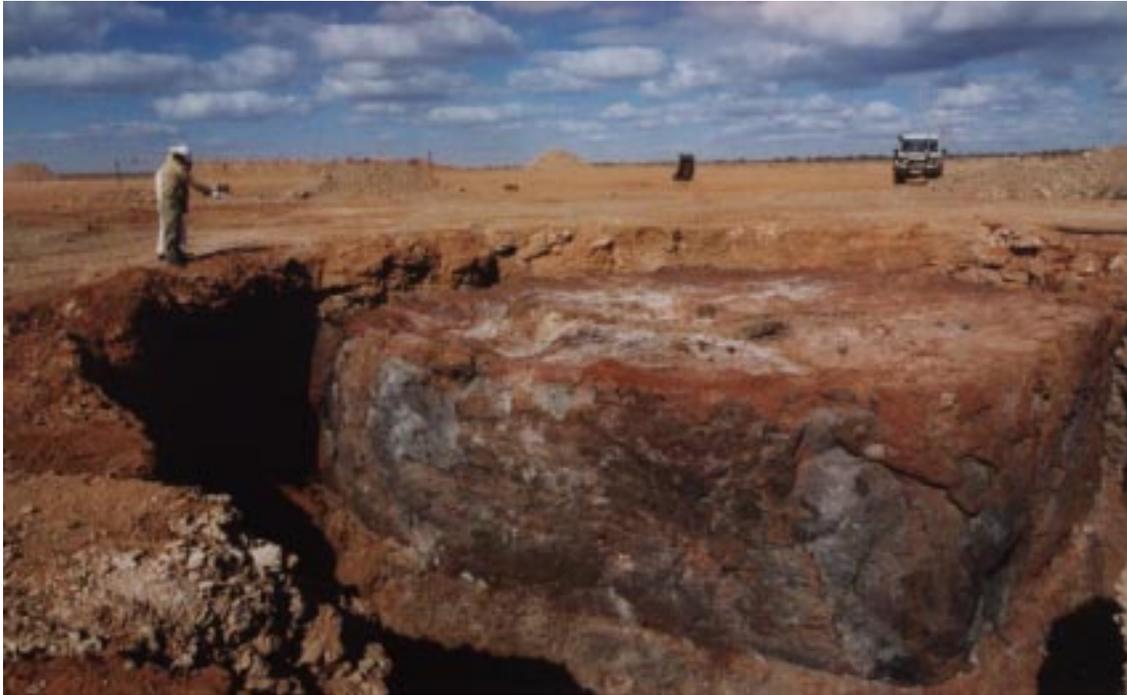
A total of 11 pits were treated with the GeoMelt-ISV process. The resulting vitrified monoliths associated with each pit were all intrusively sampled and examined to characterise the vitrified product and to confirm the completeness of treatment. To confirm whether or not the process had treated the whole of each pit the vitrified monoliths were all exhumed. A photograph of one of the exhumed monoliths is shown in Figure 3.

Figure 3. 500 tonne vitrified monolith resulting from the treatment of Taranaki Pit 19A.

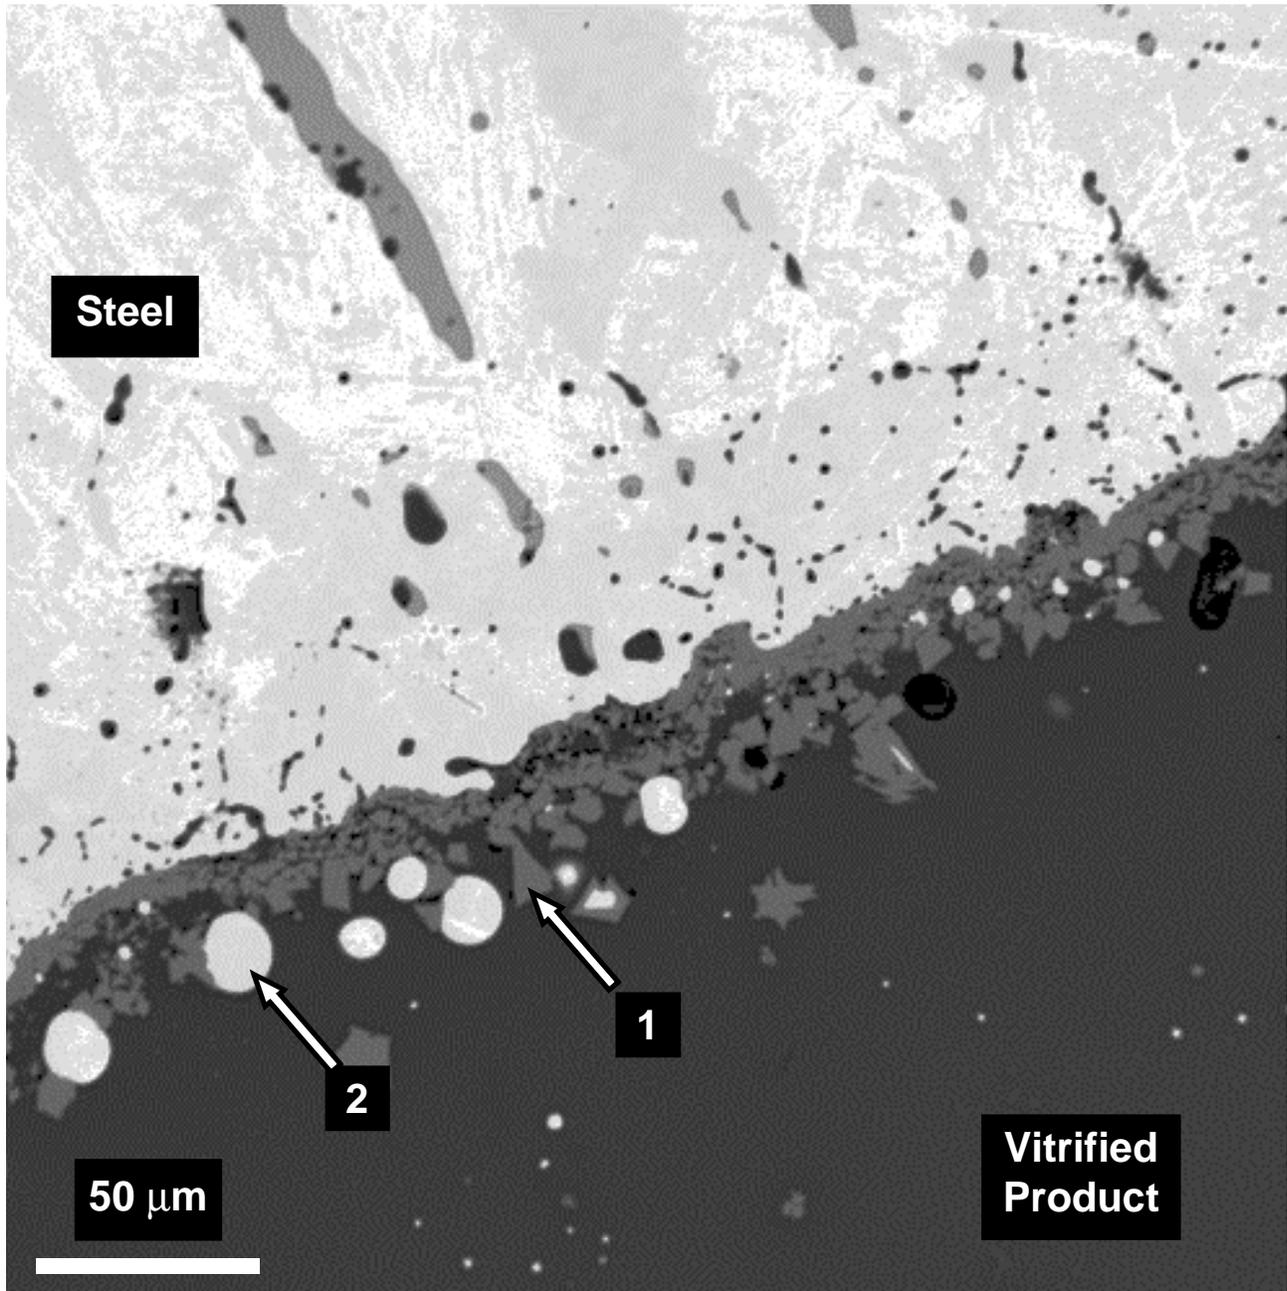
For those cases where the steel fully melted and pooled at the base of the melt, there was an apparent absence of plutonium in the melted steel ingot. For those cases where the steel did not melt, there was also an apparent absence of plutonium contamination on the surfaces of the steel exposed to the melt. Samples of unmelted steel in contact with vitrified product (the melt) were collected and studied. Electron photomicrograph analyses revealed that the corrosiveness of the melt was sufficient to promote active dissolution of the steel surfaces, which resulted in transferring plutonium from the steel into the melt (refer Figure 4). Iron rich minerals and particles of essentially pure iron were observed being incorporated into the vitrified product at the transition zone between the steel and the melt. Thus, the contaminated steel debris in contact with the melt was decontaminated by the GeoMelt-ISV process either by the complete melting of the steel or through the dissolution of the steel surfaces exposed to the corrosive melt.

Figure 4. This image is a high-magnification electron photomicrograph of the interface between a piece of stainless steel and vitrified product. The image shows the dissolved surface of the steel. The crystals (point 1) next to the heavily corroded steel interface are Mg-Al-chromite and contain nearly 60% chromium in the trivalent state. Iron droplets (point 2) are almost pure iron. The dissolution process shown in the image results in the removal of radioactive contamination from the surfaces of the steel to the melt where it is immobilised in the vitrified product.

Examinations of steel debris samples in contact with vitrified product established that the corrosiveness of the melt was sufficient to dissolve the steel surfaces in those cases where the steel did not appear to melt. This resulted in the transfer of the plutonium contamination from the exposed surfaces of the steel to the melt. There was no indication that plutonium was present in the melted steel phase when such a phase was present at the base of the vitrified monoliths.
