**157 \* 10<sup>6</sup> MWH (ELECTRIC) WITH 6217 FUEL ELEMENTS - INTACT, LEAKY,  
DAMAGED AND EXPERIMENTAL. AND NOW ?  
THE FUEL MANAGEMENT IN THE SWITCHED OFF NPP NORTH (GERMANY)**

Energiewerke Nord GmbH (EWN), Germany  
Postfach 1125  
D - 17509 Lubmin (Germany)  
Tel. +49 38354 / 4 5520  
Fax + 49 38354 / 4 5333  
e-mail [ewn1@ewn-gmbh.de](mailto:ewn1@ewn-gmbh.de)

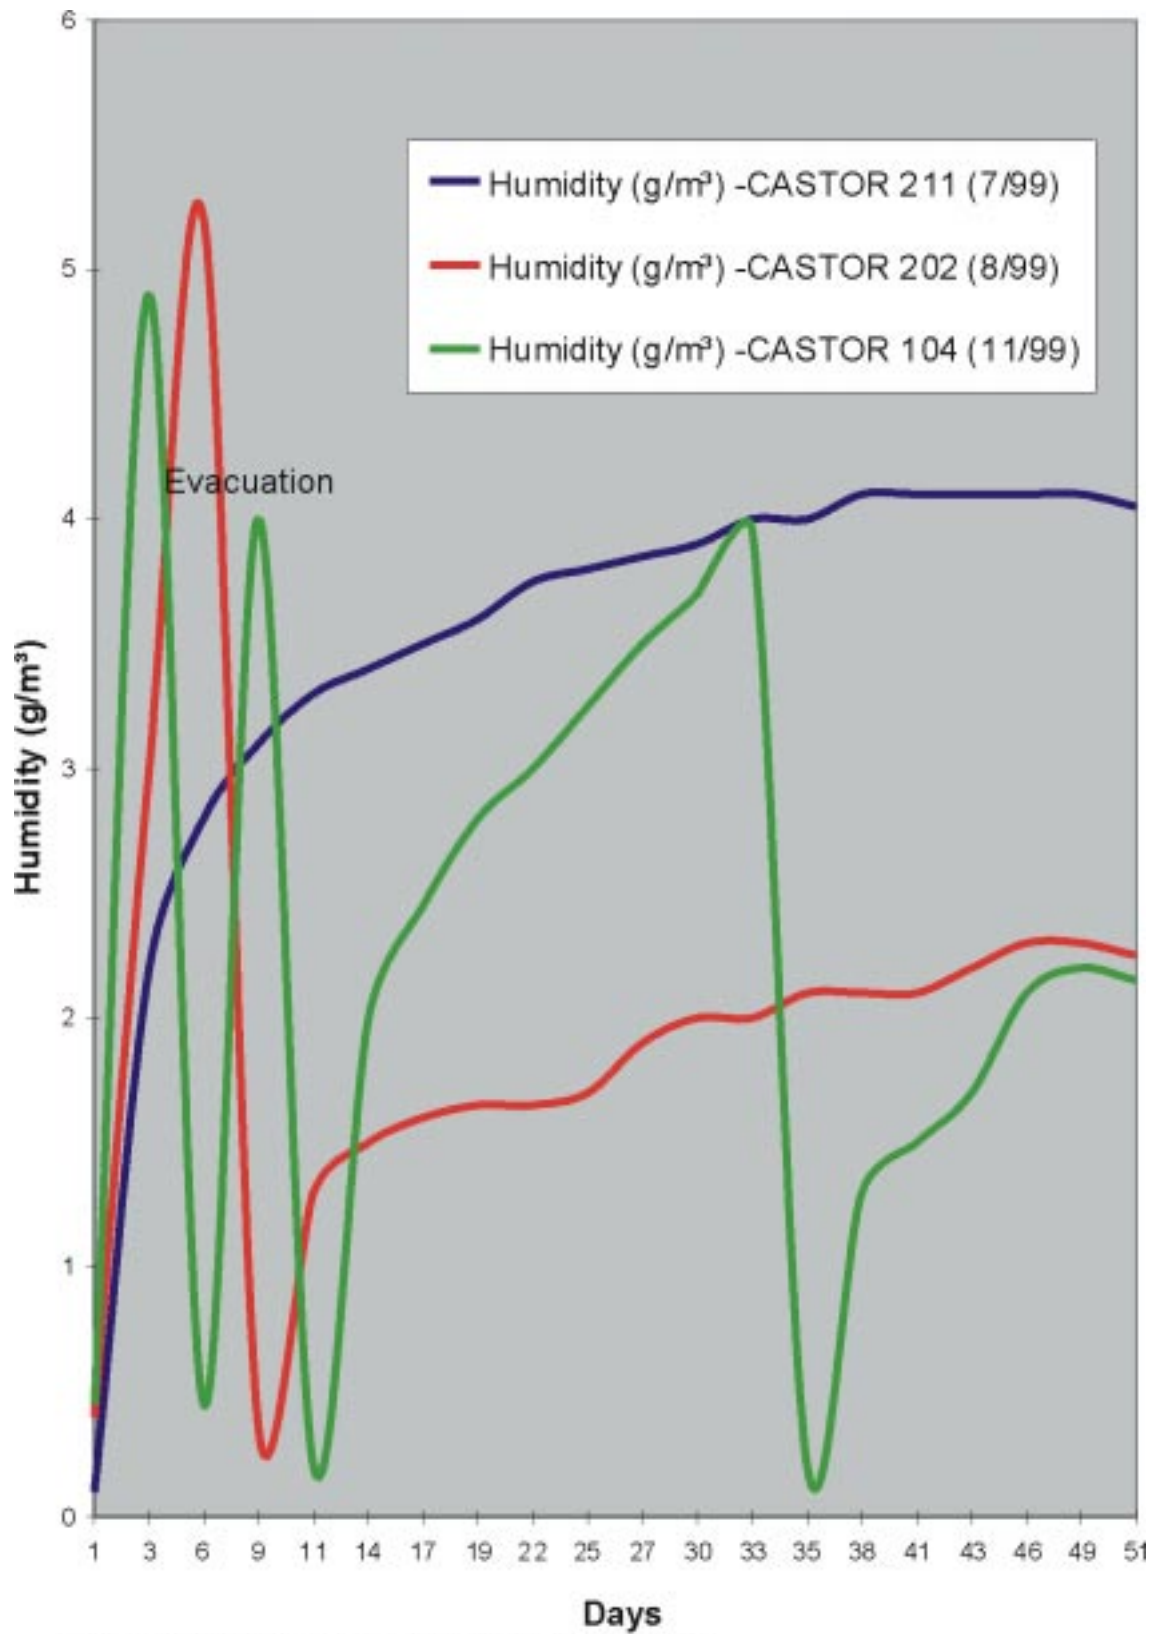
Fig 2: Humidity watch after drying (curves smoothed)

Humidity in the cask mainly can cause difficulties during storage over 40 years. To remain hermetically sealed no more than 4,8 g/m<sup>3</sup> or all 21 g water is allowed per cask. One fuel rod can contain 13 g if leaky or damaged. Therefore a detection of the defect rate (Tab. V) was required /2/. 24 defect rods or 314 g water was theoretical the maximum in a CASTOR-cask, still 310 g to much.

With 2 kg adsorption agent ( ZEOLITE <sup>d)</sup>) about 400 g water can be collected in the cask. Thus, the humidity will not cause problems.

To be sure that the basic humidity is not too high, a time consuming measurement procedure is applied (Fig. 2). Dry seals at the primary lid of the cask required a special clearance procedure after an under water loading, protection against contamination too.

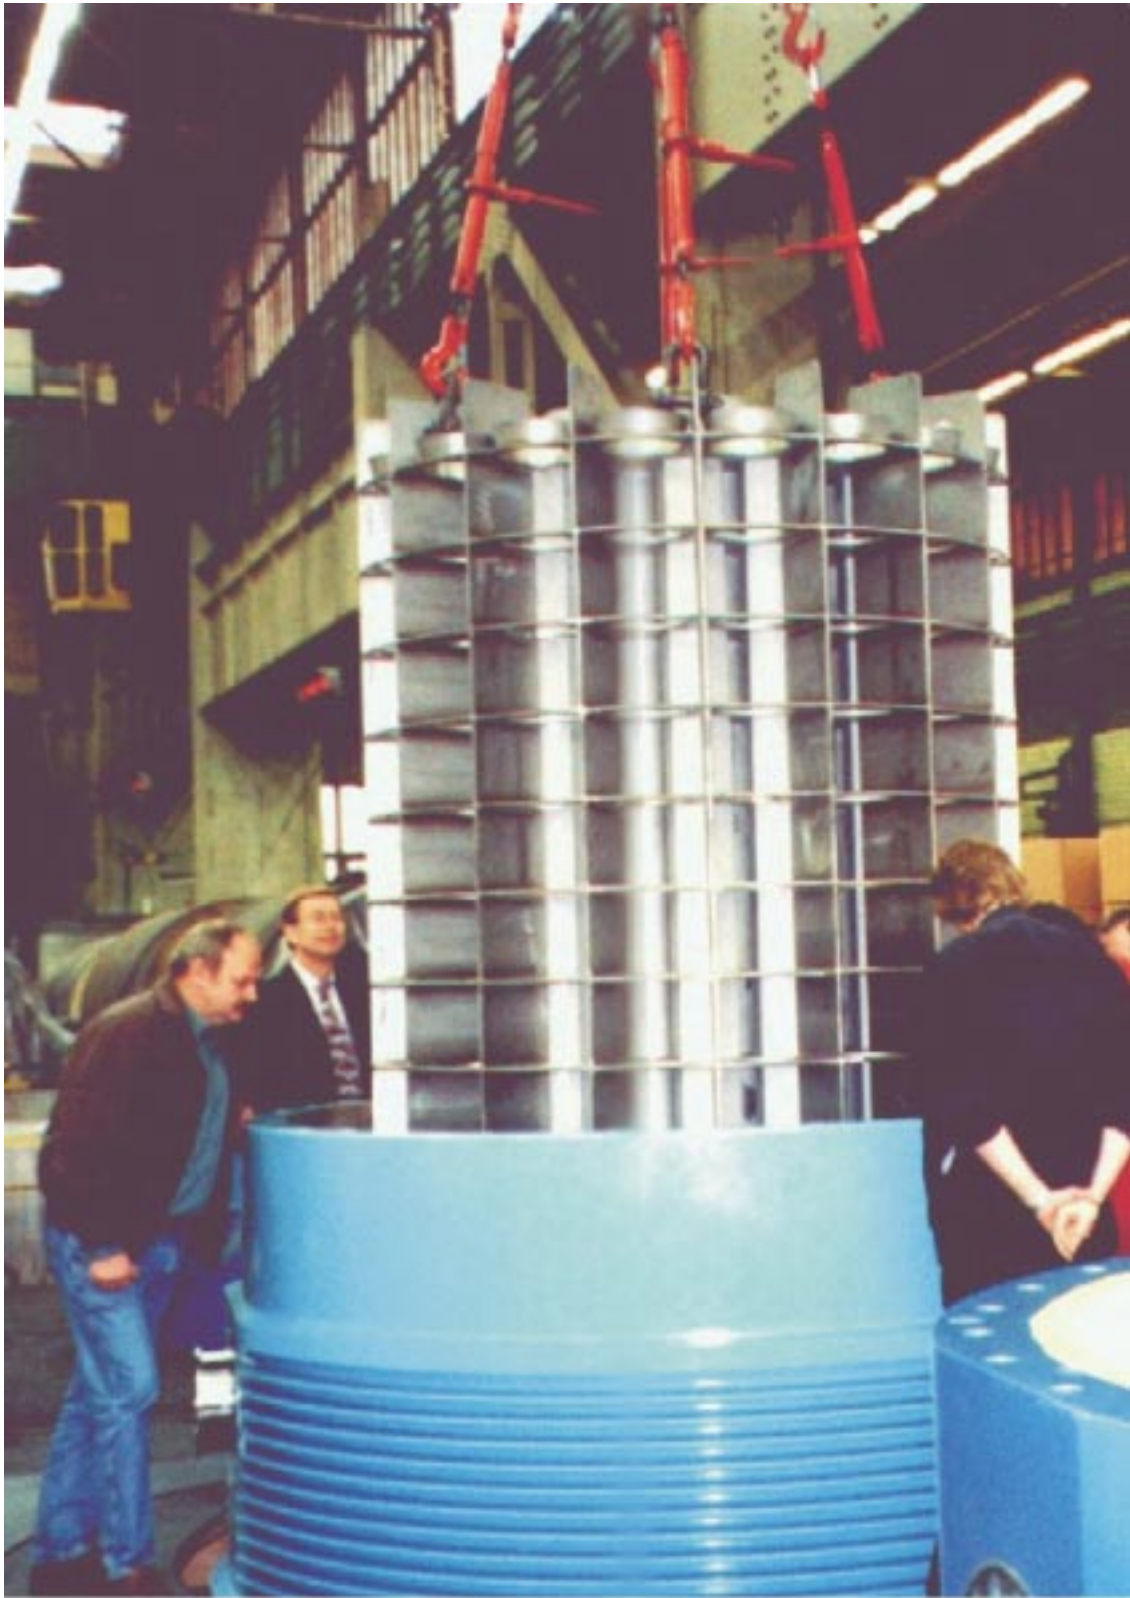
Fig. 3: Special basket for special fuel

The chosen cask was a CASTOR cask type with adapted basket (Fig. 3). This basket contains 14 intermediate bottoms with support plates and holes to carry the inventory with and without tubes.

One storage position was reserved for 25 kg ZEOLITE to collect water during loading and storage. To load all parts into the cask, difficult operations in an already existing hot cell were performed (Table VI).

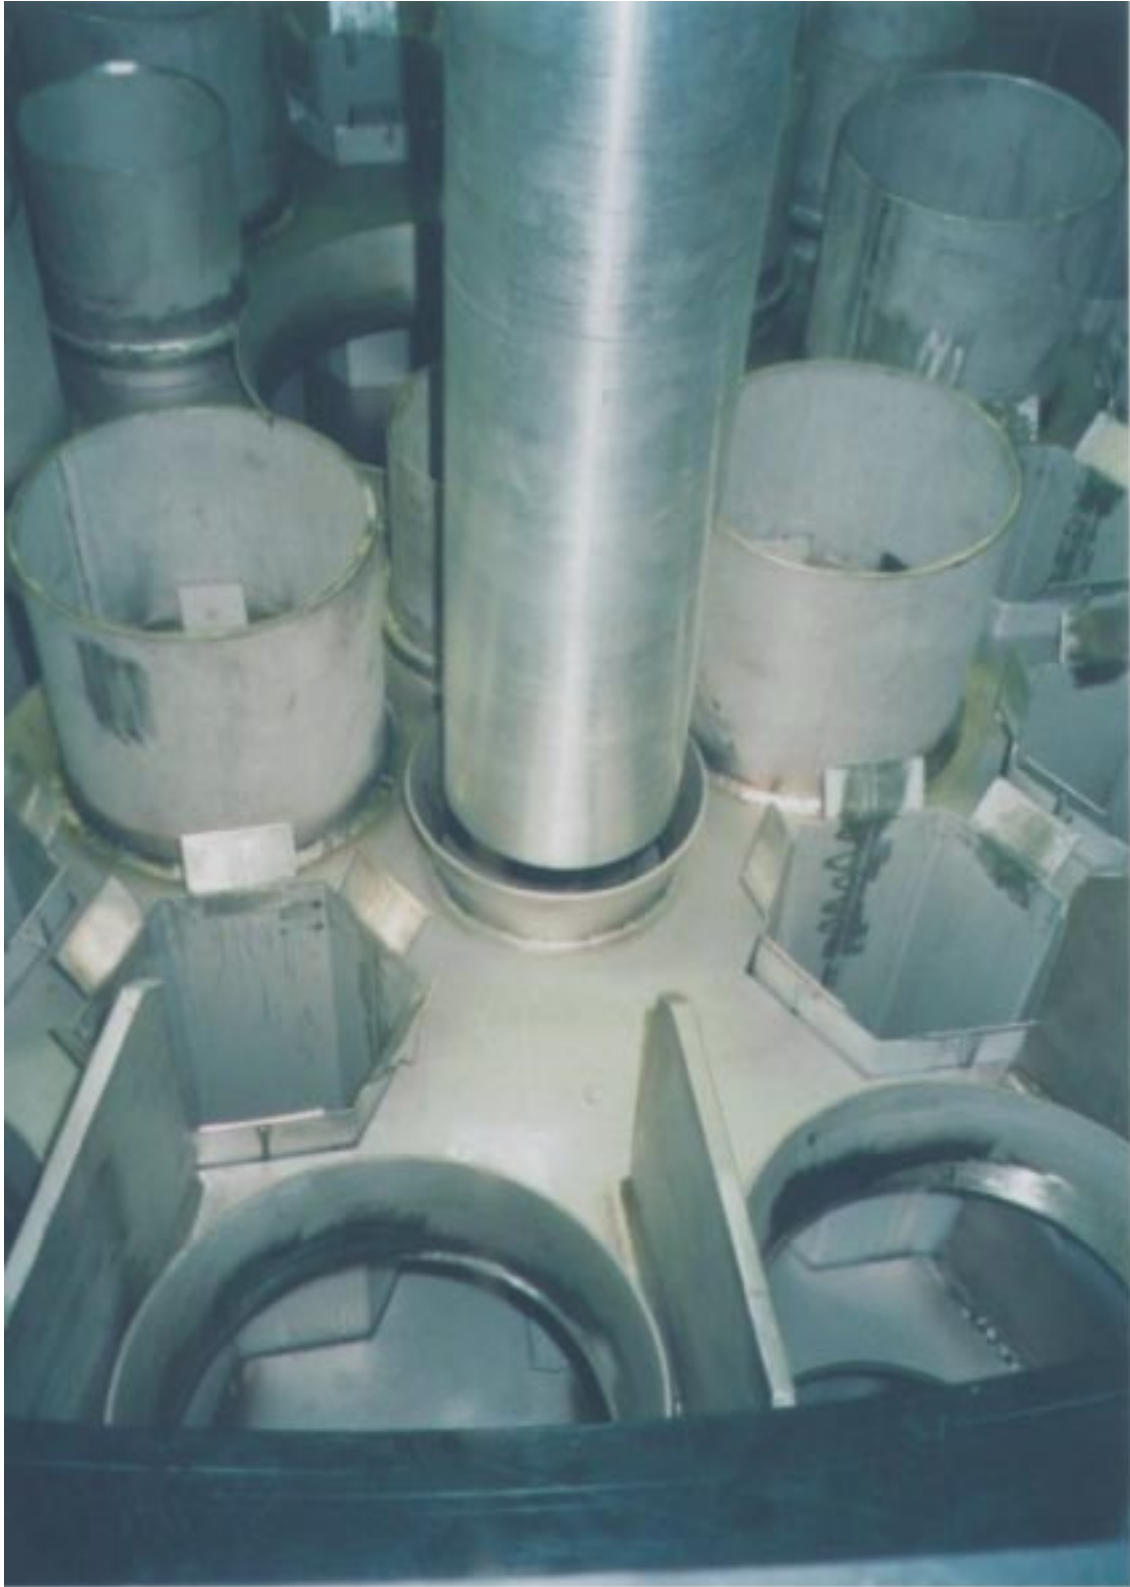
Fig. 4: Calibration tube for Zeolite

The conditioning of the parts was executed with qualified in plant staff. Complicated work steps were thoroughly trained in the front-end under control of the authorised experts (Fig. 4).
