DISPOSAL OF THE PGE TROJAN REACTOR VESSEL- SWEATING THE DETAILS

M.S. Cade, PE, US Ecology, Oak Ridge TN
J.A. Shaffner, PE, US Ecology, Richland , WA

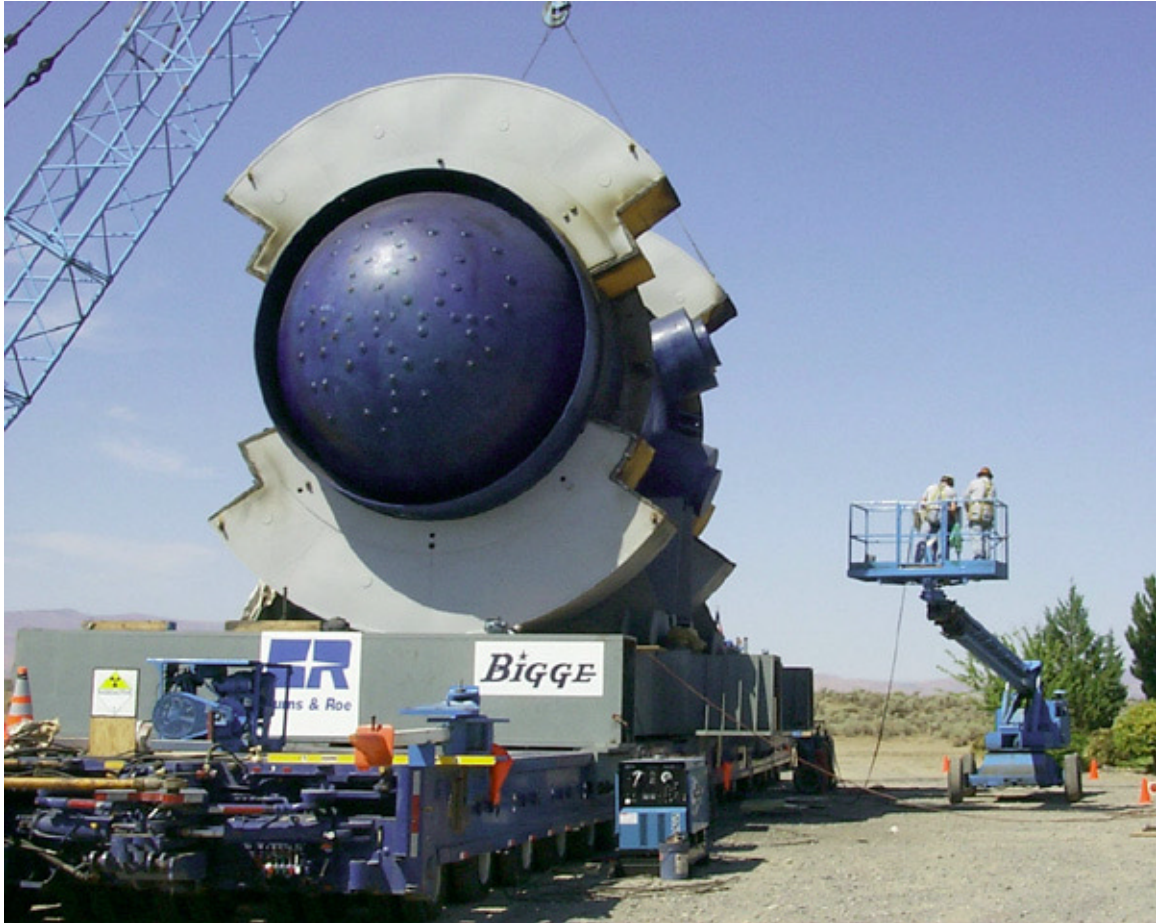
Fig. 2. Removal of Impact Limiters (photo courtesy of Dyncorp).

The RVP arrived on-site in the early morning hours of August 9th. A radiation work area was immediately established around the RVP and transporter in the parking lot between the US Ecology administration building and facility maintenance shop. The transporter and RVP were surveyed in accordance with receipt and incoming shipment criteria (8) as well as to confirm that non-radiation administrative staff working nearby would be adequately protected. Then radiation workers began preparatory work for disposal. The main work effort outside the permanent radiation controlled area involved removing, in sections, metal and foam impact limiters which had protected the RVP during transportation (Fig 2).
