D&D OF A PU EXTRACTION FACILITY IN VNIINM

S.V.Mikheikin, S.L.Khrabrov, A.Yu.Smirnov, L.V.Pronina,
P.P.Poluectov, V.F.Derzhavin, A.Ya.Chilikin (VNIINM)
V.D.Akhunov (Minatom)

Old Pu extraction facility was decontaminated and decommissioning in VNIINM in 1999- 2000.

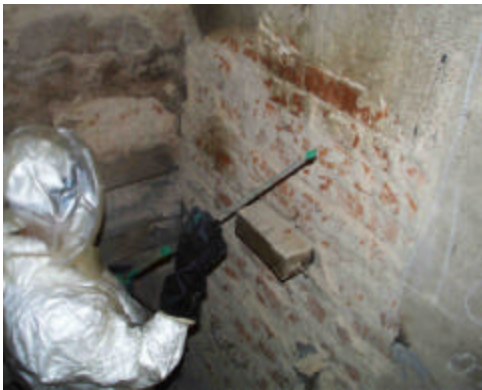
Fig 2. Application of dust-suppressing polymers

As for shift 2, U-235, Pu-239, Cs-137 and Sr-90 were major contaminants (60 a-part.min./cm², 500 B-part.min./cm², **the mean equivalent dose** being as high as 0.1 mR/hr). The surface of metallic staircases and wall plasters (at a depth of ~3 cm) was contaminated. All plaster contaminated was to be demolished. To suppress dust, beforehand the walls were treated with interpolyelectrolyte complexes (MM-1, MJ-1). The plaster was chopped off by hand-operated electric tools adapted to radioactive operating conditions. **Portable garbage** cans were used to reduce the possibility of secondary contamination.

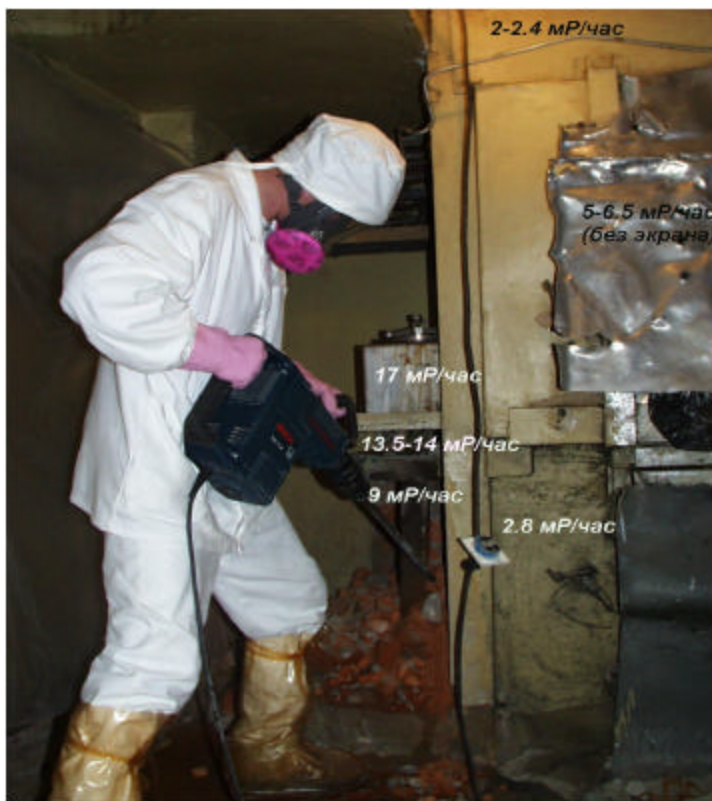
Fig. 4. Metering tank casing dismantling

The metering tank and sensors were enclosed in a steel/lead protective box (0.9x0.9x0.9 m) fitted with a batch-metering tube and placed into a stainless steel glove-box surrounded by brick/lead protective casing. The glove box was additionally protected by lead doors weighing 90-100 kg. each. The metering tank was equipped with a system of inlet and outlet stainless steel pipes 12-14 mm in dia at a height of 1.5-1.7 m. There were also two interconnected cylinders jointed to the feeder in the glove box.

Finally, the inner fittings (doors, pipelines and heavy metering tank elements) were withdrawn to facilitate the removal of the glove-box proper (Fig 4).

All inner surfaces of the metering tank were treated with our earlier developed decontaminating strippable PVA coatings. Beforehand brickwork was treated with aqueous IPEC-based solutions to suppress dust. Contamination levels inside the metering tank as high as $1 \cdot 10^5$ β -part.min/cm², 13 mR/hr for γ -radiation and 22-5 a-part.min/cm² were caused by Cs-137.
