## **A COMPLETE HISTORY OF THE HIGH-LEVEL WASTE PLANT AT THE WEST VALLEY DEMONSTRATION PROJECT**

Lawrence L. Petkus, James Paul, Paul J. Valenti, Helene Houston,  
West Valley Nuclear Services, WVNSCO  
and  
Joseph May  
U.S. Department of Energy

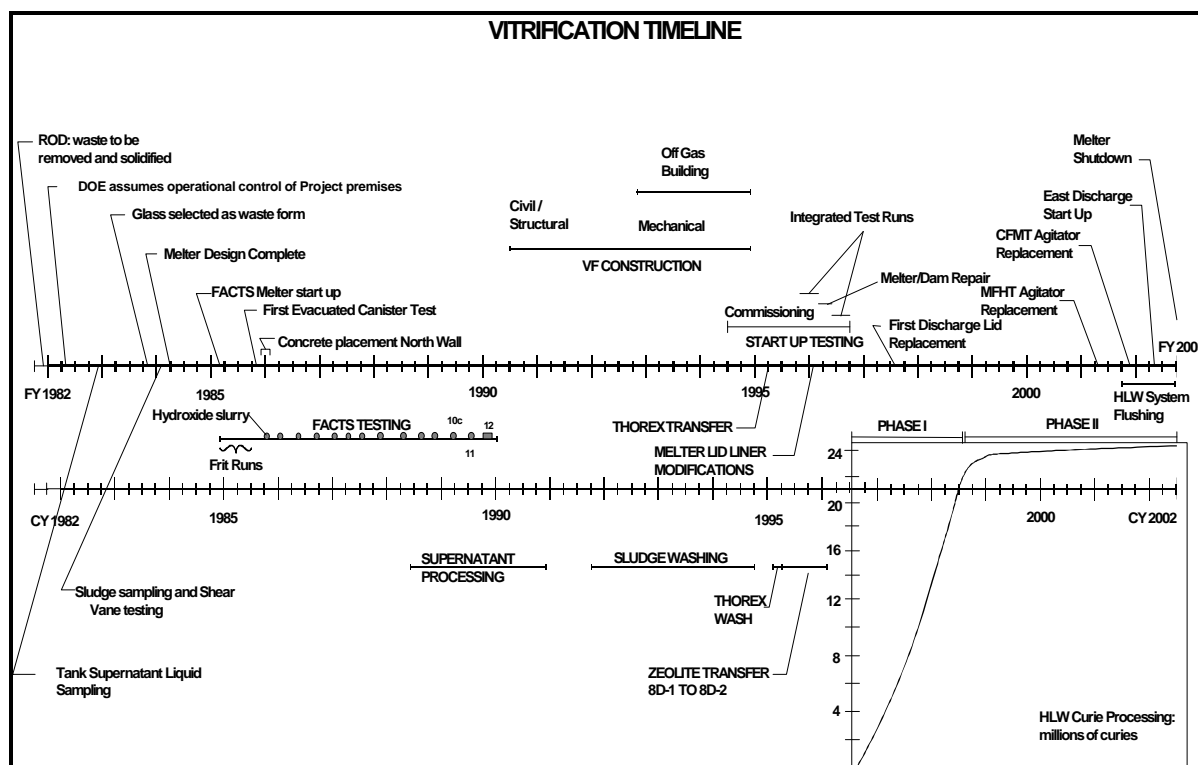
Fig. 1 Timeline

Based on analyses of the first HLW samples taken, the decision made was to use a chemical method to separate HLW from the liquid, combine it with sludge, and vitrify the resulting HLW mixture into a glass waste form. The proposed approach to chemically separate (pre-treat) the HLW also involved developing a method to process the resulting decontaminated liquid into an approved low-level waste (LLW) form. By taking this approach, it was possible to significantly reduce the amount of glass that needed to be produced while also ensuring the integrity of the final glass product. Once this processing decision was made, efforts got underway to select the best methods to achieve decontamination, process LLW, and produce a final HLW glass form. The general progression of events following this early process development decision is shown on the timeline in Fig. 1.

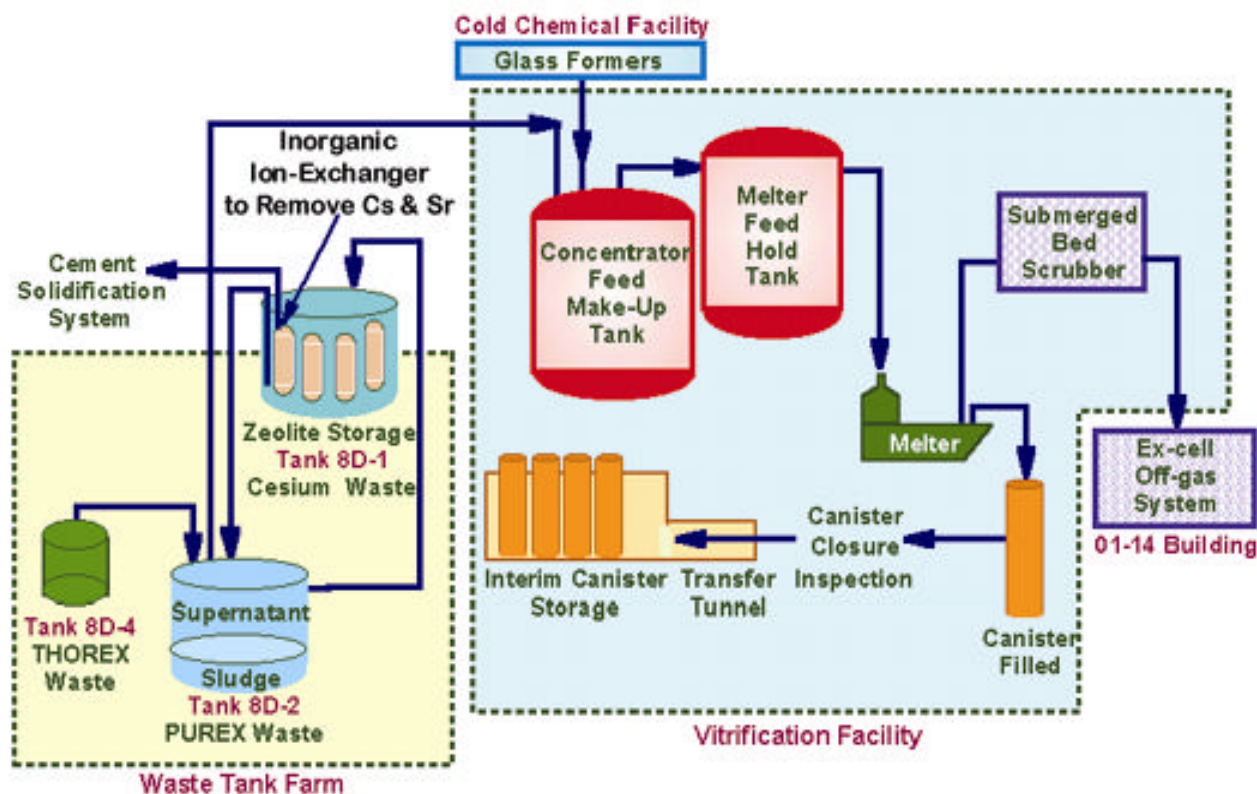
Fig. 2 HLW Process

The overall method developed for processing HLW involved preparing the HLW for processing by separating (removing) the majority of the radioactive species (Cs-137 and Sr-90) from the waste liquid, combining the resulting HLW with the waste sludge, and processing the HLW mixture into the approved glass waste form. After removing HLW from the waste liquid, the resulting low-level waste (LLW) liquid also was processed into an approved waste form, cement encapsulated LLW. The basic overall method and systems used to process liquid HLW into approved HLW and LLW forms are illustrated in Fig. 2.

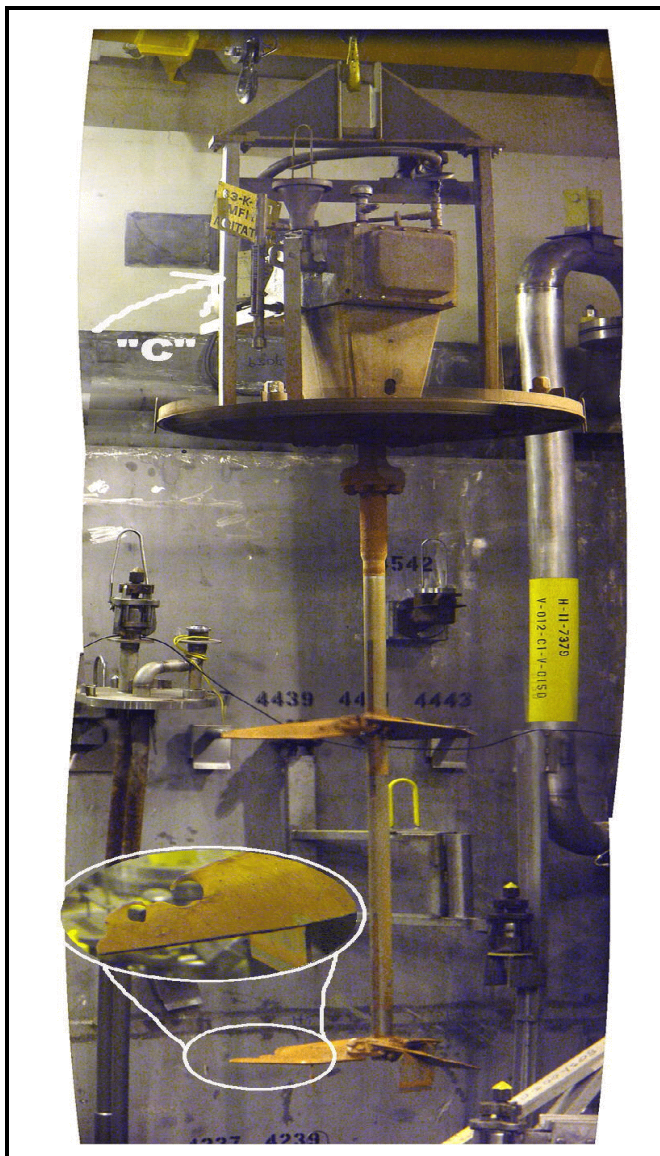
**Fig.4 MFHT Agitator**

for both agitators. Failure occurred within the flexible coupling, located between the motor and the gearbox, the metal grid holding the two mating hubs together (see Fig.4, "C"). The agitator manufacturer did indicate that grid failure occurs if the coupling is not greased periodically. When the motor housing was remotely removed from the coupling, a broken grid and hardened grease was found. As no method was available to replace the grid or the coupling, the entire agitator assembly had to be replaced. Blade wear was noticed on all blades after the agitators were removed from each tank. MFHT agitator failure occurred first because it was used on a full 24 hour cycle to keep feed slurry suspended during melter feed operations. Its blades showed the greatest amount of wear (see Fig.4 inset). Although the CFMT was used steadily, it was shut off when new batches of glass forming chemicals were being prepared.

**Agitators:** The homogeneous slurry mixture needed to make HLW glass was prepared and fed to melter using two slurry tanks, the Concentrator Feed Make-up Tank (CFMT) and the Melter Feed Hold Tank (MFHT). Homogeneity of slurry mixtures held in each tank was maintained by using commercial agitators that had been modified for remote service. Although the Vit Cell was not equipped to perform preventive maintenance on these agitators, it was possible to add oil to the agitator gear box using in-cell equipment. Radiation resistant lubricants were specified for periodic additions of oil. Generally one frame size larger than standard motors, the agitator motors were specified with a 1.15 service factor but were not radiation resistant. Both agitators failed after five years of radioactive service. Failure mode was identical

A number of preparations had to be made so that the replacement agitators could be moved into the Vit Cell, including construction of a tipping frame used to fit the agitator assemblies through the shield door during transfer cart operation. Replacement was accomplished by bolting the agitator onto the tipping frame, placing the tipping frame onto transfer cart, and moving the transfer cart into the Vit Cell. Once inside the Vit Cell, the frame was tipped upright, allowing lubricating oil to be pumped into the agitator gear box before installation.
