DECOMMISSIONING OF SHIELDED FACILITIES AT WINFRITH USED FOR POST IRRADIATION EXAMINATION OF NUCLEAR FUELS & OTHER ACTIVE ITEMS

RWE NUKEM Limited

ABSTRACT

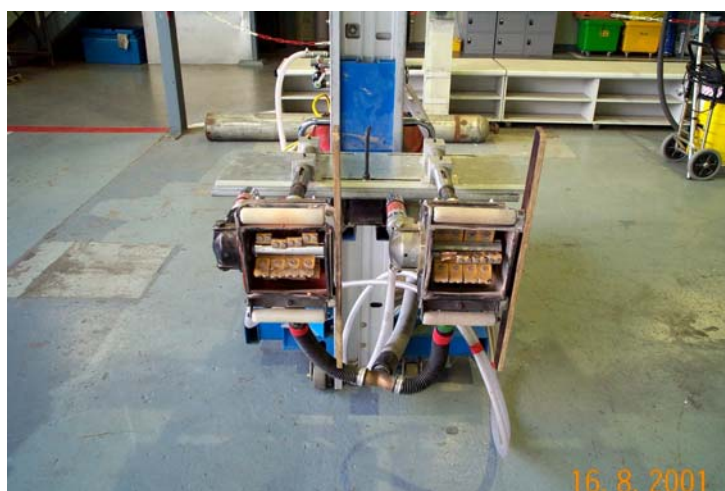
Once the cleaned surfaces were dry, they were then abraded using a range of suitable tooling that had been found effective for the purpose. The cave surfaces were both painted steel and concrete and 'Trelawny' units were used with suitable inserts to abrade them. These tools, Figure 4, comprise a series of hardened steel inserts connected to a central rotatable spindle by narrow leather strips.

Fig. 4. View of Trelawny Surface Scabbling Unit used in PSA Facility

The units are located inside a semi-circular housing from which a vacuum cleaner draws the air, dust and contamination freed by the abrasive action of the inserts. They can be operated either electrically and pneumatically but the operators developed a preference for the electrically driven units, which tended to be more powerful. In each cave, the removal of all the paint from the walls, floor and ceiling led to a significant reduction in activity levels with dose rate reduced to around $20\mu\text{Sv/h}$ in caves 4-7 and around $100\mu\text{Sv/h}$ in Caves 1-3. At this point the surfaces were resealed with various paints to protect them into the next stage of the cave decontamination and decommissioning process. This allowed the cave windows to be drained of their zinc bromide and then removed from the structure. The means of carrying out this routine task lies outside of the scope of the paper, but it should be noted that each window comprised three items, a concrete framed tank holding ~ 920 litres of zinc bromide, a 100mm thick lead glass attenuator block and finally a 30mm thick piece of lead glass to seal the internal face of the cave.
